CRMC ASSENT APPLICATION – CONCRETE PEN STABILIZATION PROJECT
McALLISTER TOWING FACILITY
1 INDIA STREET, PROVIDENCE, RI

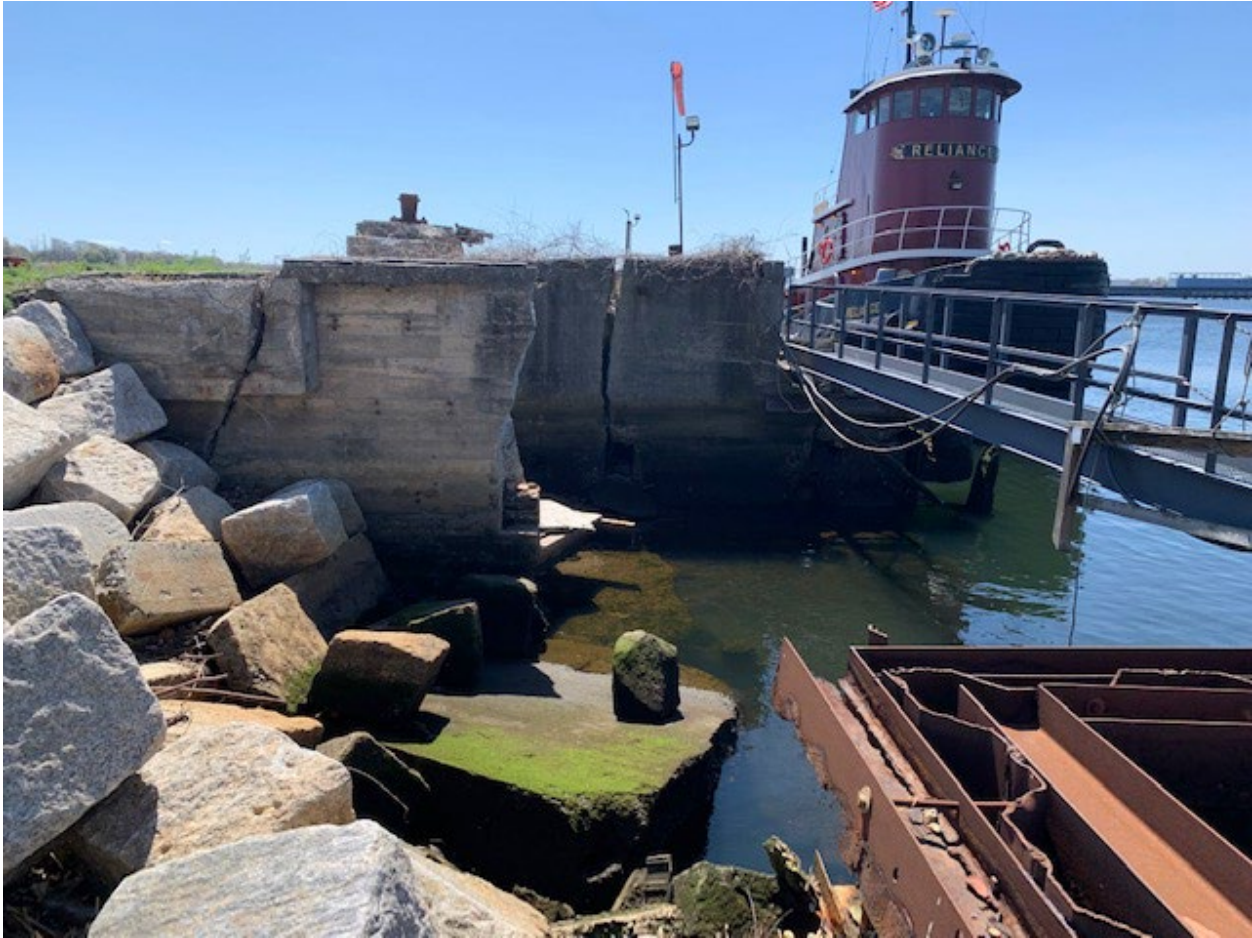
Photo 1: Overview of the north concrete pen; note partial failure and large crack in remaining wall (a portion of this structure (wall & slab) previously failed into the ship berth and required removal). The project would demolish the failed north wall of this structure, construct a stone revetment/rip across the pen floor area to the south wall (generally matching the profile of the existing revetment), and installing sheeting from the bulkhead at the south side of the pen across the opening to the steel sheets at the timber pier (generally aligned to match the aluminum bridge across the area. This work would stabilize the area and remove any future hazards to persons or navigation.

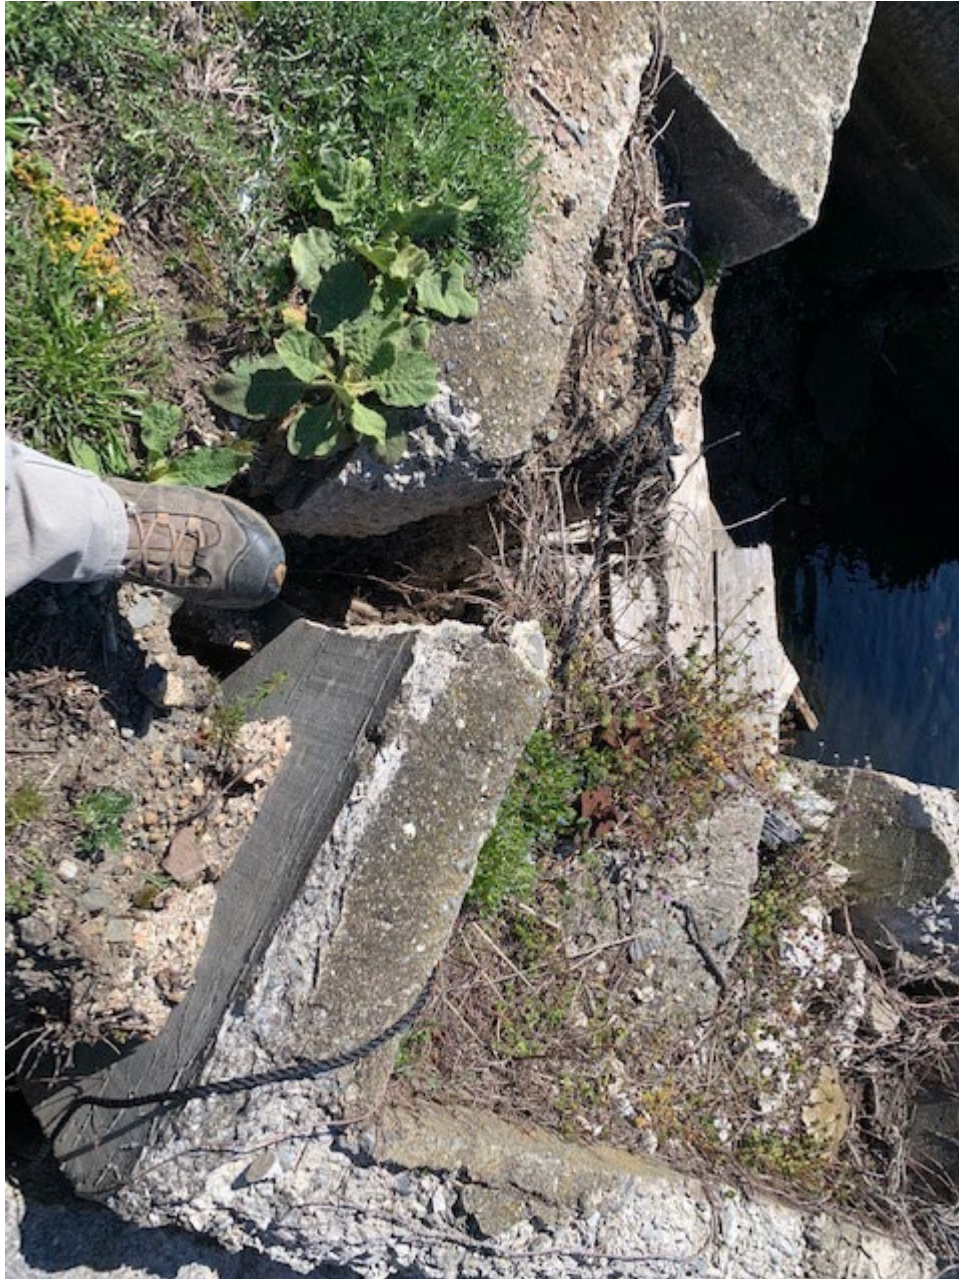
Photo 2: Large crack and displacement in back wall of north pen

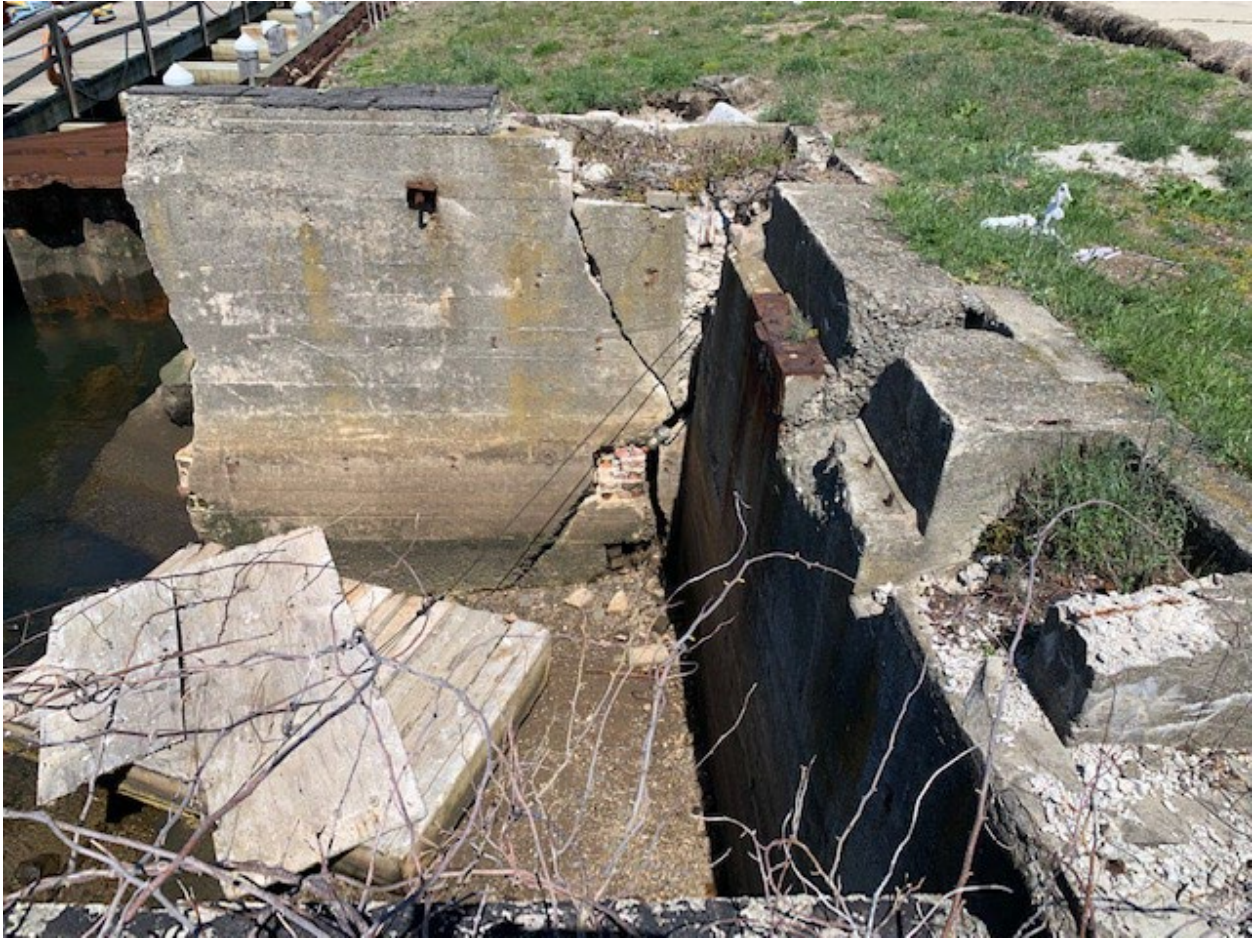
Photo 3: Overview of the north concrete pen; note partial failure and large crack in remaining wall (a portion of this structure (wall & slab) previously failed into the ship berth and required removal). The intent would be to demolish the north wall of this structure, return the proposed sheeting to a point about at the west end of the pen, and extend the existing stone revetment across the pen. This would stabilize the area and remove any future hazards to persons or navigation.

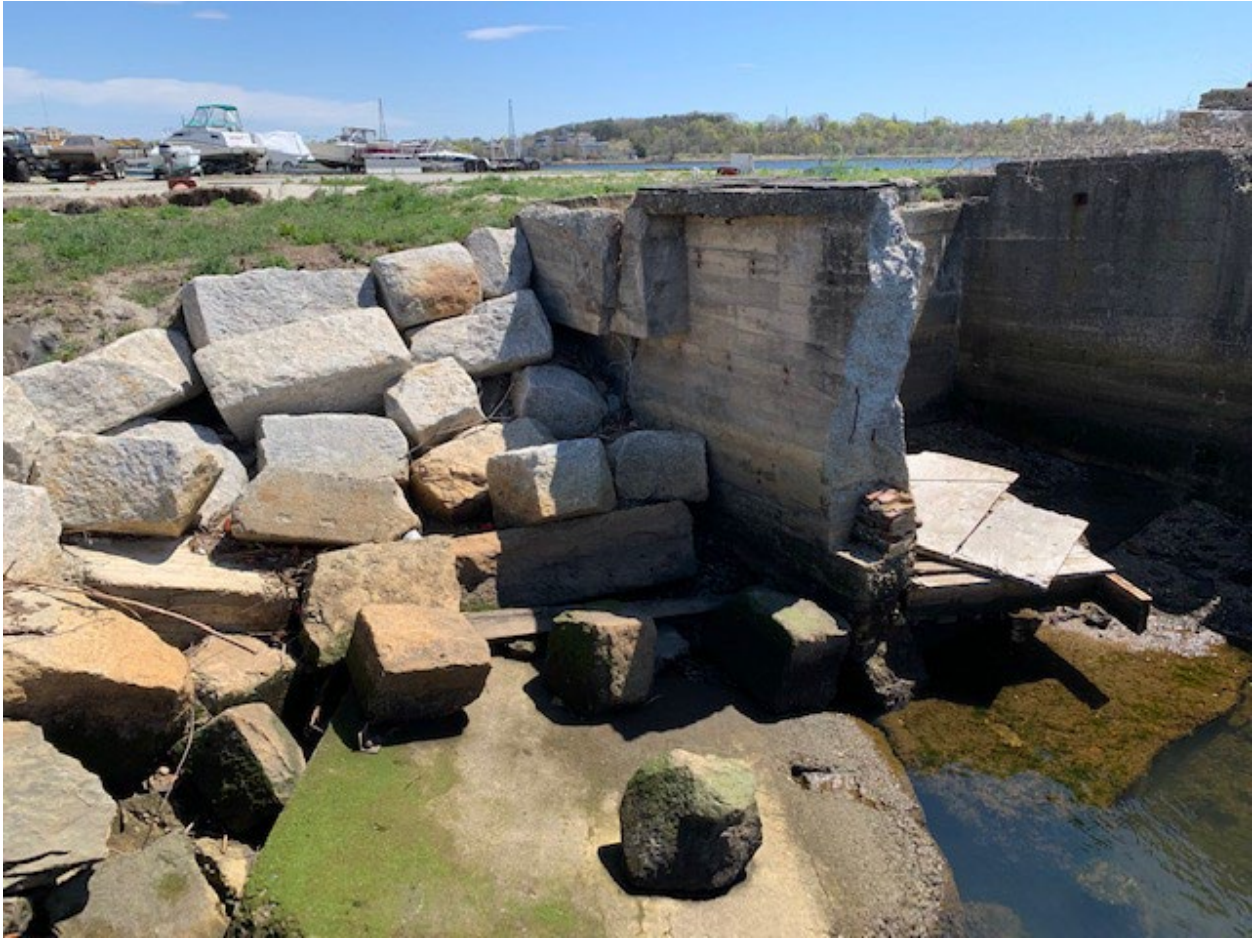
Photo 4: Stone revetment just north of the north concrete pen.

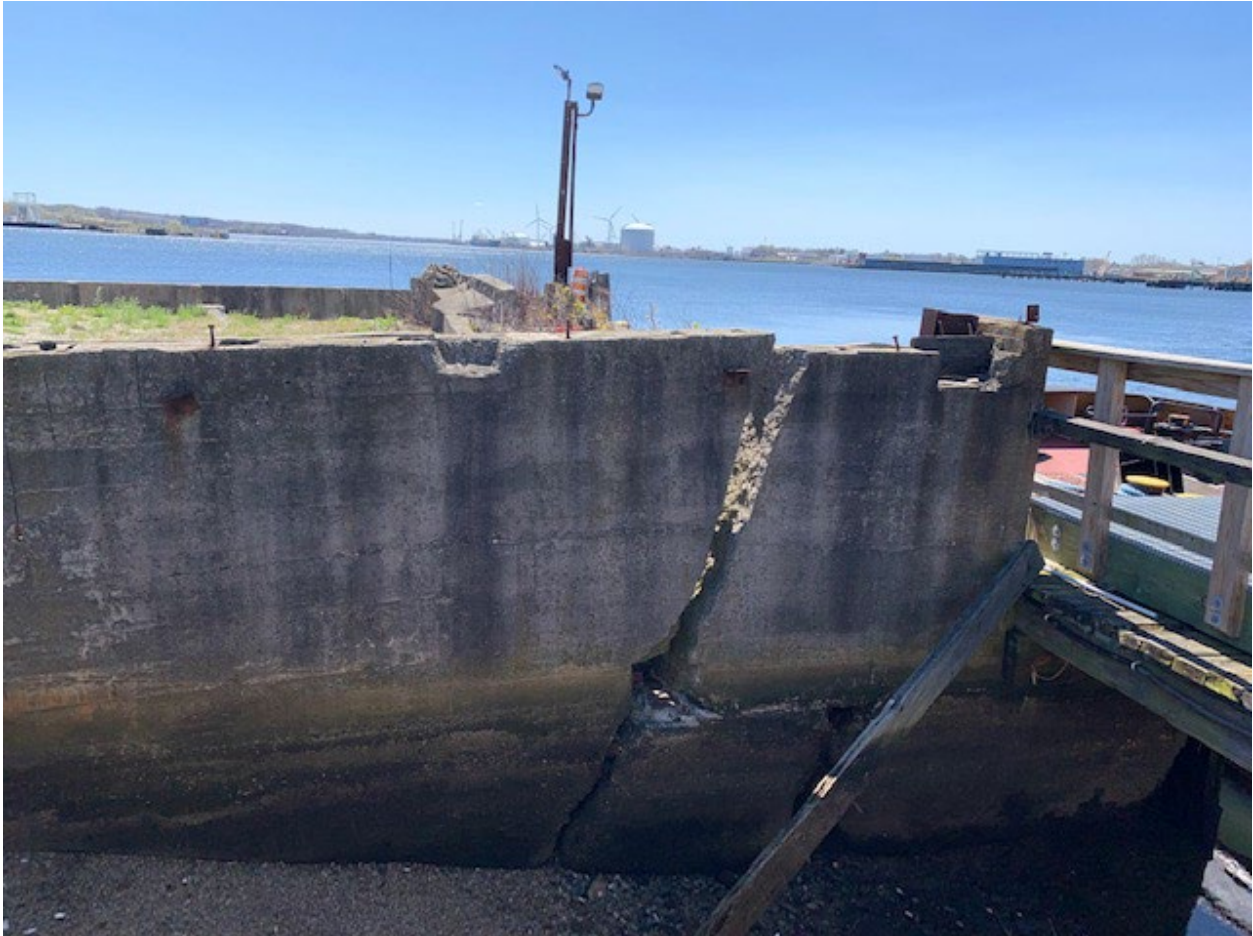
Photo 5: Failure/crack in the south wall of the south concrete pen; displacement indicates differential settlement across the pen. The intent would be to demolish the top few feet of this structure, extend the stormwater outfall through the steel sheetpile bulkhead , and backfill the area level with the adjacent ground. This would stabilize the area and remove any future hazards to persons or navigation.

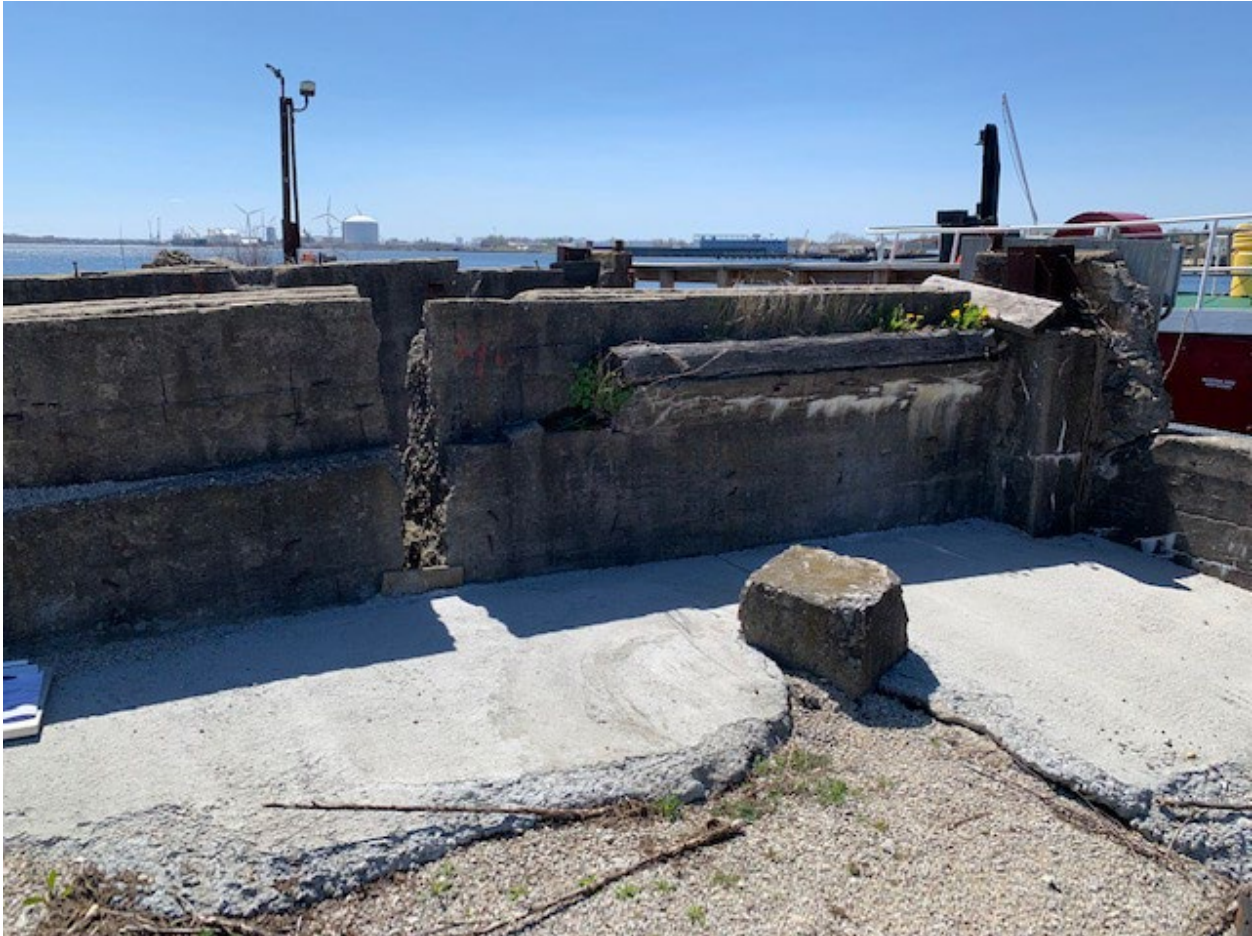
Photo 6: Failure/crack in the north wall of the south concrete pen; displacement indicates differential settlement. Note concrete placed in an attempt to address soil loss into the pen.

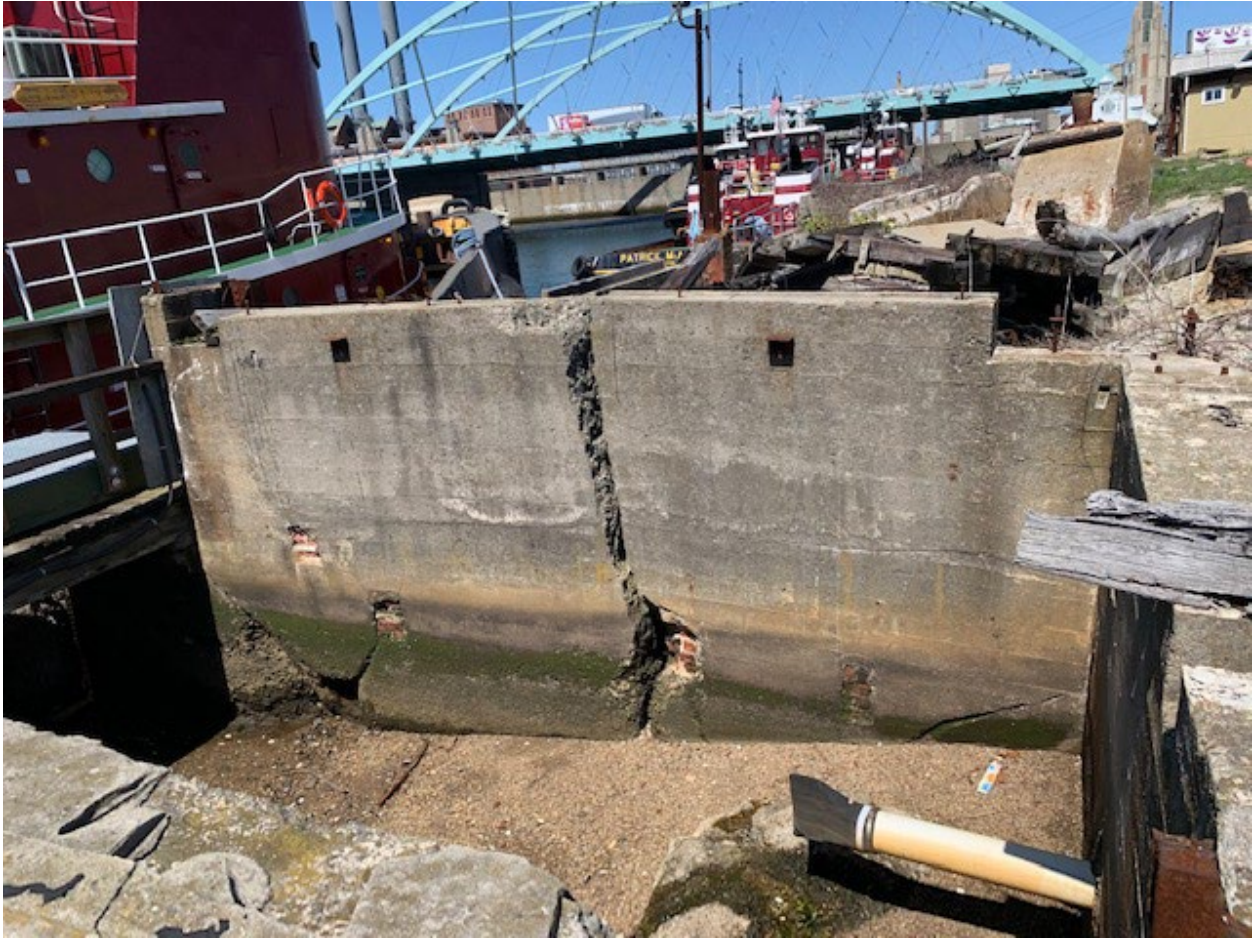
Photo 7: Failed north wall of the south concrete pen and 8" dia. stormwater outfall with duckbill valve. The intent would be to extend this outfall pipe through the steel sheetpile bulkhead. The mean high tide line was determined at this site from the black staining on the concrete walls. The soil above the concrete floor at the western end of the pen is believed to be the result of erosion of the upland soil through the large cracks in the pen walls.

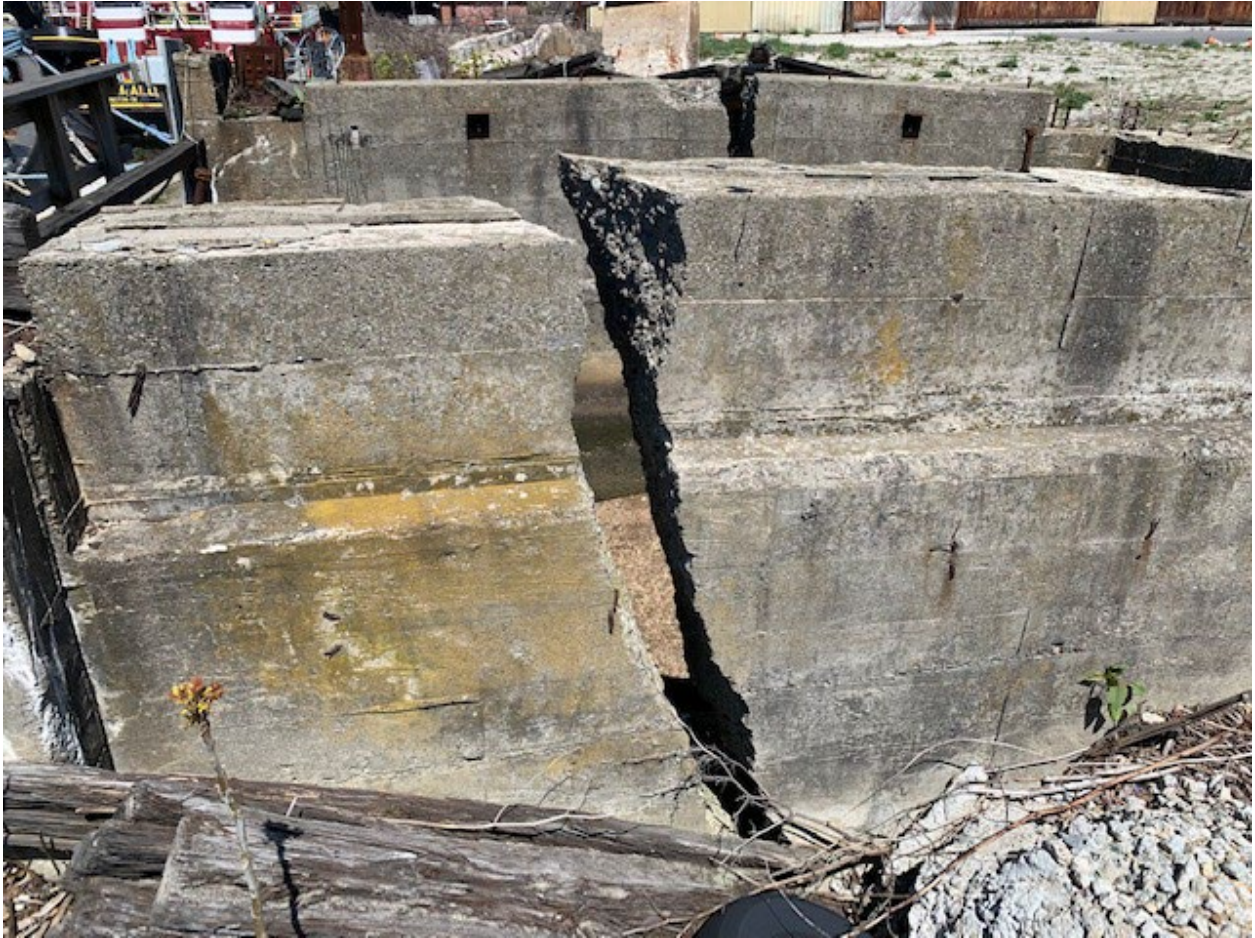
Photo 8: Close view of failure in south wall of the south concrete pen

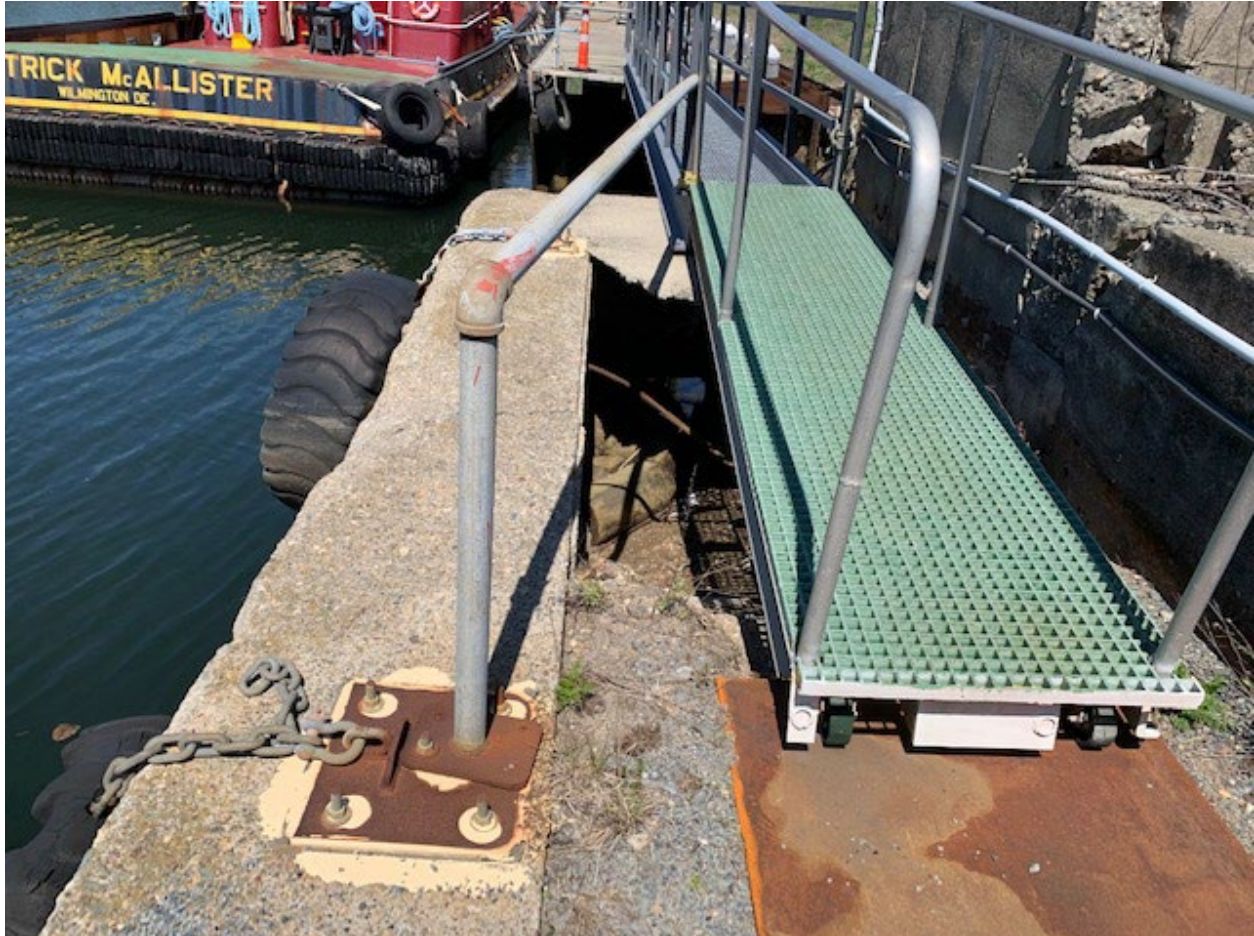
Photo 9: Severe settlement and soil loss adjacent to failing north concrete pen. This condition creates a dangerous condition at the support/landing at the pedestrian bridge used to access the south tug berth.

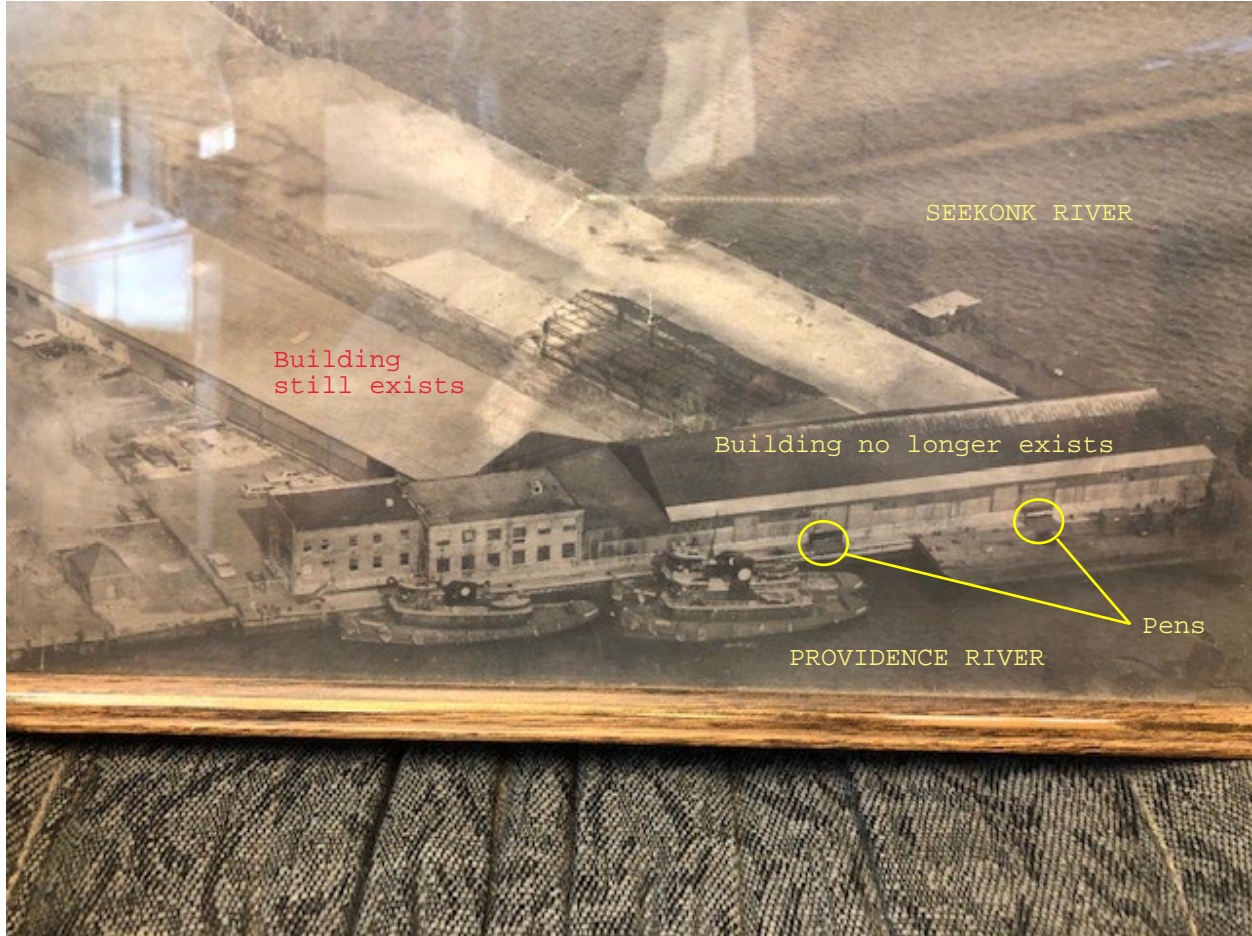
Photo 10: Aerial photograph from 1955 showing port area conditions when the building along the waterfront was still in place. Note the concrete pen areas at the face of the building.
