## **Application for State Assent**

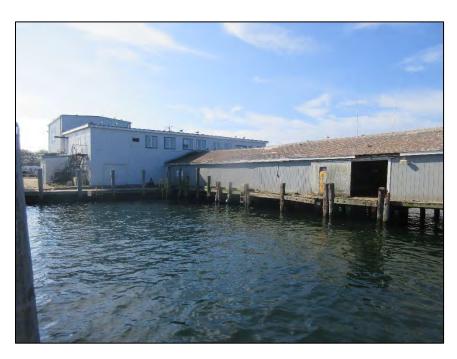
Photo 1: Pier F with missing and/or dislodged exterior chocks. Fenders along the building observed to be damaged and/or missing.

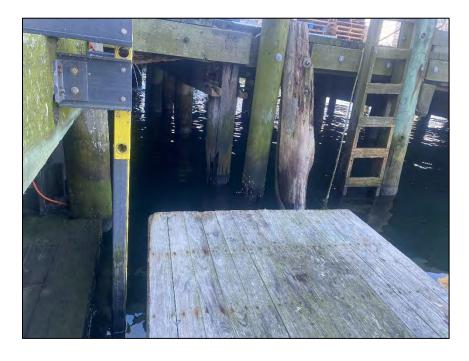
Photo 2: Support piles splintering and/or necking exhibiting signs that the piles are beyond the serviceable life in the current condition

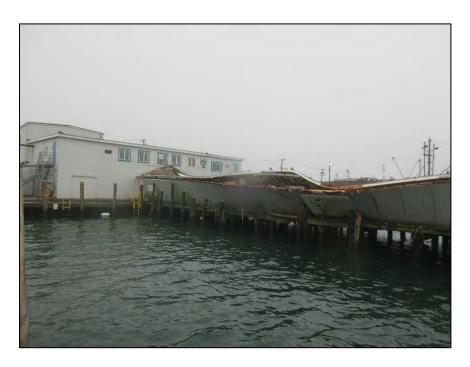
Photo 3: Prior to construction the building collapsed due to a snowstorm in March of 2023. The pier at this time in not in operation.

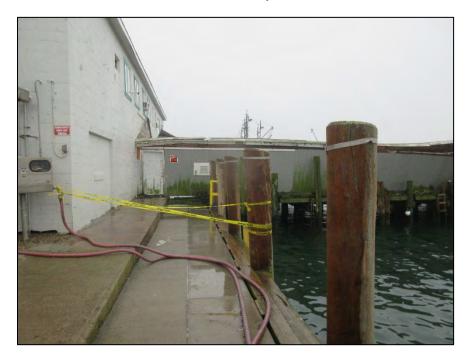
Photo 4: Original pier elevation continuing at an elevation higher than the existing bulkhead to connect to the landside buildings FFE.

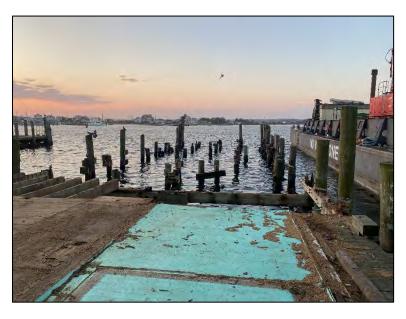
Photo 6: View of the 5-pile alignment post building and pier removal.
