Block Island Wind Farm CVA

Status of Verification of Substructure
Installation (July 19 to August 24)

August 25, 2015

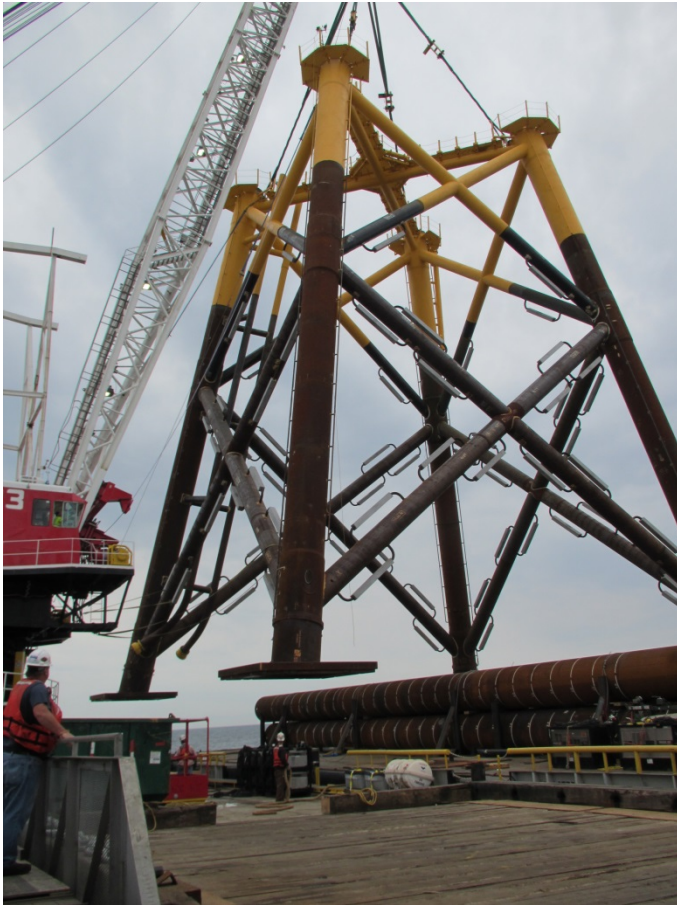
Jacket 1 – Lift from Cargo Barge

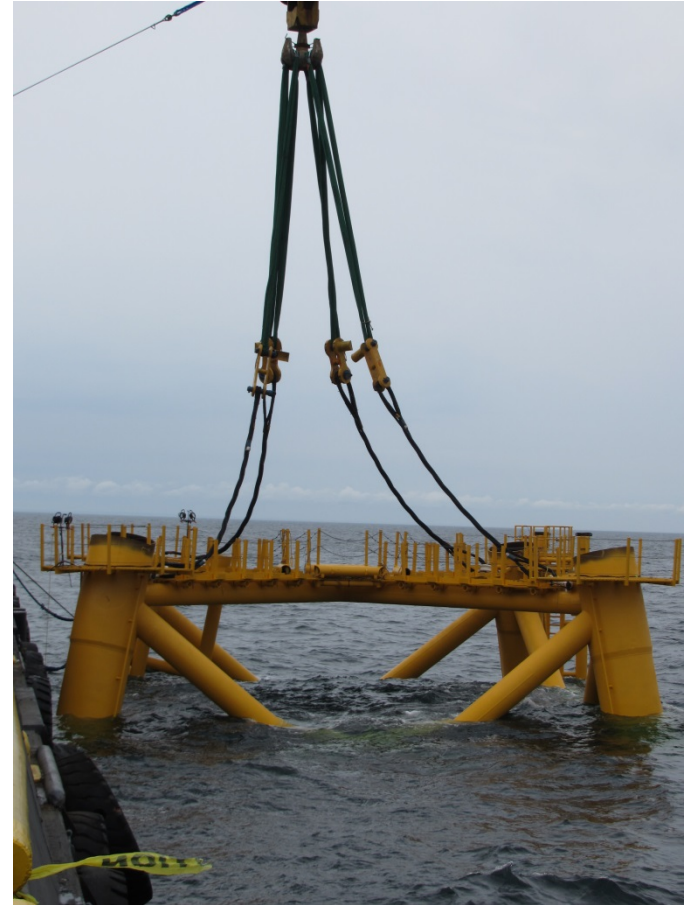
Jacket 1 - Installed 7/26

Jacket 1 later removed after damage – now in dock in New Jersey for repair

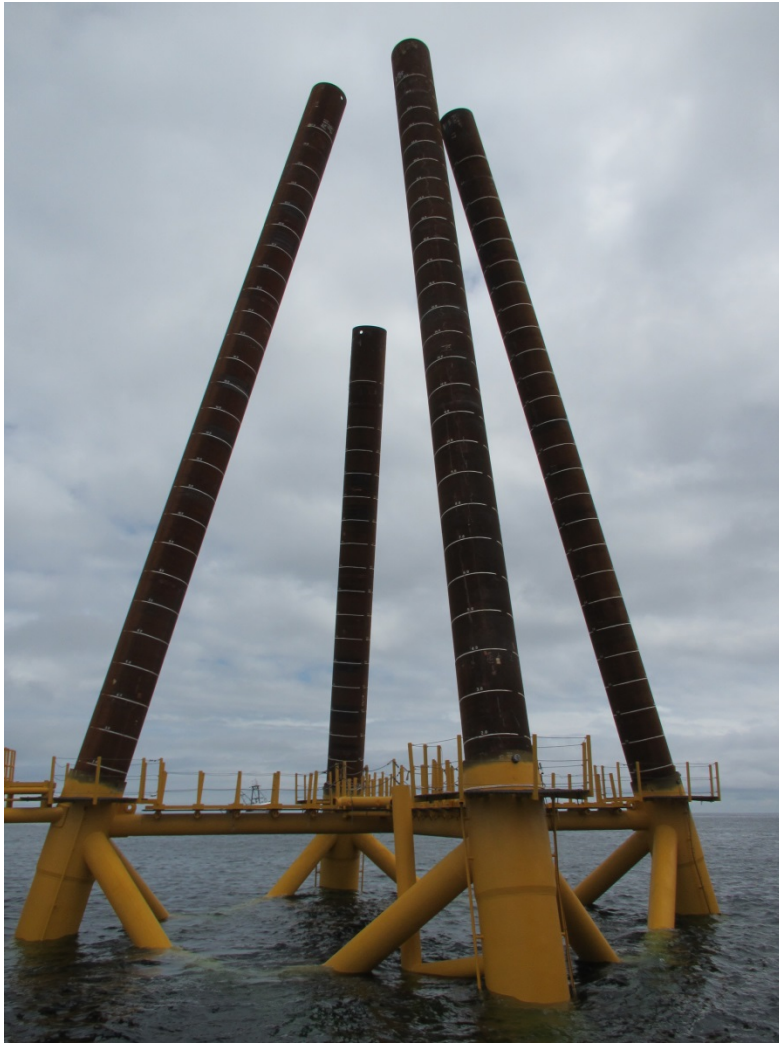
Jacket 2 – P1 Piles Stabbed

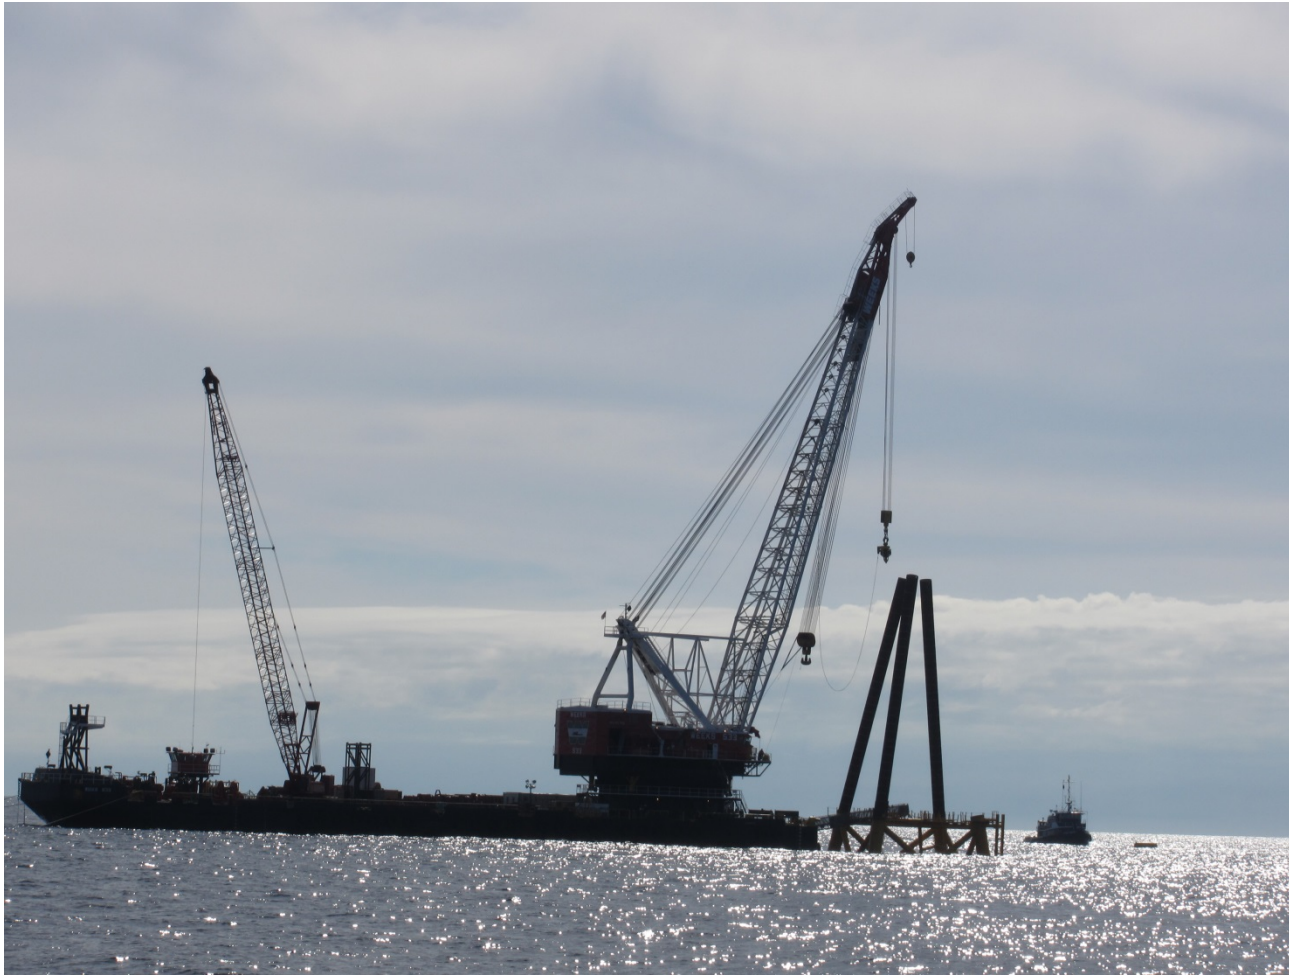
Jacket 3 – 3 of 4 P1 Piles Stabbed

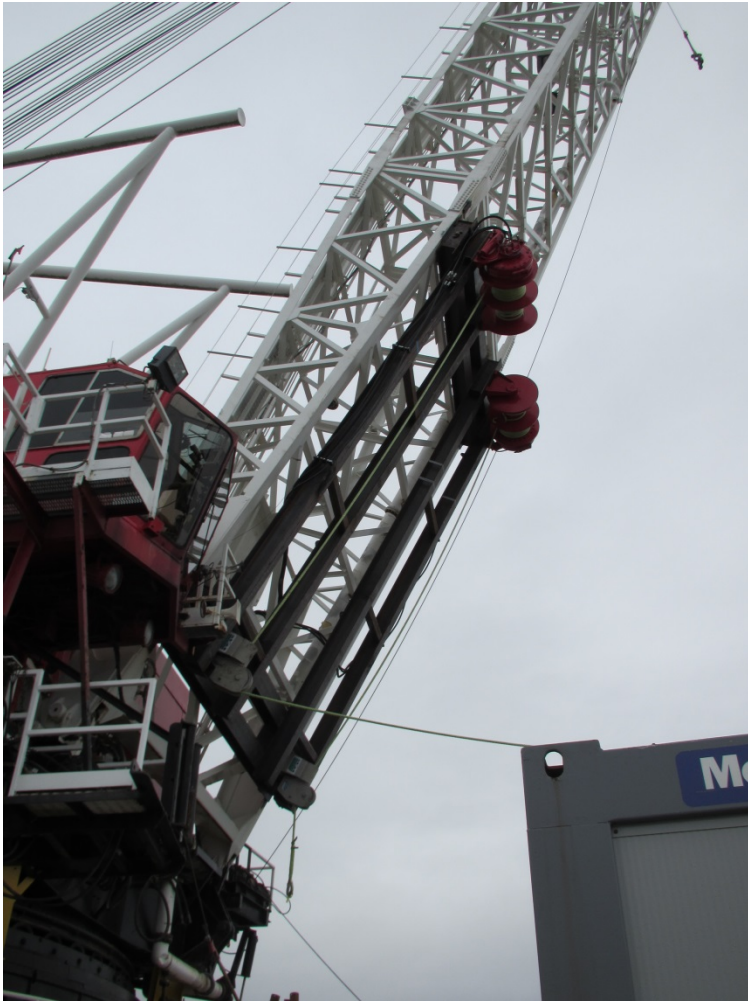
Tuggers on 526 Crane

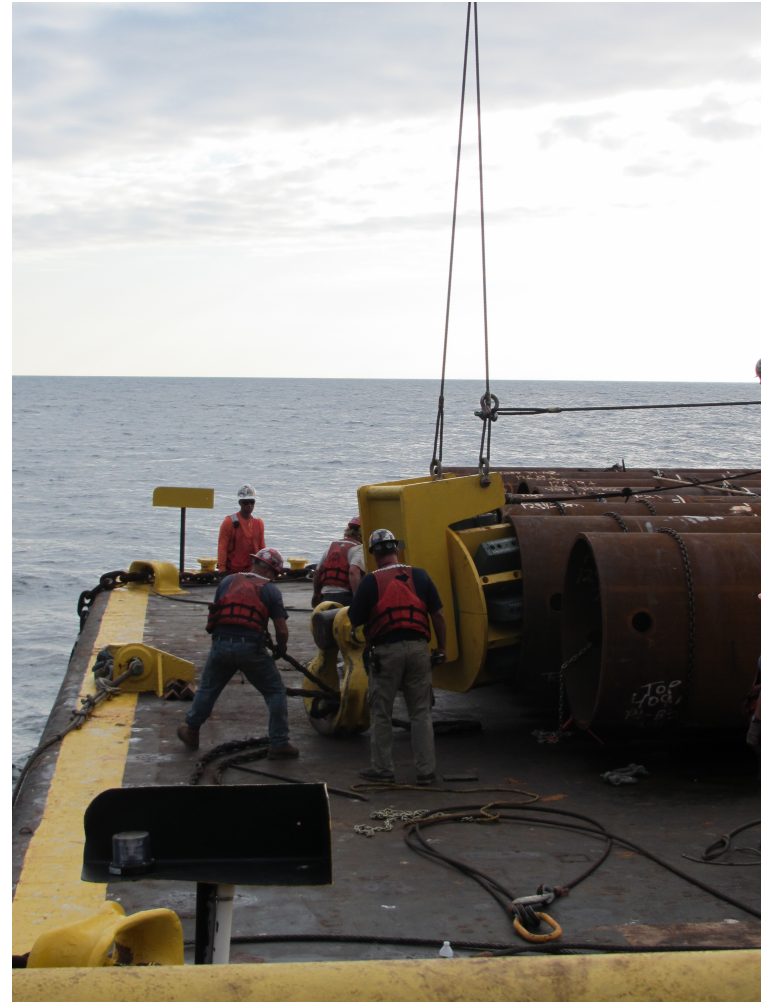
Rigging of P1 Piles

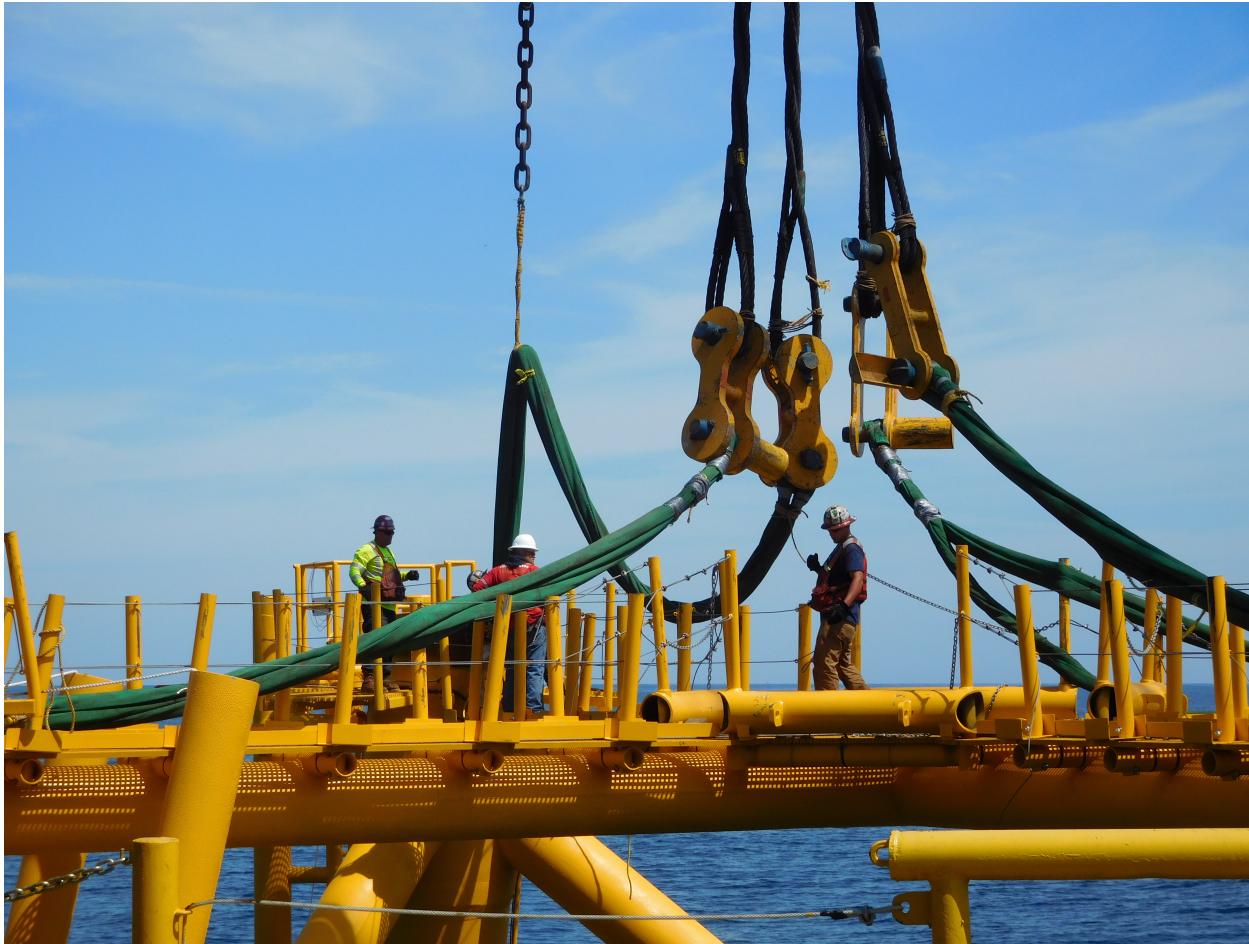
Rigging for Jacket Lift

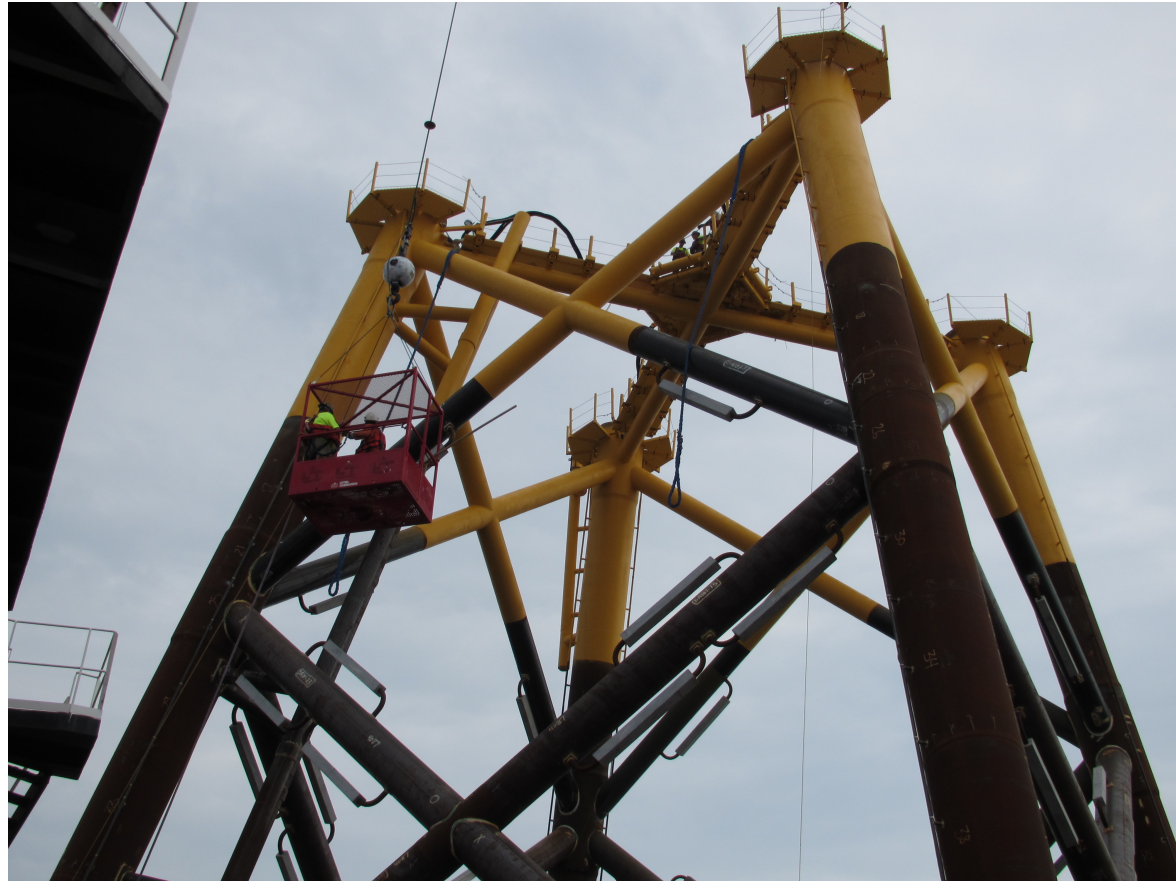
Working at Height

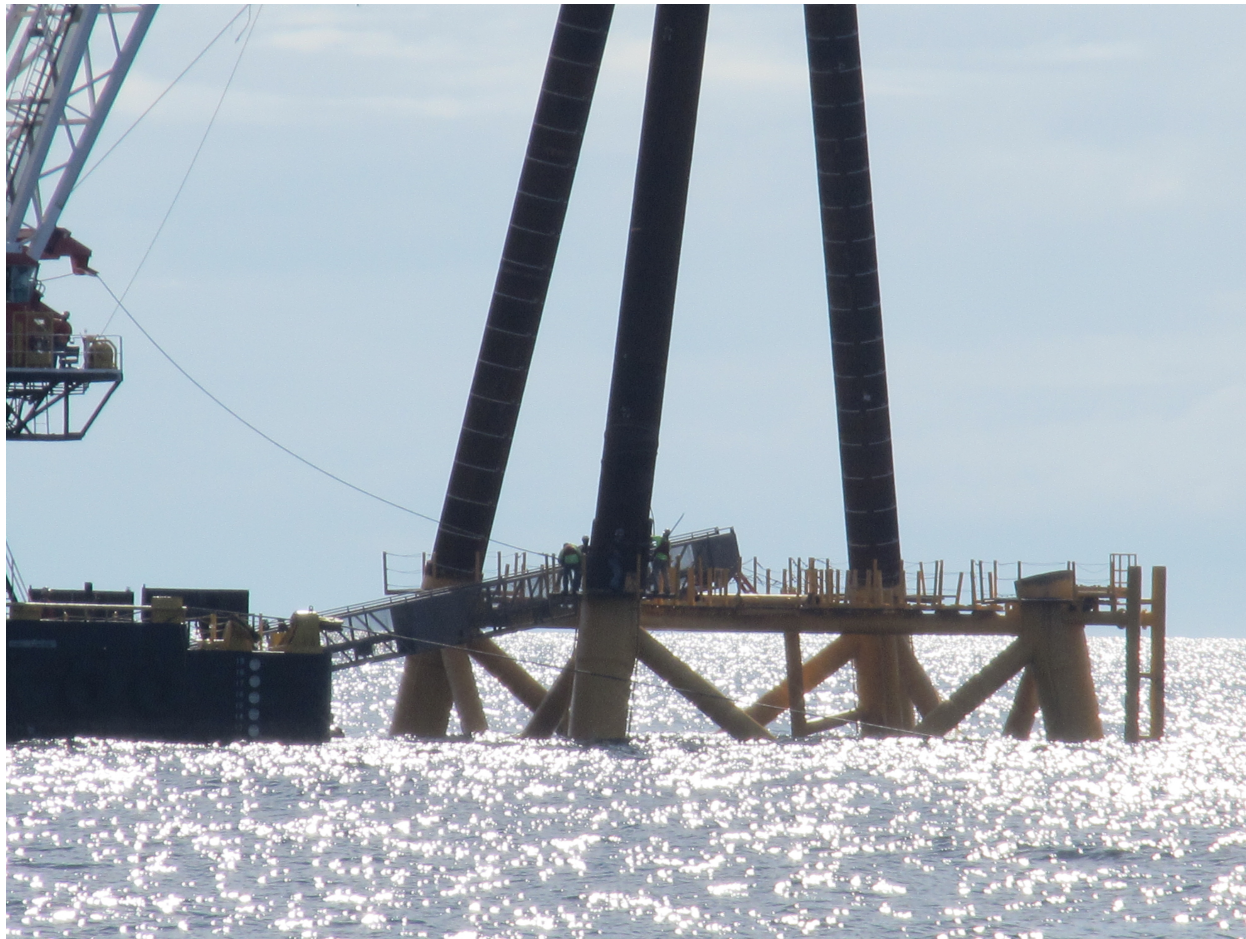
Installation of 3rd P1 Pile Jacket 3

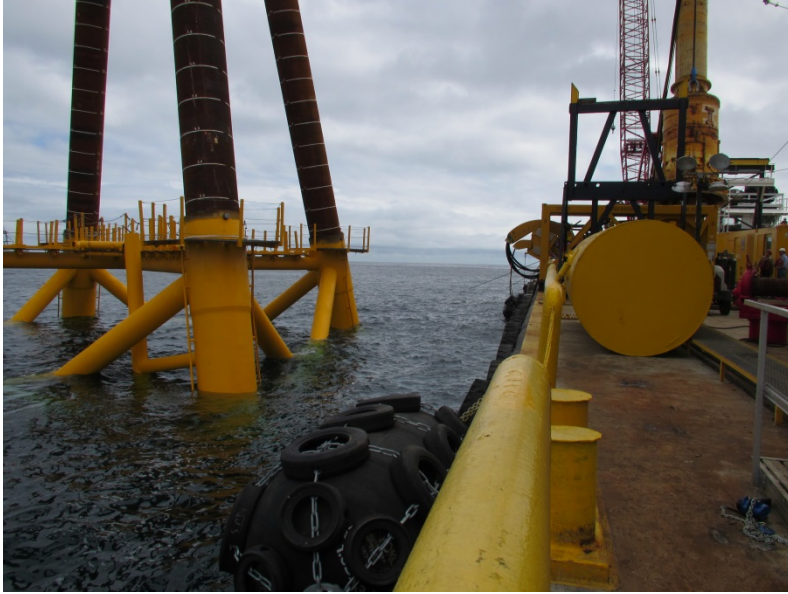
Yokohama Fenders Added

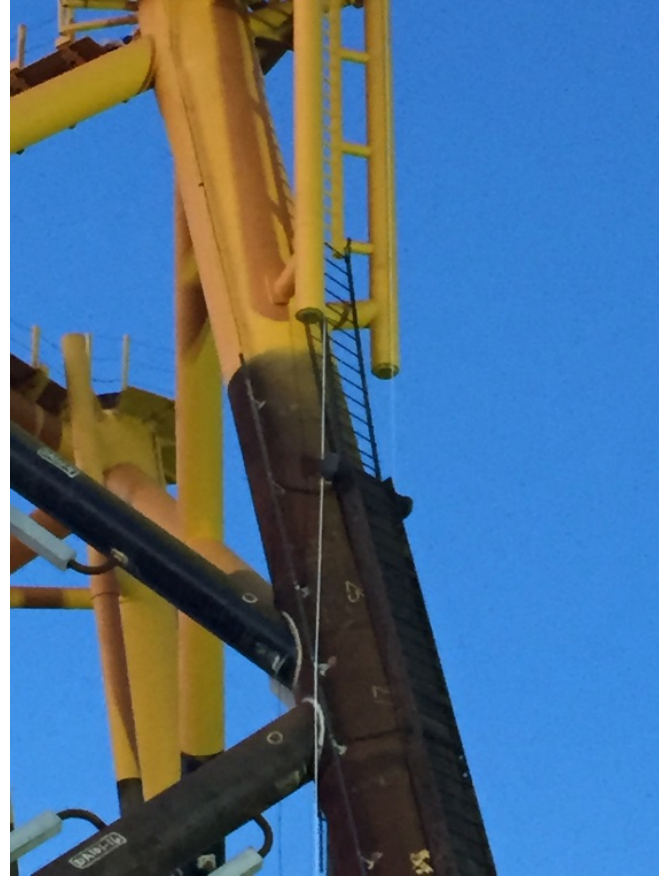
Access Ladder and Tie-Offs
