Block Island Wind Farm CVA

Status of Verification of Substructure
Installation (July 19 to September 22)

September 22, 2015

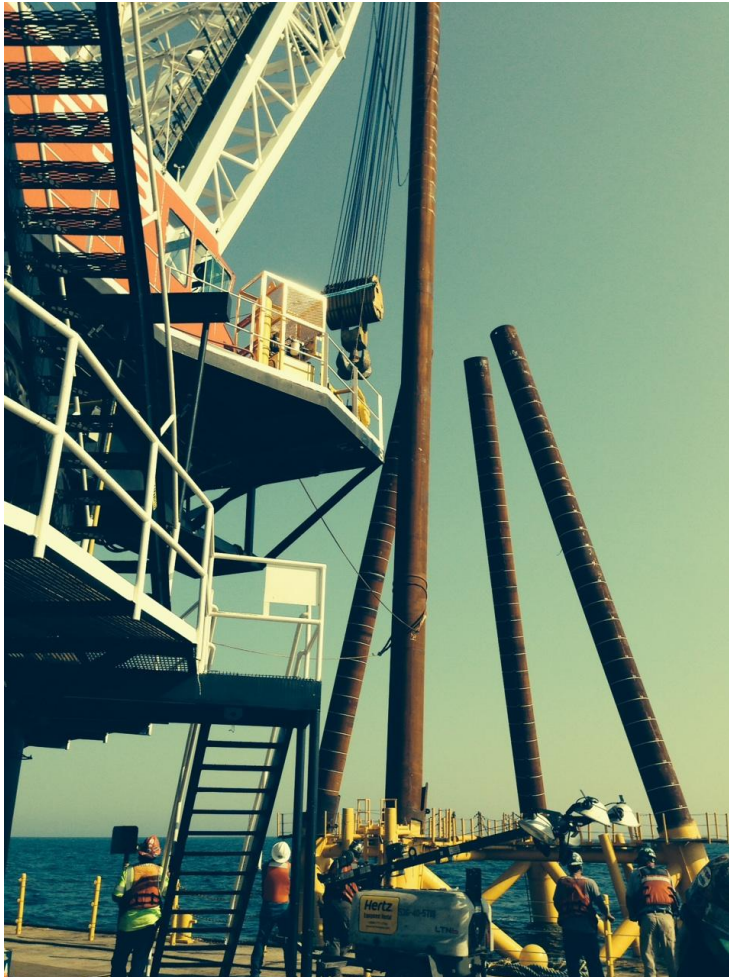
Jacket removed and repaired onshore
Jacket set at location
P1 Piles stabbed but not driven

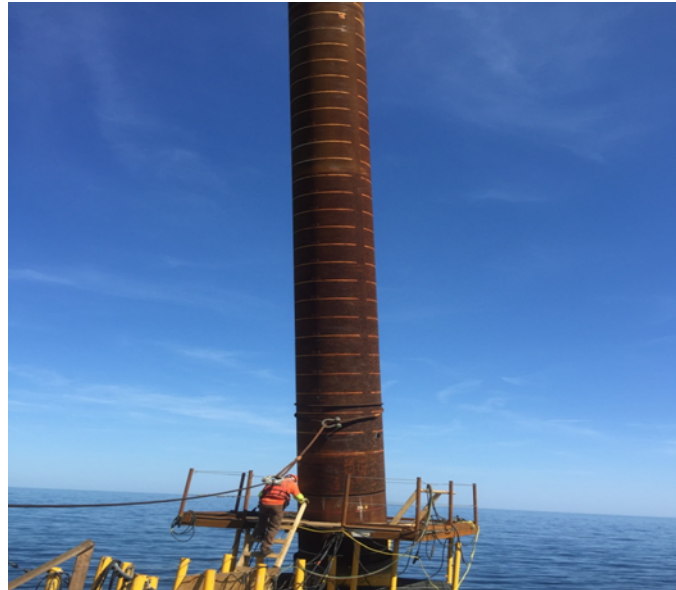
Jacket set at location
All Piles driven to depth
Ready for deck installation

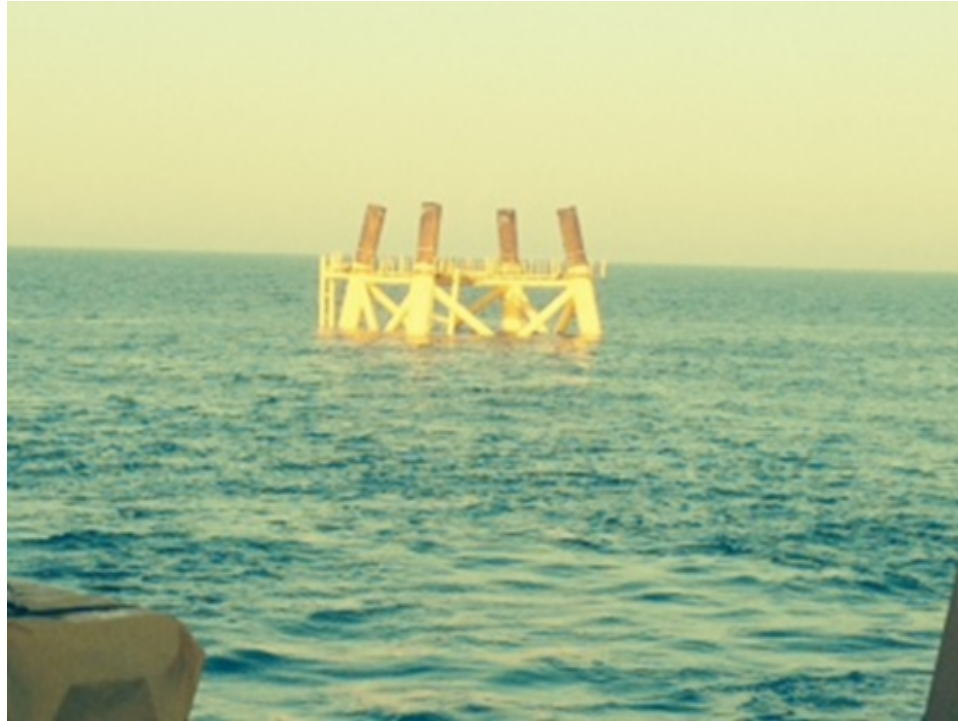
Jacket set at location
All Piles driven to depth
Ready for deck installation

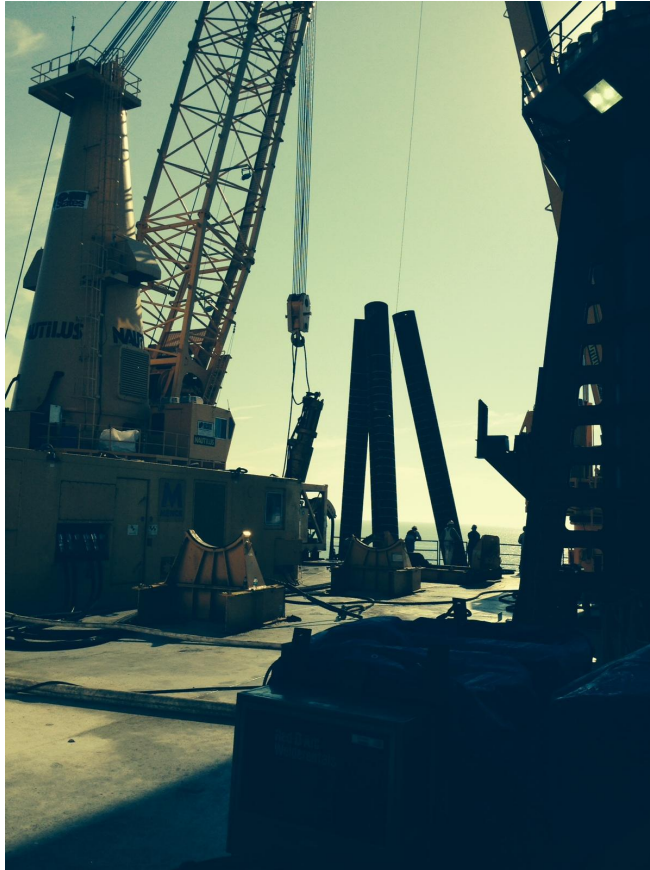
Jacket set at location

P1s stabbed and one leg partially driven

B1 runaway pile

P1s to be driven by LB Robert

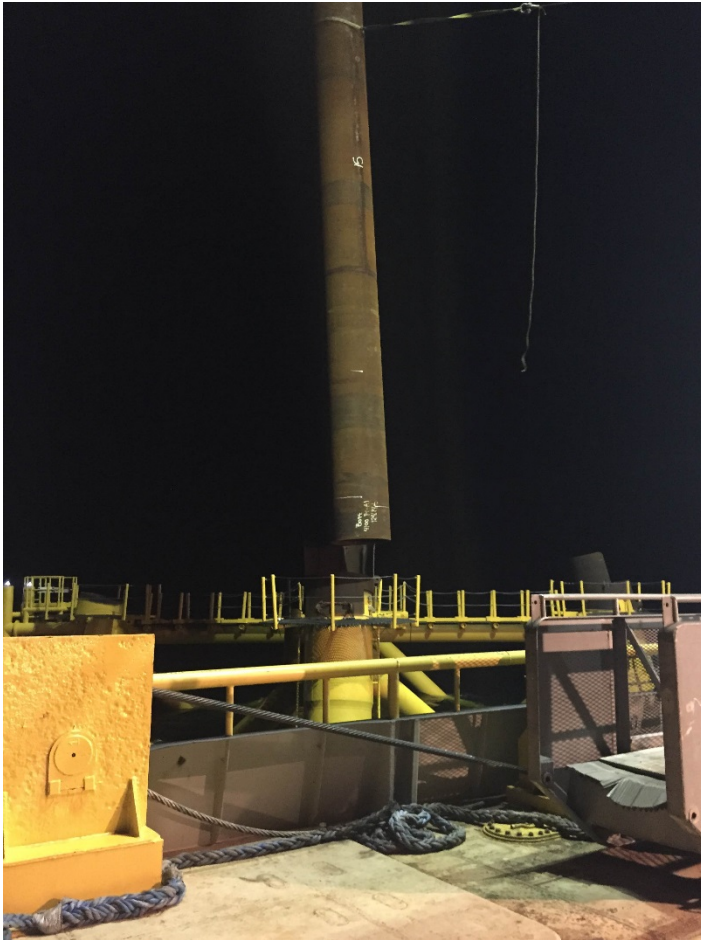
Jacket set at location
P1 Piles driven to depth
P2 piles to be spliced by W526

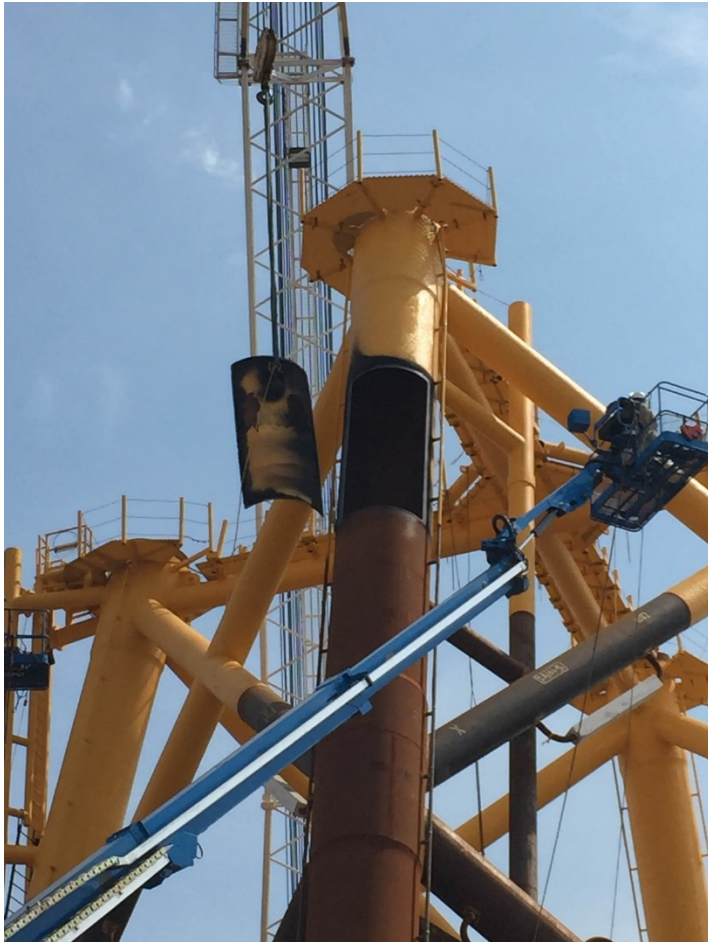
Jacket 1 Repair in Progress

Repairs have now been completed and verified

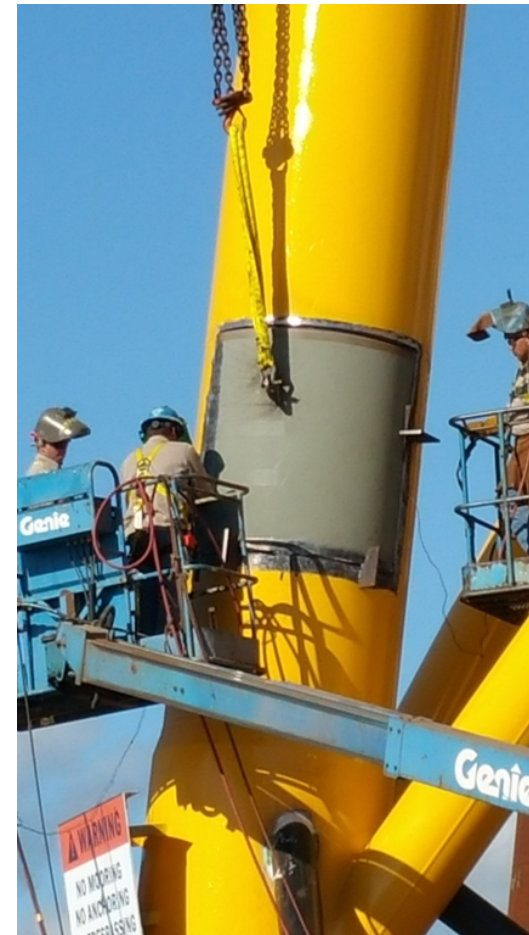
Deck 2 Repair in Progress
