Block Island Wind Farm CVA

Status of Verification of Substructure
Installation (July 19 to November 24)

November 24, 2015

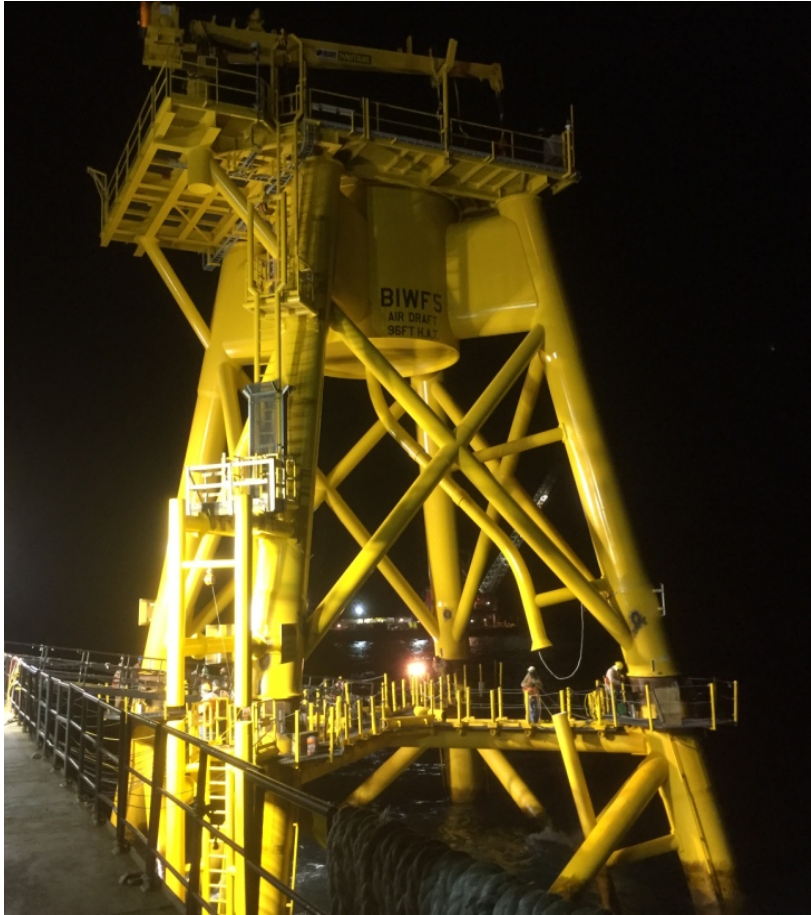
Deck 5 Setting Nov 21

- All decks have been set and levelled
- All deck to pile welding completed
- Temporary finishing for over-wintering (primer and sealing deck legs) planned to be completed next week*

*ABS Awaiting details of temporary finishing and risks including

- corrosion protection
- structural integrity

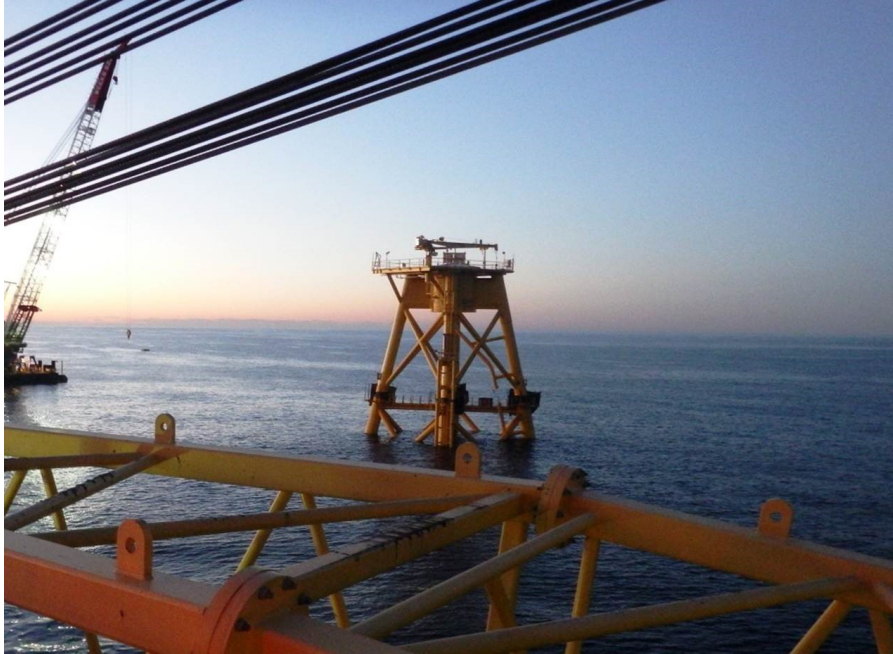
Deck 1 Set and Levelled Nov 2

Postponed to Spring 2016*

- Grouting
- Sealing tops of legs
- Final Painting

*ABS Awaiting updated FIR to reflect change

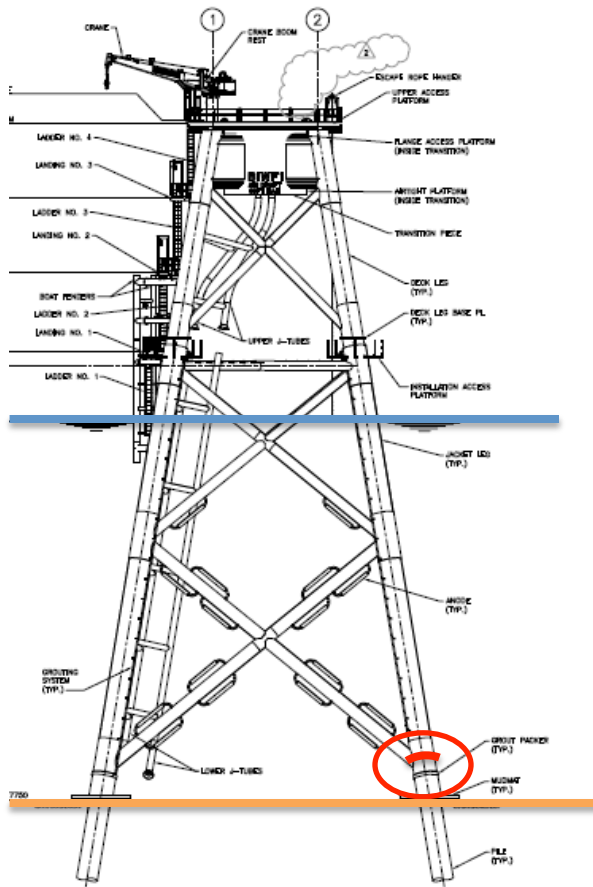
Location of Pile Weld Repair

Repaired circumferential weld on four Jacket 1 piles at approx 2.5m above mudline

- Lifetime estimate based on scaling factors completed by designer
- DWBI agreed to perform an updated pile driving analysis during the last meeting (Oct 27), but now has requested ABS to reconsider where it is necessary based on the results of the estimate

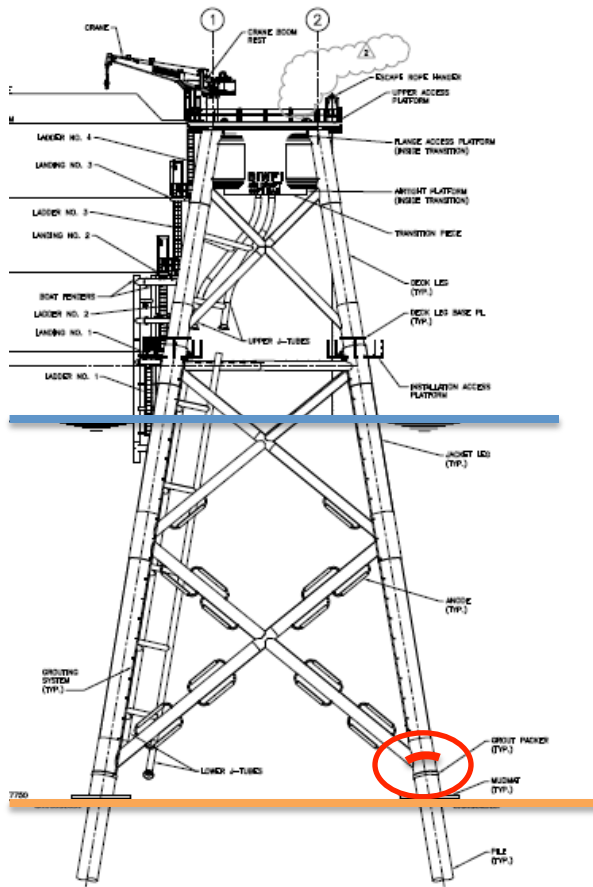
Location of Pile Weld Repair

- ABS considers the full analysis important for increased confidence in lifetime of joint
- ABS does not consider estimate to be accurate enough to ensure life of joint; joint is not inspectable (above mudline, within grouted section of leg)
- Lifetime calculation is very sensitive to alignment of pile sections during the offshore repair – introduces uncertainty in the calculation
- If mitigation were found to be required, the only possibilities are during operation... Structural Monitoring, inspection or retrofit may or may not be feasible/ cost effective.
