Fairbanks Engineering Corporation  
Geotechnical & Marine Engineers

Re: A2026-01-003 CRMC Assent Application – Letter of Support  
Repair of the Cliff Walk Slope along Ochre Point Mansion Property  
Newport, RI  
FEC Project No. 18028.00

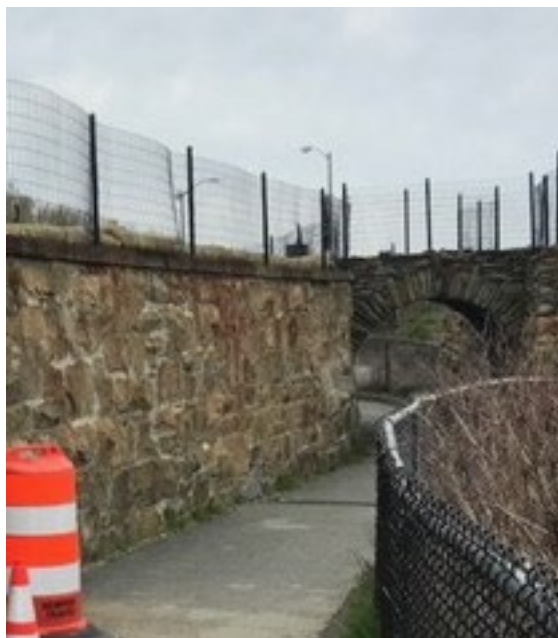
The stabilization of the existing slope using the proposed stone revetment would allow continued access along the shoreline. It would also ensure that the public’s health, safety and welfare are maintained while doing so. This includes stabilizing the overlook area that supports stone arch bridge over the walkway. This bridge weighs more than 10 tons. A failure of the overlook area, or excessive lateral movement (visual observations indicate the overlook is actively moving), could result in the bridge falling onto the Cliff Walk walkway below. This could injure or kill a pedestrian walking below it.

Photo 1: Stone Arch Bridge over the Cliff Walk walkway

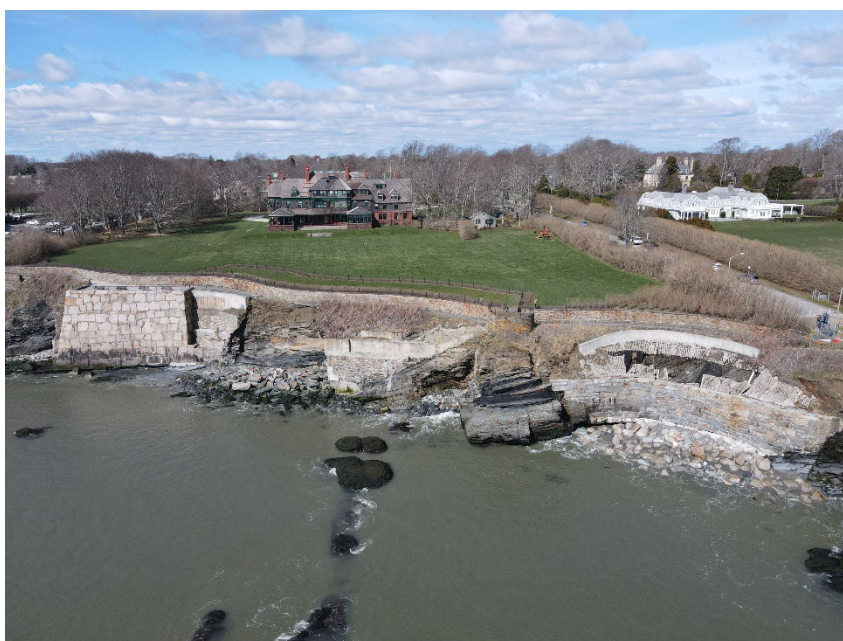
The existing slope along this section of the Cliff Walk is comprised of various types of stone masonry and concrete retaining walls, bedrock, and vegetated soil areas. It is apparent from the various types of retaining walls, and concrete underpinning of some of these walls, that this slope area has been unstable for a long time.

Photo 2: Slope along Cliff Walk proposed for repair – note failed areas & various wall generations

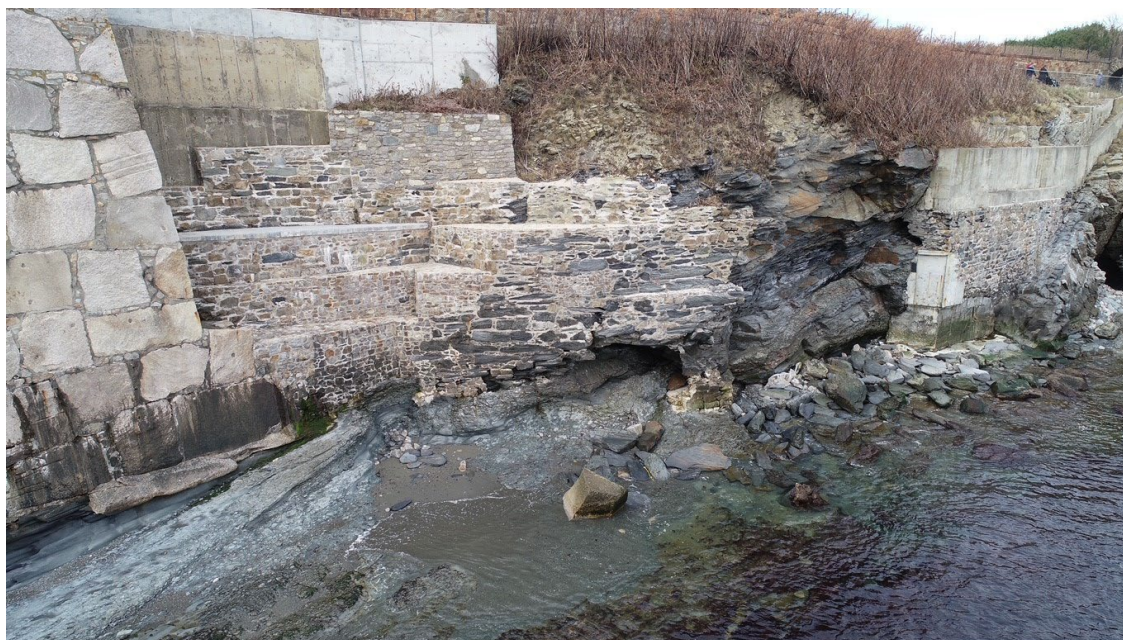
The bedrock type and condition along this section of the Cliff Walk make it more susceptible to instability. In general, the bedrock is the Rhode Island formation generally comprised of shale type bedrock. This bedrock is generally highly fractured and soft. The bedrock is also jointed and bedded toward the south and east. This condition causes the bedrock to fail toward the water creating the slope instabilities apparent in this area.

Photo 3: Slope along Cliff Walk in 1<sup>st</sup> area that failed (prior to the failure) – note hole in masonry seawall along its base and also the bedding joints in the bedrock sloping toward the water

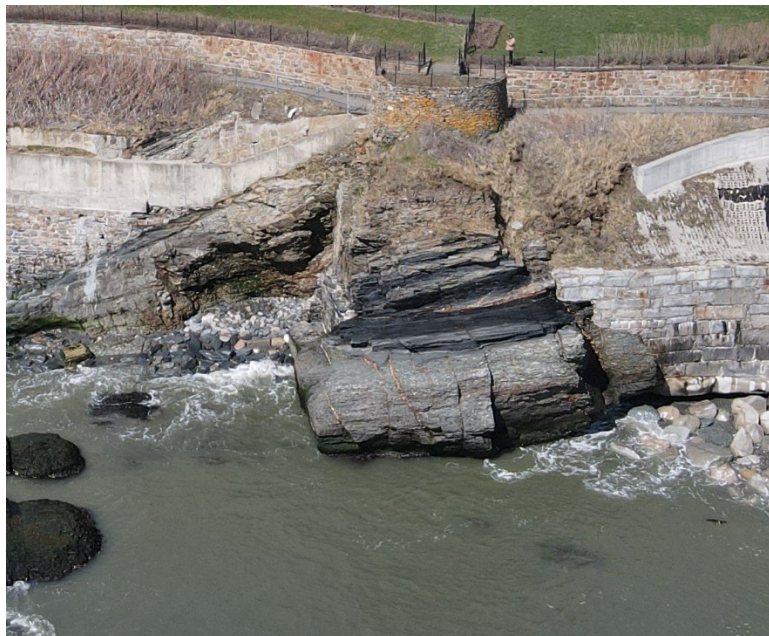
The overlook area of the shoreline that supports the stone masonry bridge over the Cliff Walk walkway is an outcrop comprised of variable bedrock types. The lower portion of this formation is comprised of what appears to be a harder/more sound bedrock. However, the bedrock above this is softer, more bedded and fractured. It also has bedding planes that slope fairly steeply toward the water. It’s this upper section of bedrock that supports the stone masonry retaining wall that supports the grass overlook area adjacent to the stone pedestrian bridge over the Cliff Walk walkway. The bedrock at this location is/was obviously more competent than the bedrock immediately adjacent to it. However, there are many such formations along the

Cliff Walk and many remanent outcroppings in the water just offshore that were probably similar at some time in the past. There are several such formations just offshore of this outcrop, refer to Photo 2 above and Photos 4 & 5 below. Although it is not possible to predict the timeframe, this outcrop area will fail in the future due to the normal erosion forces present along this coastline.

Photo 4: Overlook feature: note varying bedrock type along height – softer less competent rock up high

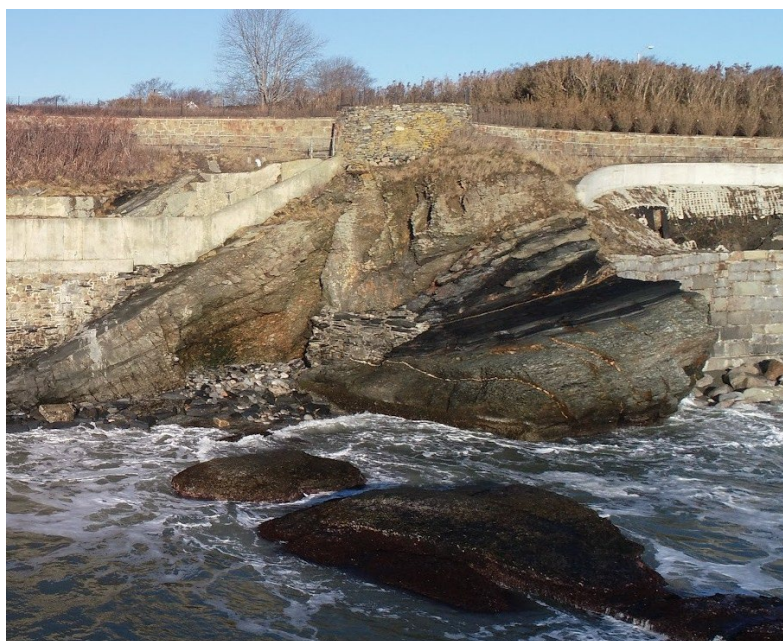
Photo 5: Overlook feature: note large eroded area between lower and middle bedrock section – given the sloping bedding plane the upper section will fail along this plane in the future which would cause failure of the bedrock, retaining wall and bridge supported above.

Another concern associated with not extending the revetment across the overlook is the increased wave forces that would result. Leaving a gap (if feasible) at the overlook would create an “alley” and/or “ramp” that would funnel wave forces directly against the overlook bedrock and stone masonry walls. This change to the shoreline profile would greatly increase the force of the wave impacts on the area. This is similar to areas where there are trench type features below water that funnel water to the shoreline to create large waves. Any gap left at the overlook would be expected to result in the accelerated degradation and failure of the overlook which could cause a failure of the arch bridge over the Cliff Walk walkway. It is also noted that the overlook is comprised of different rock types and hardness. The bedrock clearly is softer and less competent as you go higher up the slope. The alleyway created by leaving a gap would focus larger wave forces onto these less stable, and more erosive, bedrock areas – refer to photos 4 and 5.

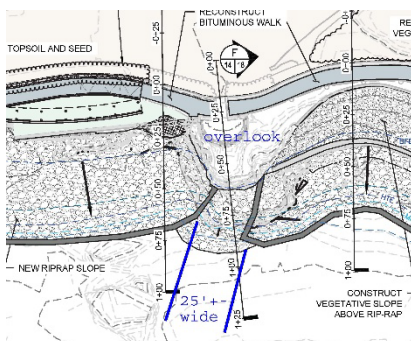
There has been discussion about eliminating the overlook area from the overall project. Given the relatively narrow width (it's only about 25 ft wide) of the overlook and the size of the revetment armor stone, this is not considered feasible from a constructability standpoint. The revetment includes smaller bedding stone layers that cannot be exposed to the large wave forces that frequently exist in Easton Bay. As such, the armor stone would need to be returned at each end of the overlook area to accomplish this. Due to the size of the armor stone, the armor layer is about 8 ft thick, these returns would take up most of the gap area. Also the returns would create a narrow channel that would focus and amplify the wave energy. See Figure 1 below, taken from the permit plans, to better illustrate the constructability issue.

Figure 1: Plan at Overlook area showing relatively narrow width of gap & also that it is aligned in the direction of the storm waves which exacerbates the issue if the revetment in this section were eliminated
