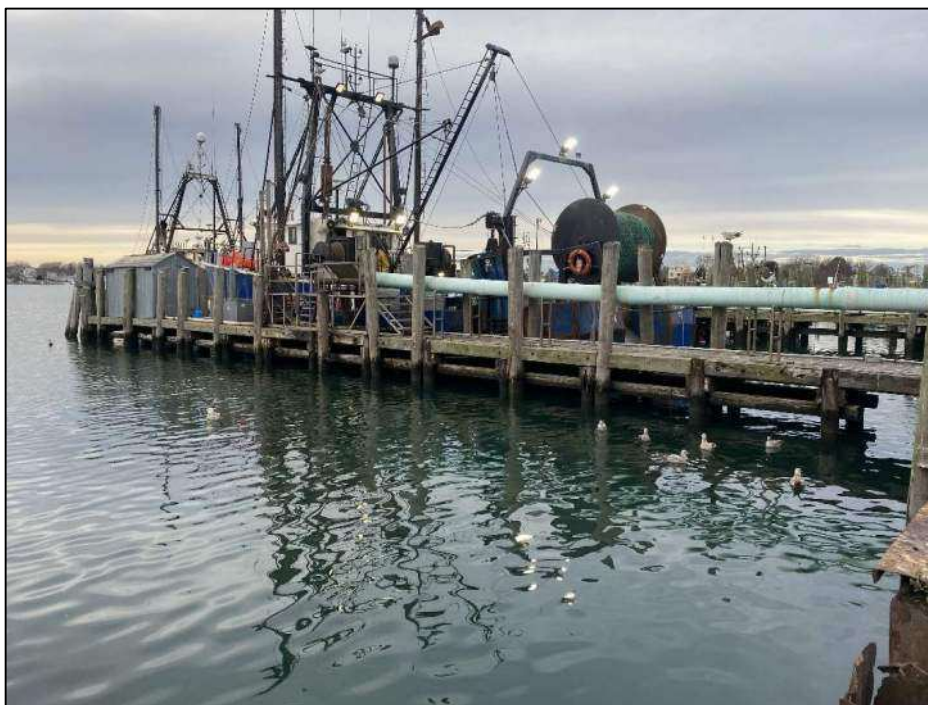
Photo No. 1.: View of Pier 'JJ' looking north.

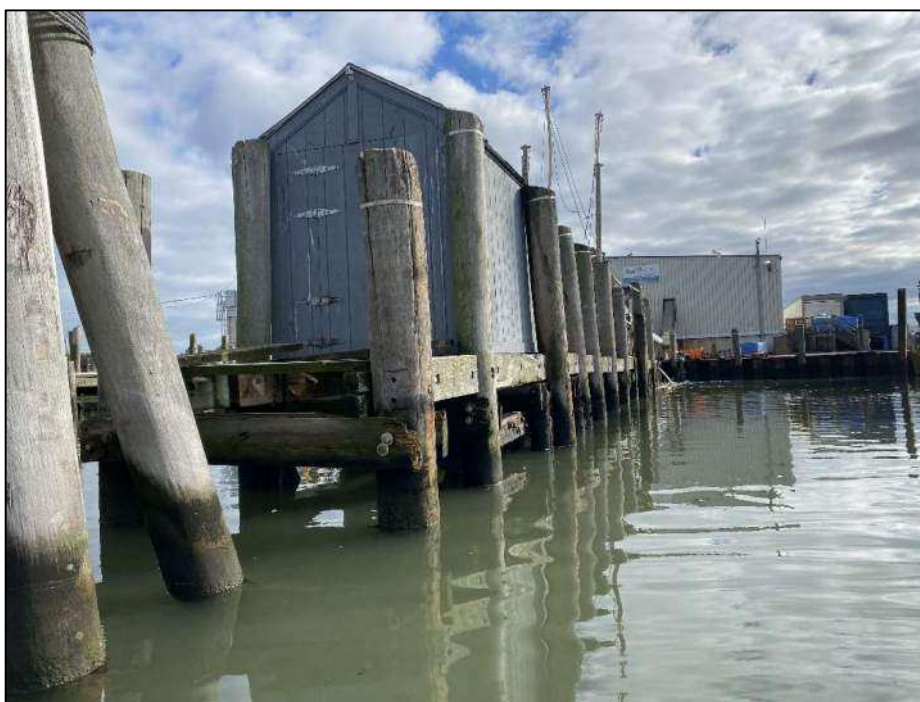
Photo No. 2.: View of Pier 'JJ' looking toward the bulkhead.

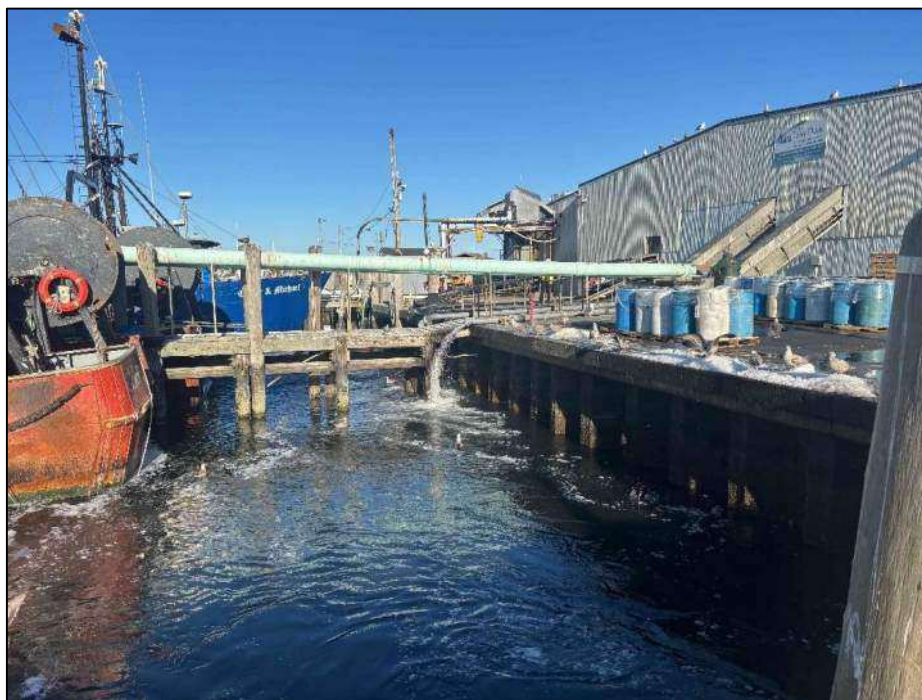
Photo No. 3.: View of the landside connection to the bulkhead of Pier 'JJ' looking north. (Photo 12/18/2025)

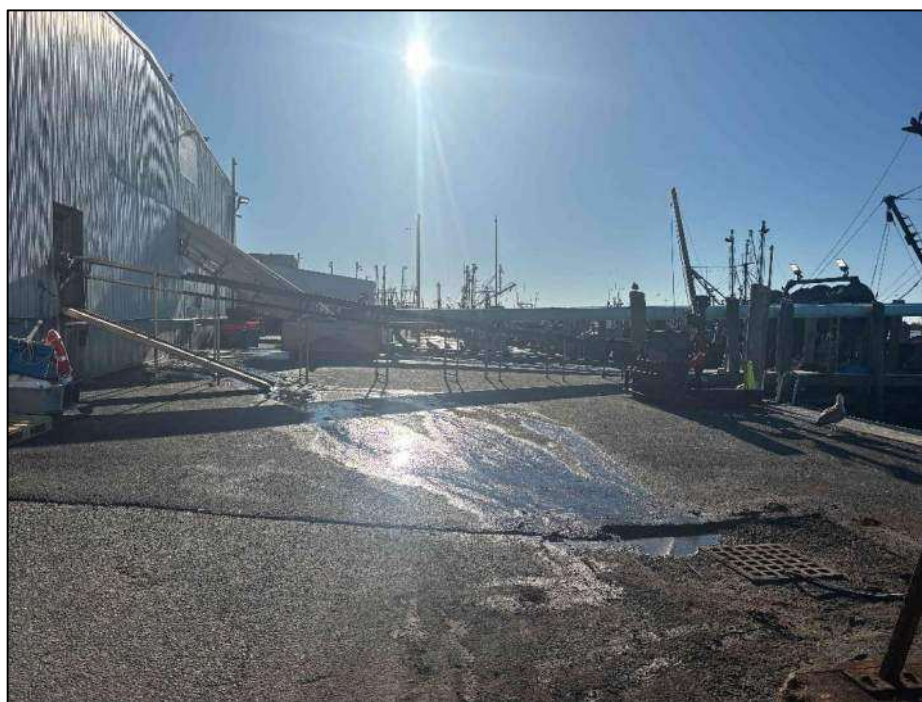
Photo No. 4.: View of the landside area behind the bulkhead at Pier 'JJ' looking south. (Photo 12/18/2025)

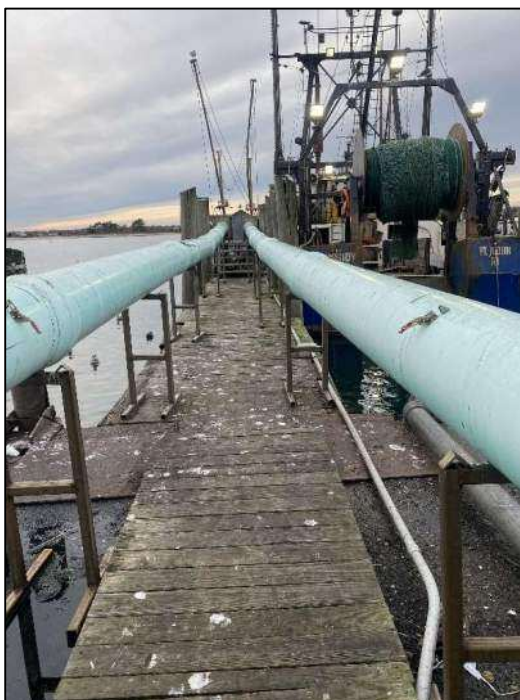
Photo No. 5.: View of the weathered decking of Pier 'JJ'.

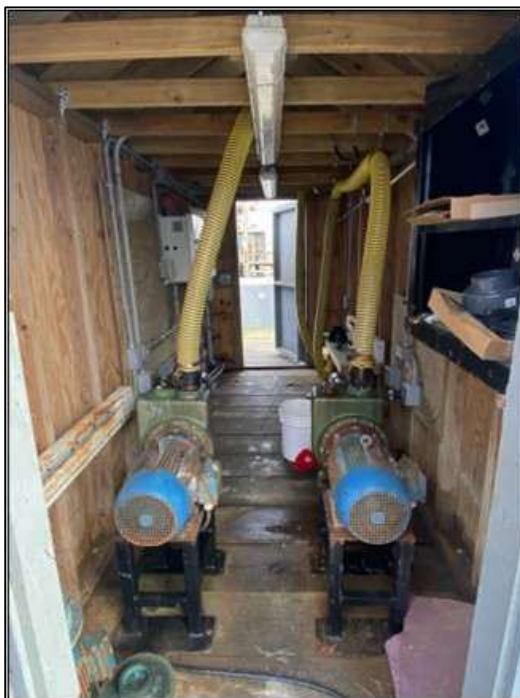
Photo No. 6.: View of the interior of the shed at the end of Pier 'JJ'.

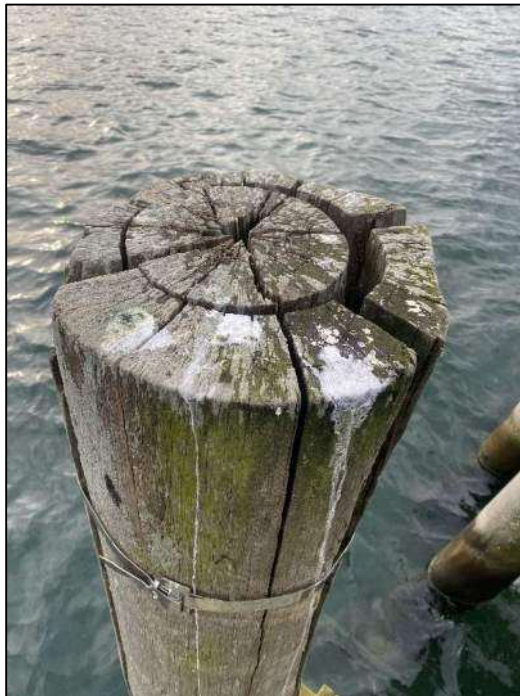
Photo No. 7.: Typical splitting of the fendering observed.

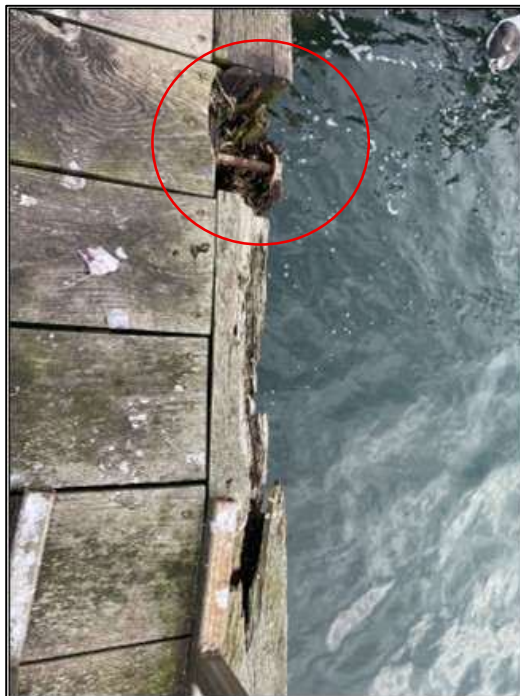
Photo No. 8.: Deterioration of timber chocks and observed damage to the timber support pile.

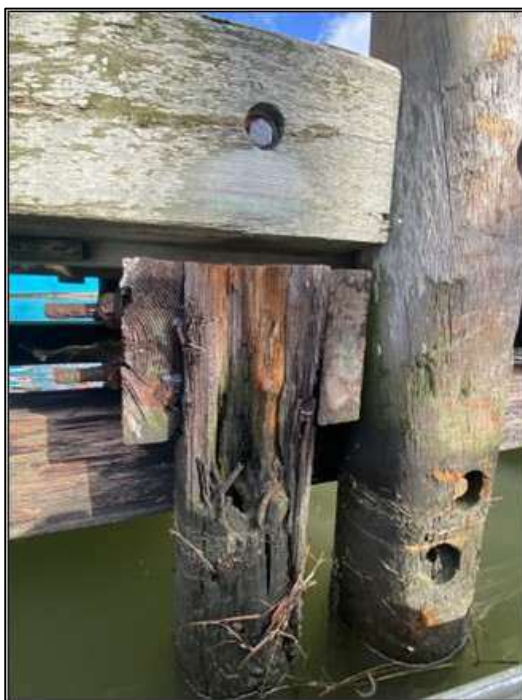
Photo No. 9.: Deterioration to the butt of the timber support piles, typical for 50% of observed support piles.

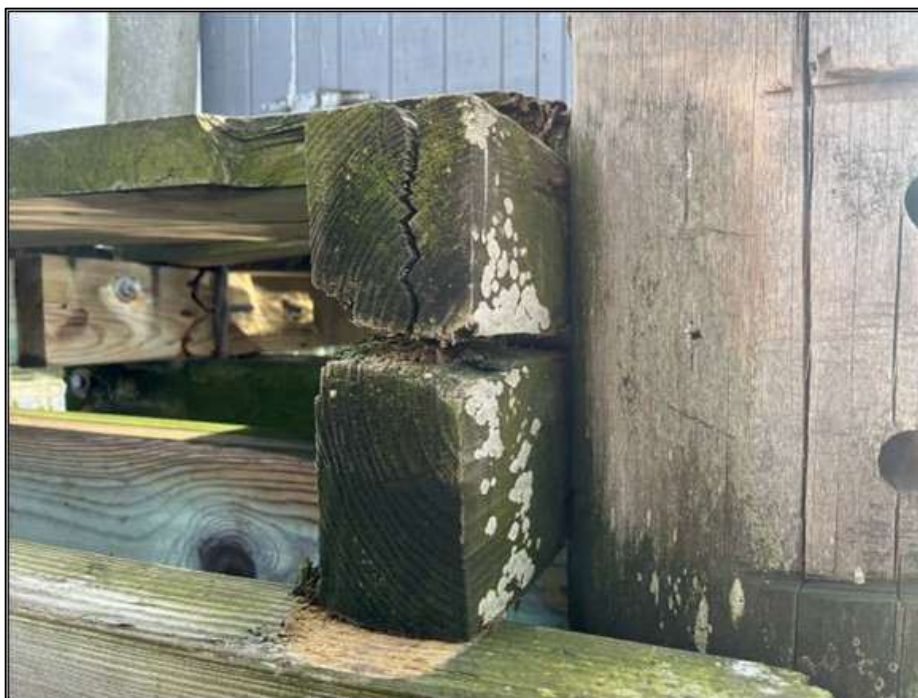
Photo No. 10.: Splitting of the end stringer of Pier 'JJ'.
