**From:** Rich Lucia  
**Sent:** Wednesday, March 25, 2026 3:19 PM  
**To:** Megan Elwell; Amy Silva; Cstaff  
**Cc:** Tim Smith  
**Subject:** RE: 2026-01-003 - Newport Cliff Walk

## RESPONSE TO COMMENTS

Re: Newport Cliff Walk Repairs

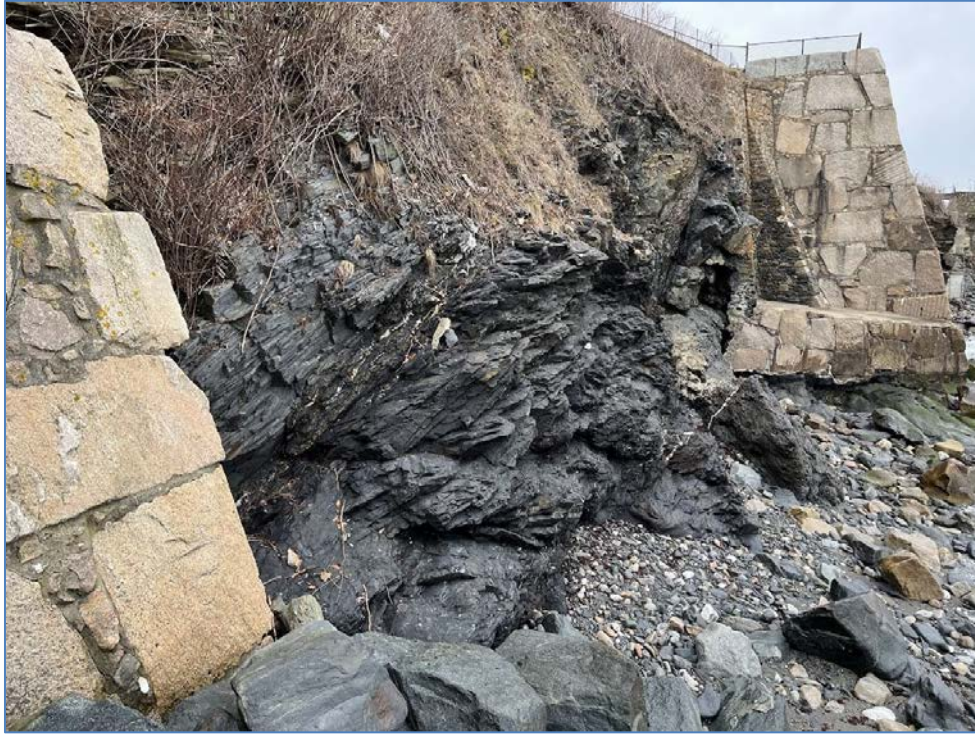
*The shale was observed to have a hardness ranging from soft (Can be gouged or grooved readily with a knife or pick point. Can be excavated in chips to pieces several inches in size by moderate blows of a pick point. Small thin pieces can be broken by finger pressure) to medium (Can be grooved or gouged 1/16-in deep by firm pressure on knife or pick point. Can be excavated in small chips to pieces about 1-in maximum size by hard blows from the point of a pick) and was generally identified as being severely to moderately weathered and extremely to moderately fractured.*

*The conglomerate bedrock was observed to have medium hardness and like the shale, was identified as being severely to moderately weathered and extremely to moderately fractured.*

*The southernmost portions of the Section 1 work area appear to be compromised primarily by the Shale bedrock (see Photo 1) whereas the more northern portion of Section 1 adjacent to the extant granite block wall exhibits more conglomerate bedrock (see Photo 2). There is evidence of accelerated wear of the Shale bedrock which is interwoven with the conglomerates and voids behind the man-made structures.*

PHOTO 1: BEDROCK AT SECTION 1 CLIFF FACE - LOOKING NORTH

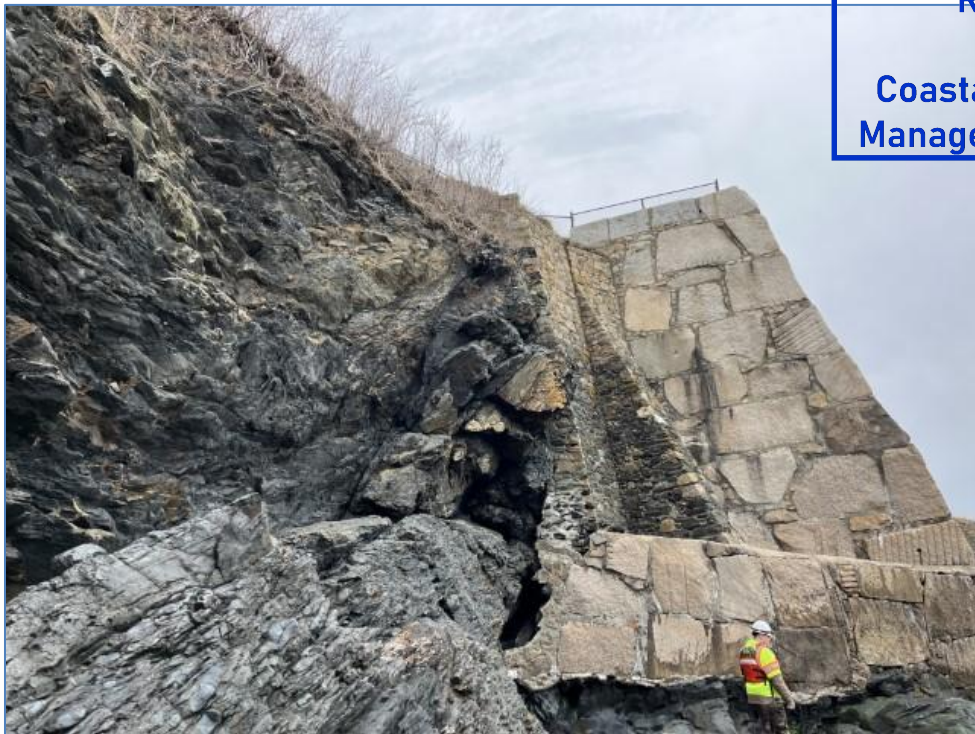
PHOTO 2: INTERWOVEN BEDROCK AT SECTION 1 CLIFF FACE - LOOKING NORTH

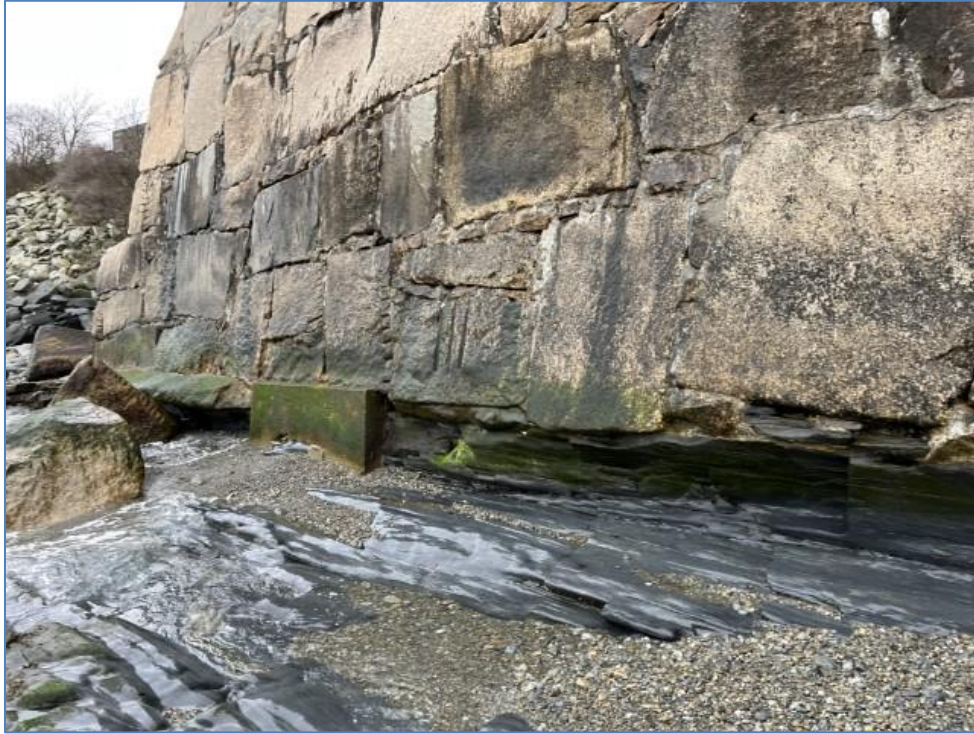
**GZA Response:** *The extant granite block wall is understood to have been installed circa 1976, based on CRMC Assent 75-9-13, which depicts both the stone wall and a revetment seaward of it. While the original plans indicate the intended presence of a protective stone layer, existing-condition surveys show that no functional armor layer remains in place today. Field observations instead document undermining at the wall's interface with the bedrock surface, indicating that any previously placed armor was either never installed as designed or has since been displaced by decades of wave action.*

- *Structural condition of the wall — Survey data show voids and undercutting at the bedrock contact, demonstrating that the wall is currently exposed to direct wave attack. This condition is inconsistent with long-term stability and suggests that the wall is no longer receiving the toe protection originally envisioned.*
- *Visual evidence of active erosion — Photographs of the site clearly show eroded and scalloped bedrock outcrops seaward of the wall. This pattern of bedrock wear is characteristic of repeated high-energy wave impact and confirms that the shoreline is actively retreating at the toe. Continued erosion of this surface will progressively remove support from the base of the granite wall, eventually leading to settlement, rotation, or localized failure.*

PHOTO 3: BEDROCK UNDERCUTTING AT THE TOE OF THE EXTANT GRANITE BLOCK WALL - LOOKING SOUTH

*Given these conditions, the decision to install a new riprap armor layer is driven by the need to re-establish the level of protection the wall requires to remain stable. The proposed riprap revetment will shield the exposed bedrock and wall toe from further erosion, dissipate wave energy before it reaches the wall, and prevent the progressive undermining that is already observable in the field.*

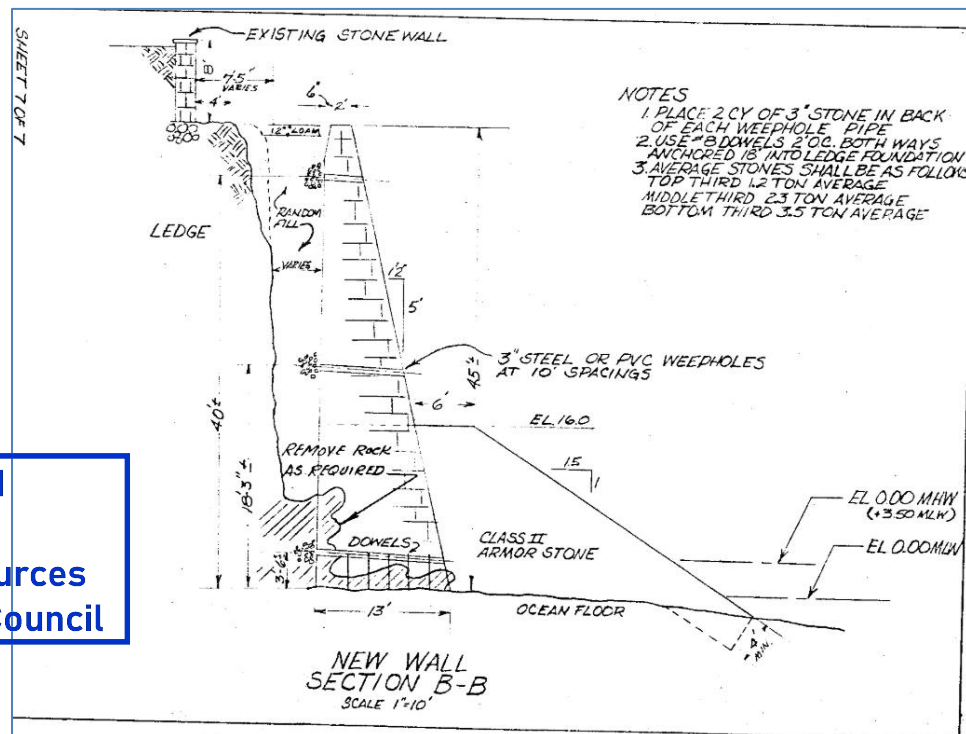
PHOTO 4: EXTANT GRANITE BLOCK WALL SECTION ILLUSTRATED WITHIN CRMC ASSES 75-9-13

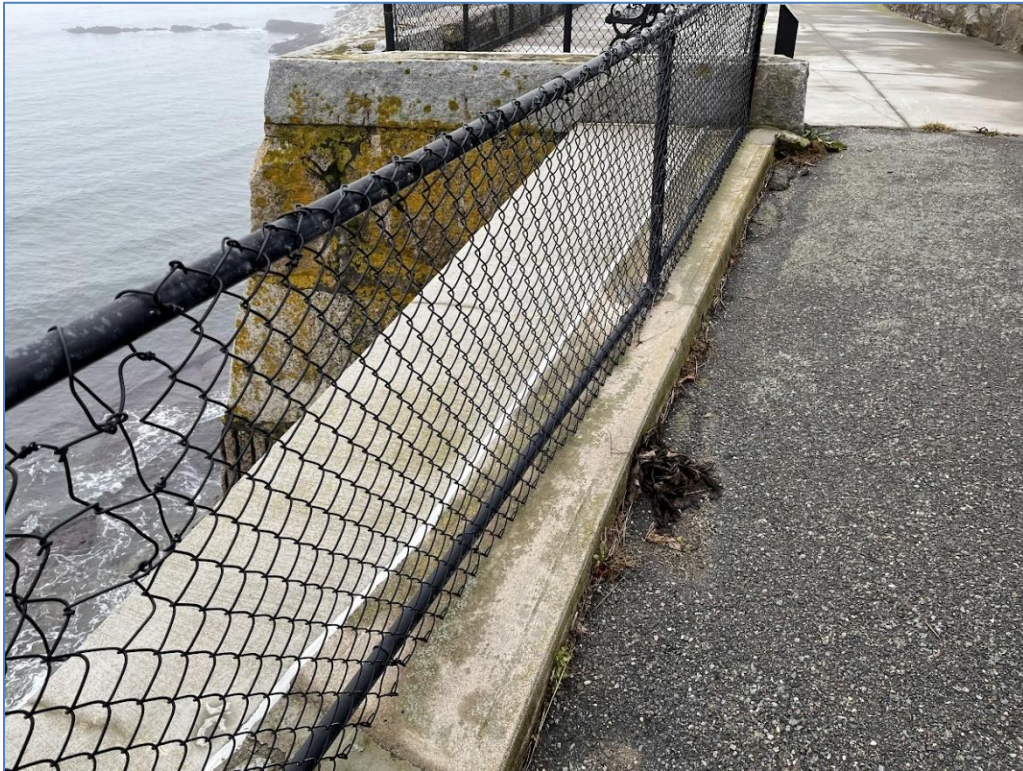
**GZA Response:** *At this time, the proposed final handrail has not been selected, and the drawing is a placeholder. Currently, a black chain link fence is present along this portion of the cliff walk. At a minimum, the railing will be replaced in kind.*

PHOTO 6: RAILING ALONGSIDE CLIFF WALK WITHIN PROJECT LIMITS
