STATE OF RHODE ISLAND AND PROVIDENCE PLANTATIONS
COASTAL RESOURCES MANAGEMENT COUNCIL
INTER-OFFICE MEMORANDUM

DATE: April 20, 2011
TO: Grover J. Fugate, Executive Director
FROM: CRMC Policy and Permitting staff (signature sheet at end of report)
SUBJECT: Matunuck Erosion

Project: Development of “Temporary Structural Shoreline Protection” guidelines and staff recommendations for long-term solutions to address Matunuck erosion issues
Location: Matunuck Beach Road – South Kingstown
Water Type/Name: Type 1
Coastal Feature: Coastal beach backed by manmade shoreline and/or altered coastal bluff/erosive dune scarp

Matunuck Erosion

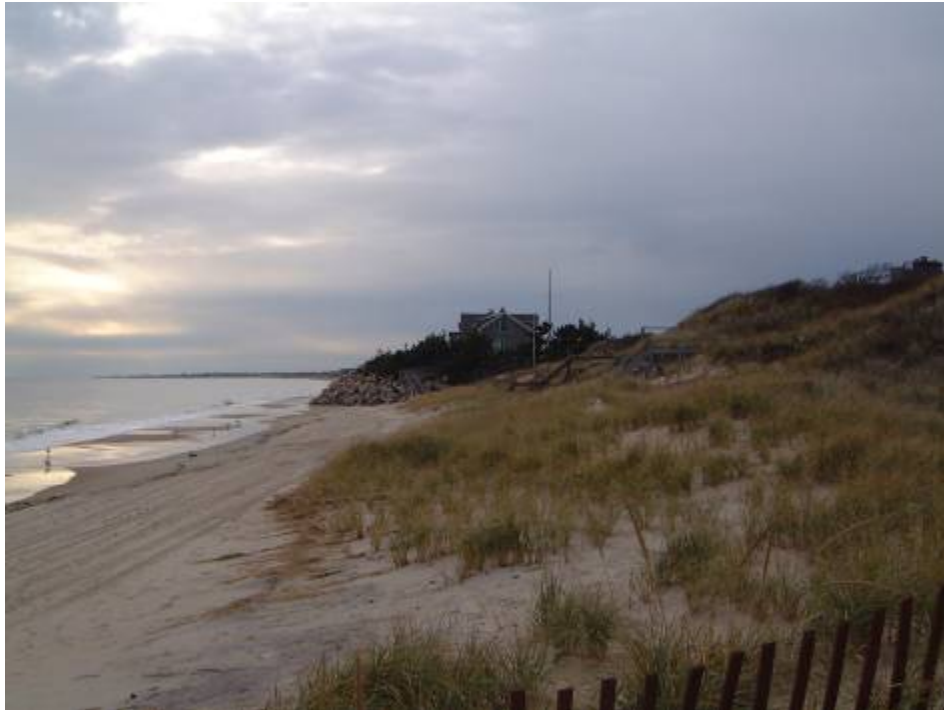
Figure 1. Lateral access obstruction in front of a shoreline protection structure in Westerly

people shall continue to enjoy and freely exercise all the rights of fishery, and the privileges of the shore, to which they have been heretofore entitled under the charter and usages of this state, including but not limited to fishing from the shore, the gathering of seaweed, leaving the shore to swim in the sea **and passage along the shore.**” (emphasis added.) See R.I.G.L. § 46-23-1(a)(1). There are many examples of preexisting shoreline protection structures that impede public access along the shoreline in Rhode Island. See Figure 1.

With the installation of hardened shoreline protection structures, whether temporary or long-term, the sediment sources are “locked” behind the shoreline protection structures, preventing renourishment of sediments to the beach. Over time, the beaches located east of Matunuck may experience sediment loss and possibly see diminished beach widths. Furthermore, shoreline protection structures, by design, cause scour and erosion at the base of the structure resulting in the permanent loss of beach sediment and public lateral access along the shoreline, especially during high tide. See Figures 1, 7 and 8.

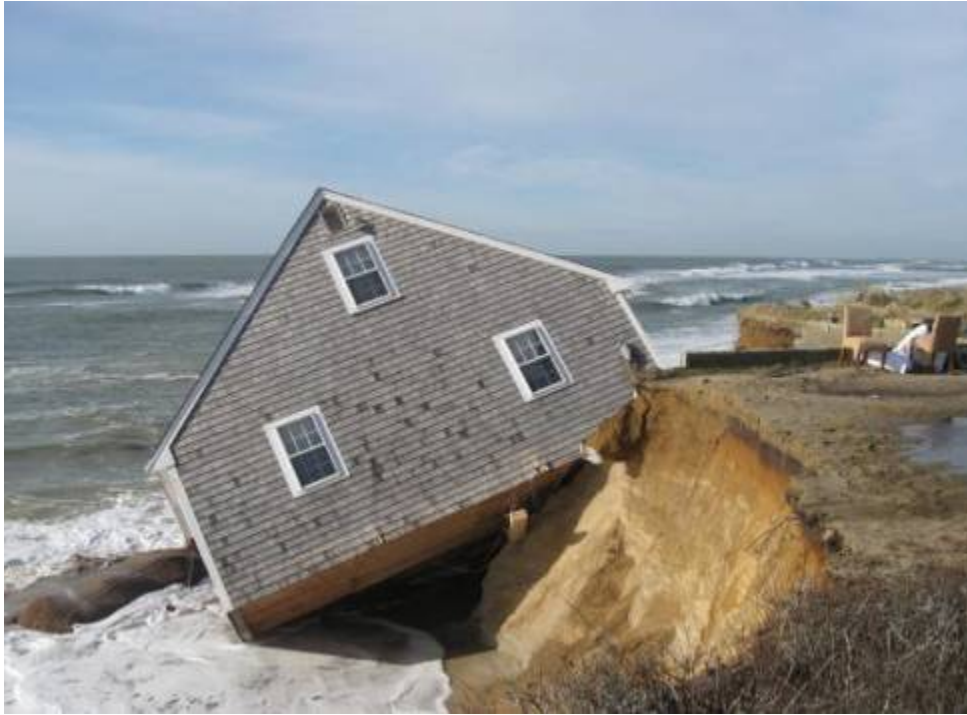
Figure 2. A December 2009 coastal storm proved too much for this Nantucket home.

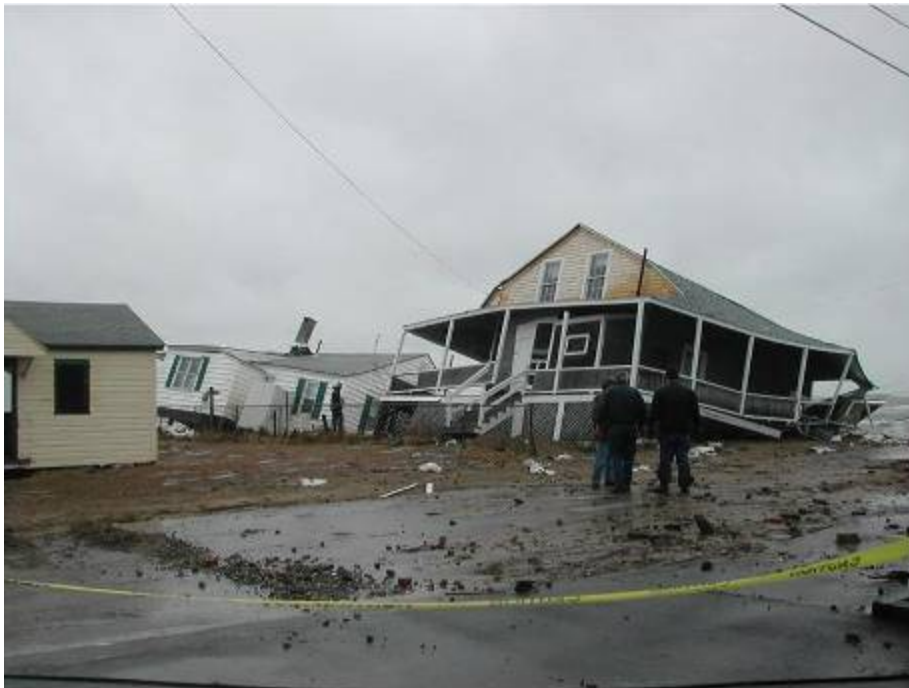
Figure 3. Patriot's Day coastal storm (April 17, 2007) causing destruction in Saco, ME.

Patriot Day Storm damage Saco, ME (courtesy of P. Slovinsky)

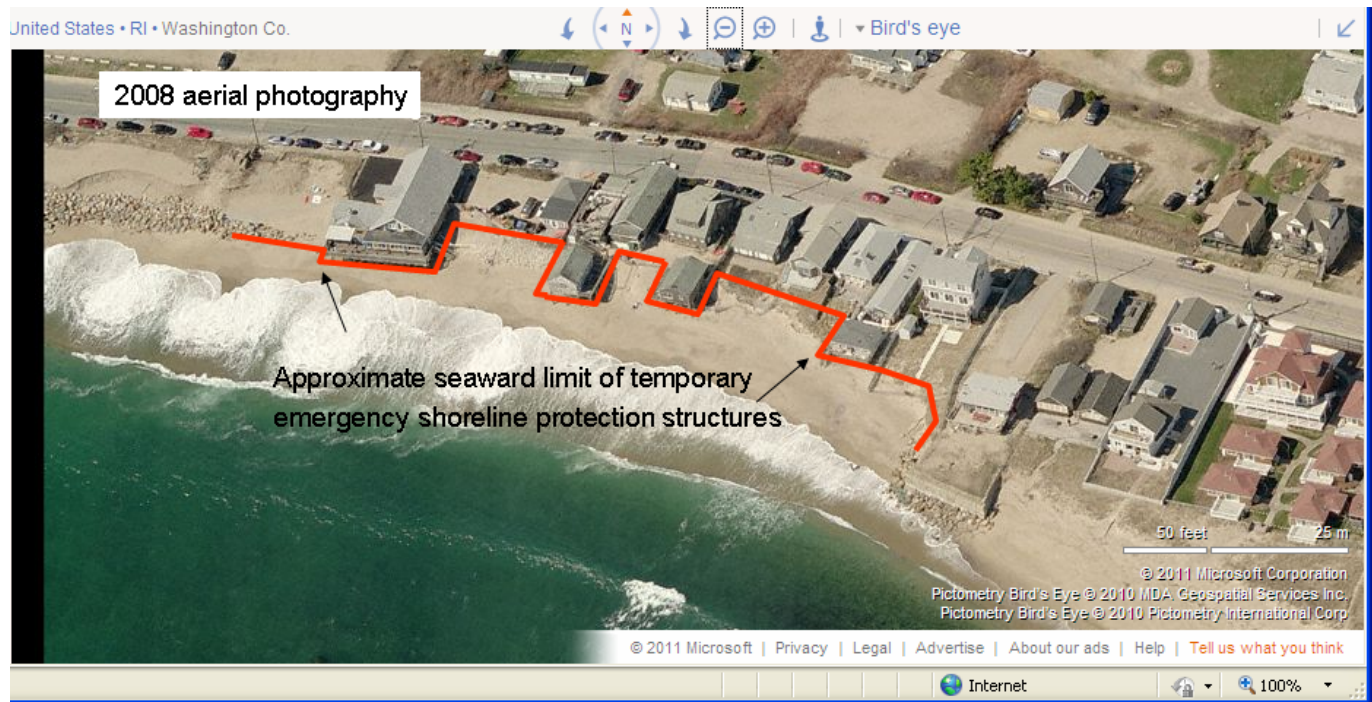
Figure 5. Potential location of temporary wooden bulkhead shoreline protection structures

In the event that the full Council determines that temporary structures are permissible in this area, CRMC staff recommend that the installation of these temporary structures be limited to the shoreline segment between parcels 92-2:47 and 92-3:9, which contain some existing hardened shoreline structures (rip-rap revetment or concrete sea wall). Additionally, these temporary wooden bulkheads must be installed as close as practicable to the existing buildings, including their pile supports, and the existing beach scarp as depicted in Figure 5 below. Furthermore, it is recommended that the Council require the endpoints of the temporary structures to not only tie in with the existing hardened shoreline structures at either end of this shoreline segment, but also be connected to one another and installed concurrently. Otherwise any gaps in the line of temporary structures will result in the premature failure of the entire system. Accordingly, this approach requires that the affected property owners and the Town coordinate their efforts. The limited area identified above was selected because it is the most highly impacted segment of this particular shoreline by ongoing shoreline erosion. And, as the Town points out in their “Matunuck Coastal Area Report,” dated April 2010⁵, the public roadway and a 12-inch town water line that serves the area, as well as two commercial businesses and other structures along this shoreline segment, are imminently threatened. Matunuck Beach Road is the only roadway providing access and exit for over 500 dwellings. See Town report at 2.⁵ The shoreline segment identified for the installation of temporary shoreline protection structures is depicted in Figure 5 below.

It is CRMC staff's opinion that these temporary wooden bulkhead shoreline protection structures are not appropriate as a long-term solution to address the erosion issues in this area, but may provide some short-term, minor level of protection while potential long-term solutions are further examined by the Town of South Kingstown and the private property owners. Specific guidelines for these temporary wooden bulkheads (detailed in the Engineering Issues and Recommended Stipulations section below) will provide criteria for the preparation of individual applications to the CRMC. CRMC staff will incorporate specific stipulations into any permits issued by the Council for this type of structure. We note also that should any portion of these temporary structures be installed at or below the Mean High Water (MHW) mark, or fill material placed behind these structures (seaward of the Highest Annual Tide), such actions will invoke federal jurisdiction and require the review and authorization by the Army Corps of Engineers. [See Figure 21.](#) Further discussion on this issue is provided in the Engineering Issues and Recommended Stipulations section below. In addition, CRMC staff recognizes that some properties within the designated area shown in Figure 5 above currently have unauthorized timber bulkheads.

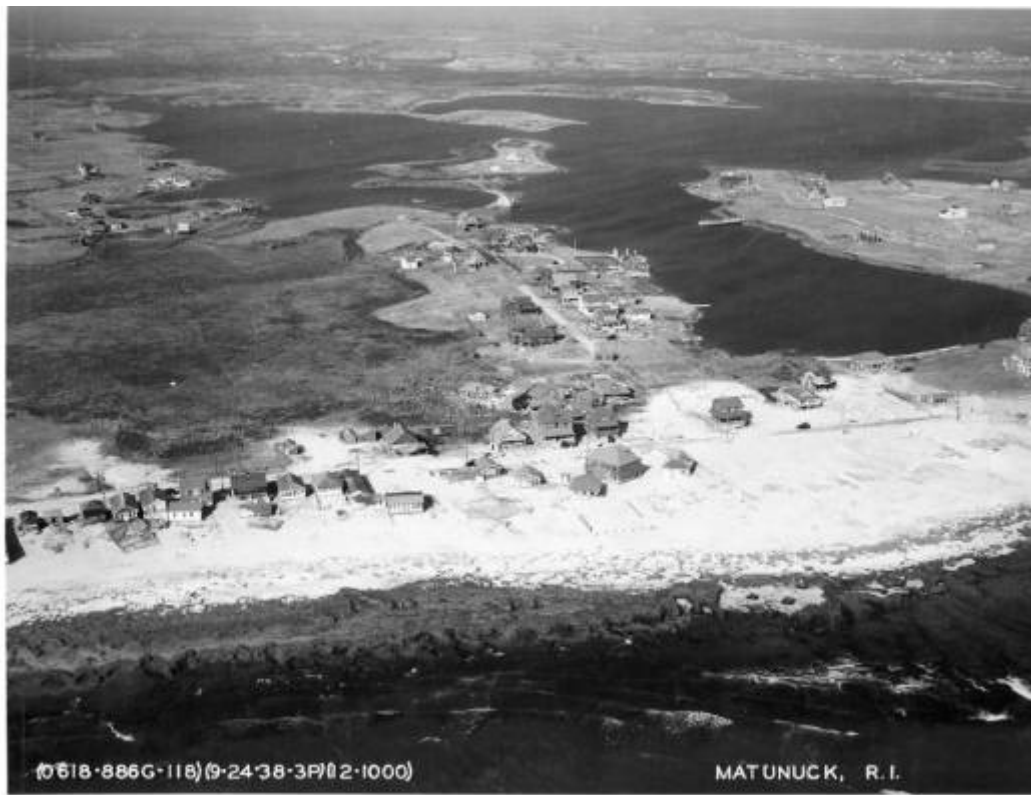
Figure 6. Matunuck Beach three days after the September 21, 1938 hurricane (Connecticut State Library Digital Photo Collections no. 00127)

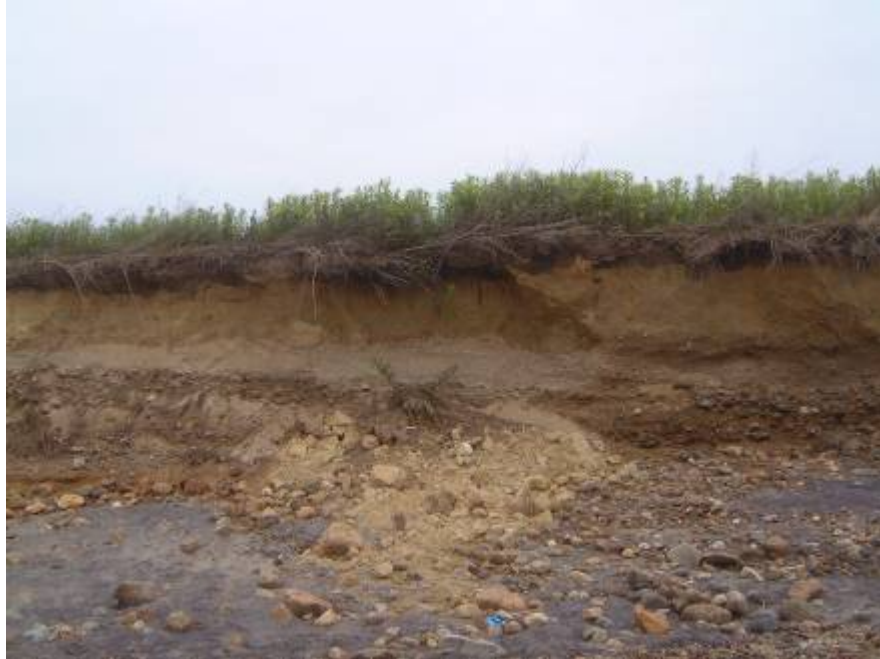
Figure 12. Headland bluff at the South Kingstown Town Beach showing glacial fluvial sediment and wind-blown loess. The bluff provides sediment for the beach.

The Matunuck Headland is one of many enclaves along the Rhode Island south shore that is subject to storm surges and high wave energy during coastal storms. The Matunuck Headland is located on Block Island Sound and receives direct onslaught from high energy events that shape the shoreline. Except for the shoreline abutting the large revetment on land owned by the Matunuck Beach Trailer Association and Mary Carpenter (parcels 92-2:46 and 92-2:47, respectively), all of the Matunuck Headland has both dry and intertidal sand beaches seaward of the headland deposits. The headland bluff, consisting of wind blown loess overtopping glacial fluvial sand and gravel, is the predominant inland coastal feature from the South Kingstown Town Beach west to the Cards Pond Barrier and is highly susceptible to erosion. See Figure 12.

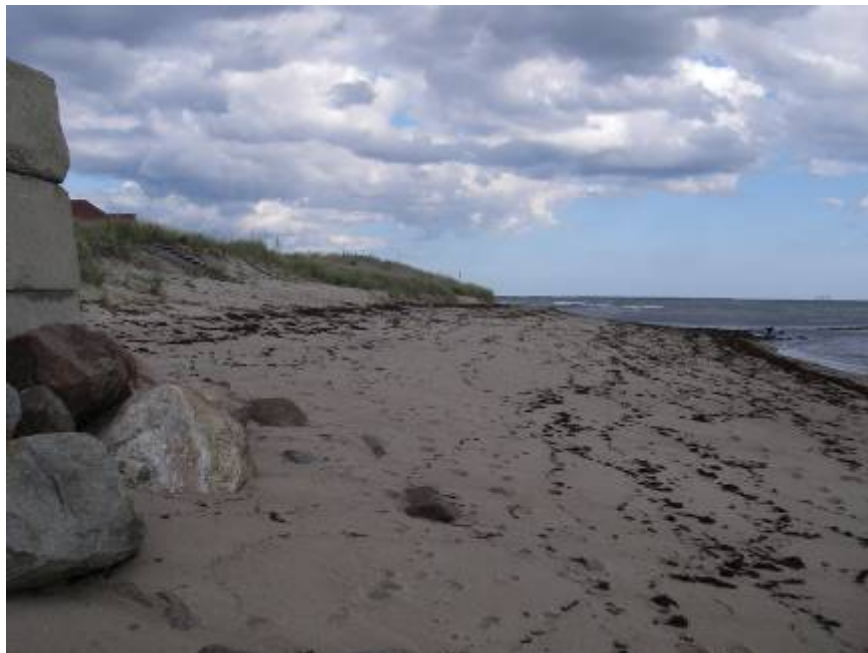
Figure 13. Dunes form in thick overwash deposits on Matunuck Headland east of the Matunuck Business District.

The upland section of shoreline between Deep Hole and the Matunuck Business District has very thick overwash sand deposits that extend inland tens of feet. Wind blown sand has formed dunes in these overwash deposits. See Figure 13. However, because this section of shoreline is classified as a headland, the inland edge of the coastal feature is the dune scarp rather than twenty-five feet landward of the dune crest as per RICRMP Section 210.7. The upper shoreface seaward of this section of shoreline consists of a cobble terrace that extends several hundred feet offshore and it dissipates some wave energy before reaching the shoreline. See Figure 14. Thus, this section of shoreline has experienced less dramatic shoreline change than shoreline segments to the west.

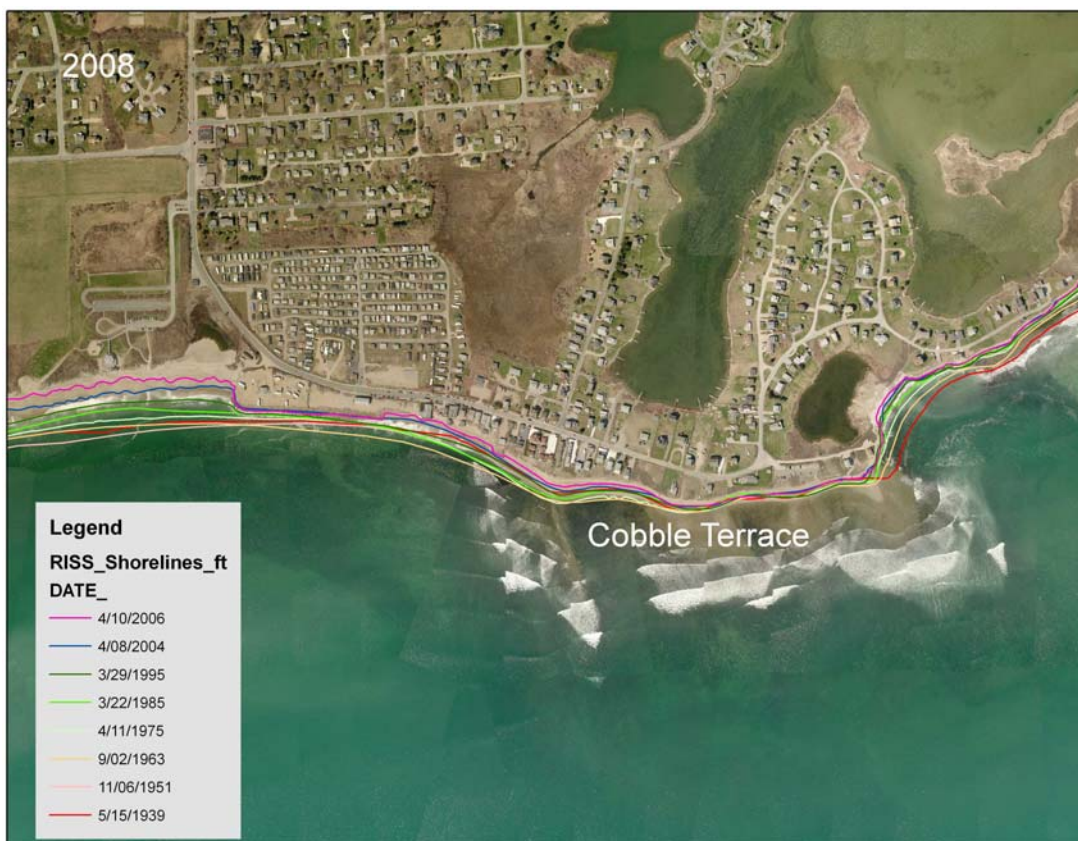
Figure 14. Matunuck Shoreline showing the offshore cobble terrace that dissipates wave energy and helps mitigate erosion along a portion of the Matunuck Headland shoreline. The delineated shorelines indicate which areas change very little over time (lines closer together) and which sections undergo radical change (lines farther apart). The Matunuck Business District has a moderate erosion rate and likely benefits from the offshore cobble terrace which dissipates wave energy.

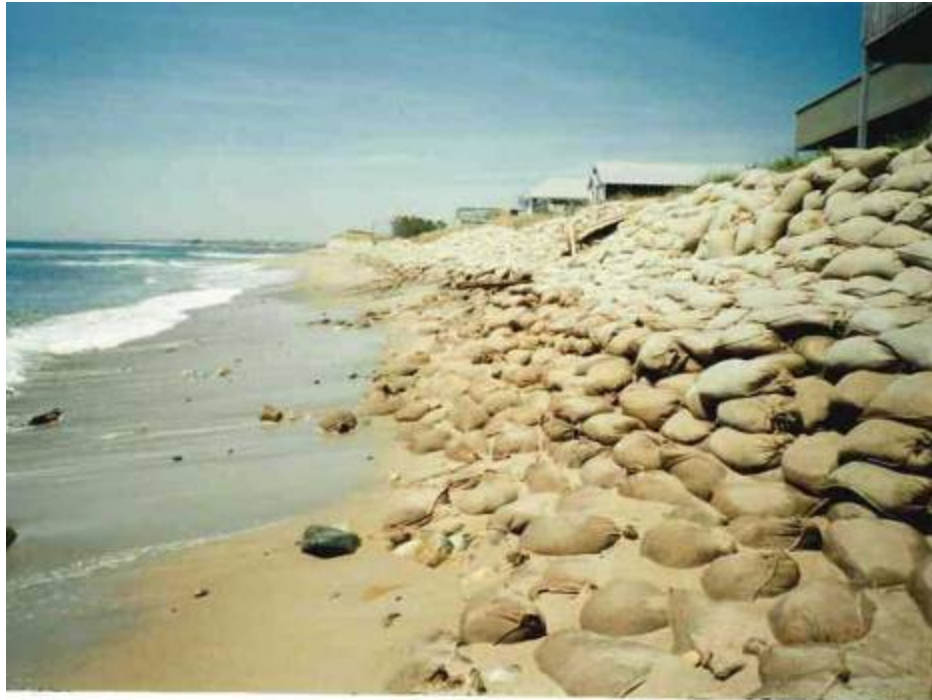
Figure 15. Emergency erosion control west of Deep Hole after 1999 extra-tropical storm.

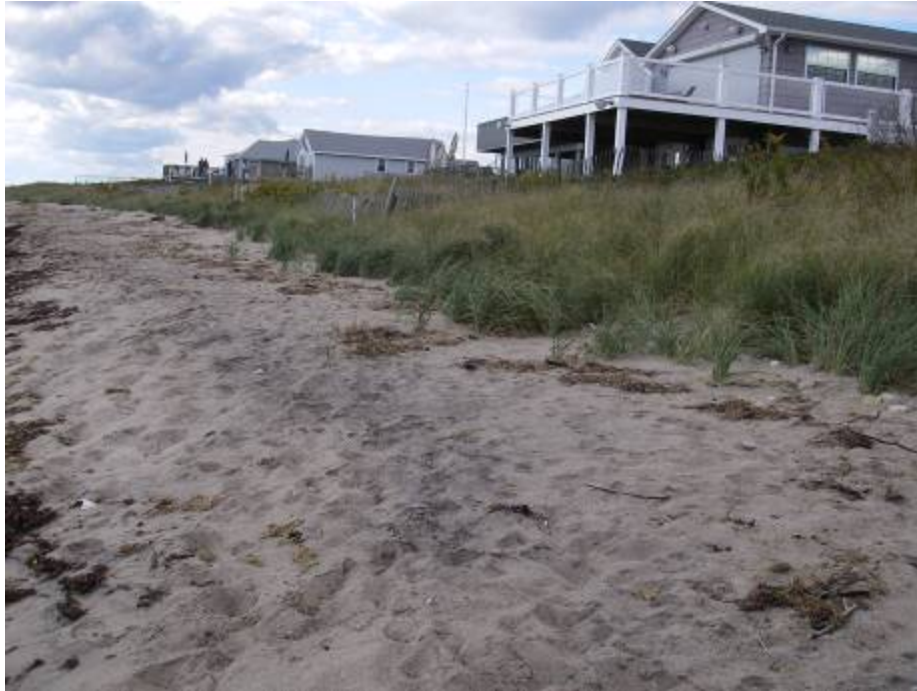
Figure 16. Same section of shoreline in 2009 showing sand accretion on the beach and the dunes.

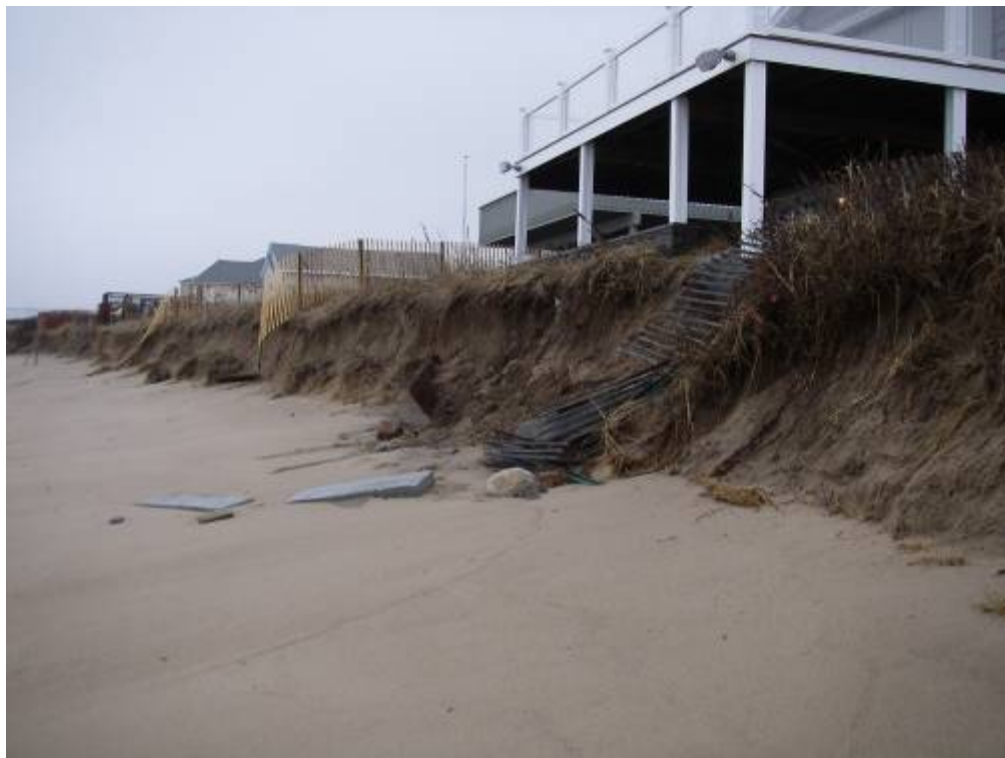
Figure 17. Same section of shoreline after a 2010 extra-tropical storm. The post-storm erosional scarp is in approximately the same position as the 1999 scarp shown in Figure 15 above.

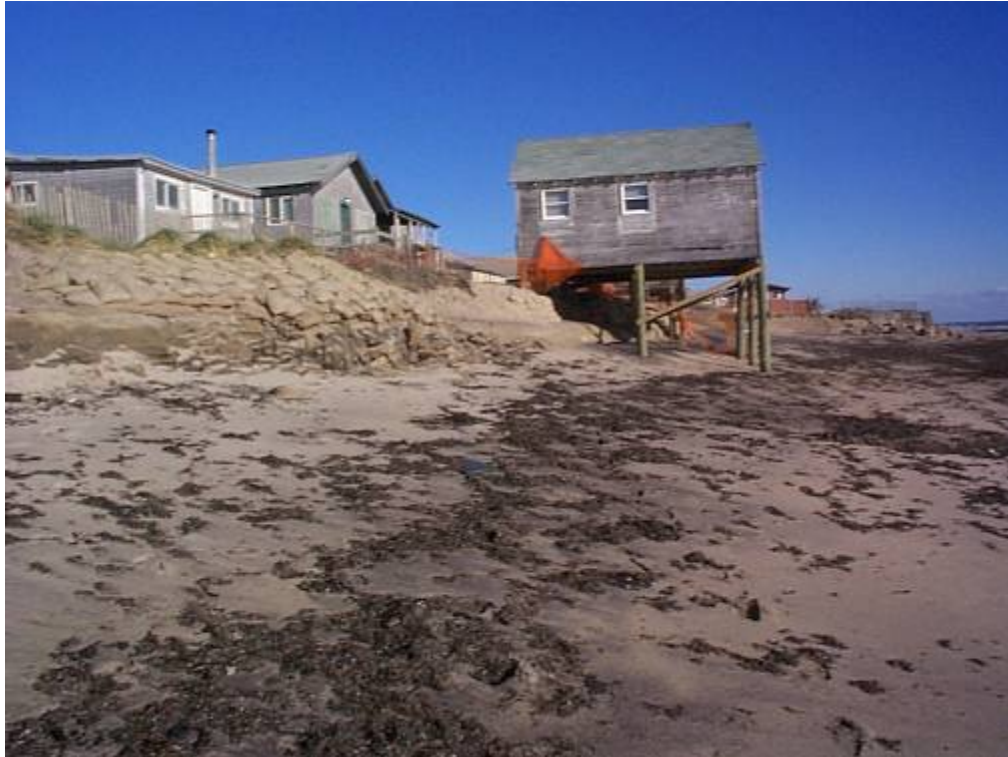
Figure 18. Matunuck Business District in 1999

The coastal bluff and dune scarp show net erosion, and anecdotal accounts suggest that erosion rates at Matunuck have accelerated since the mid 1980s. Comparing the location of the visible seaward edge of vegetation on 1985 and 2008 aerial photographs the landward migration ranges from a low of ~ 10 feet behind the cobble terrace to a high of 120 to 140 feet at the South Kingstown Town Beach. The migration of the bluff at the Matunuck Headland Business District was hard to determine for that time period due to lack of vegetation on either set of aerial photographs. Photos taken on site over the last 12 years, however, show that the bluff has migrated less than 20 feet since 1999 as shown in Figures 18 and 19. The perception is that the erosion has been far greater in this location because of the adverse impacts to the many structures and septic systems, some of which have been on the site prior to the 1938 hurricane.

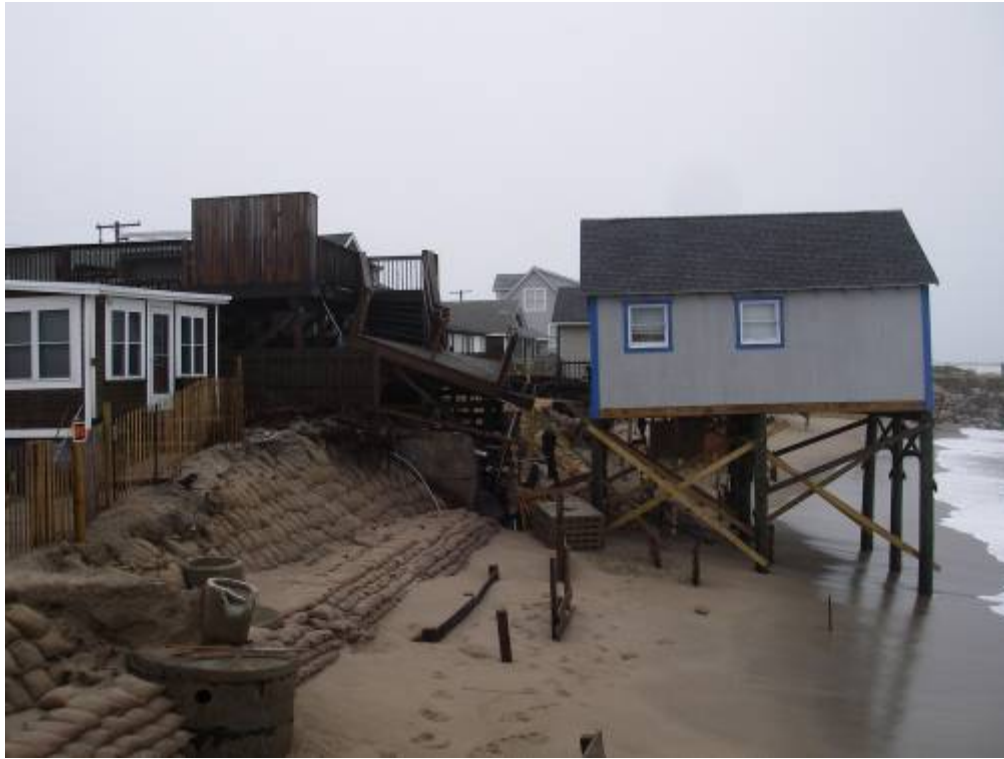
Figure 19. The same structures in 2010 as shown in Figure 18 above. Approximately twenty feet of bluff landward of the house has eroded since 1999.

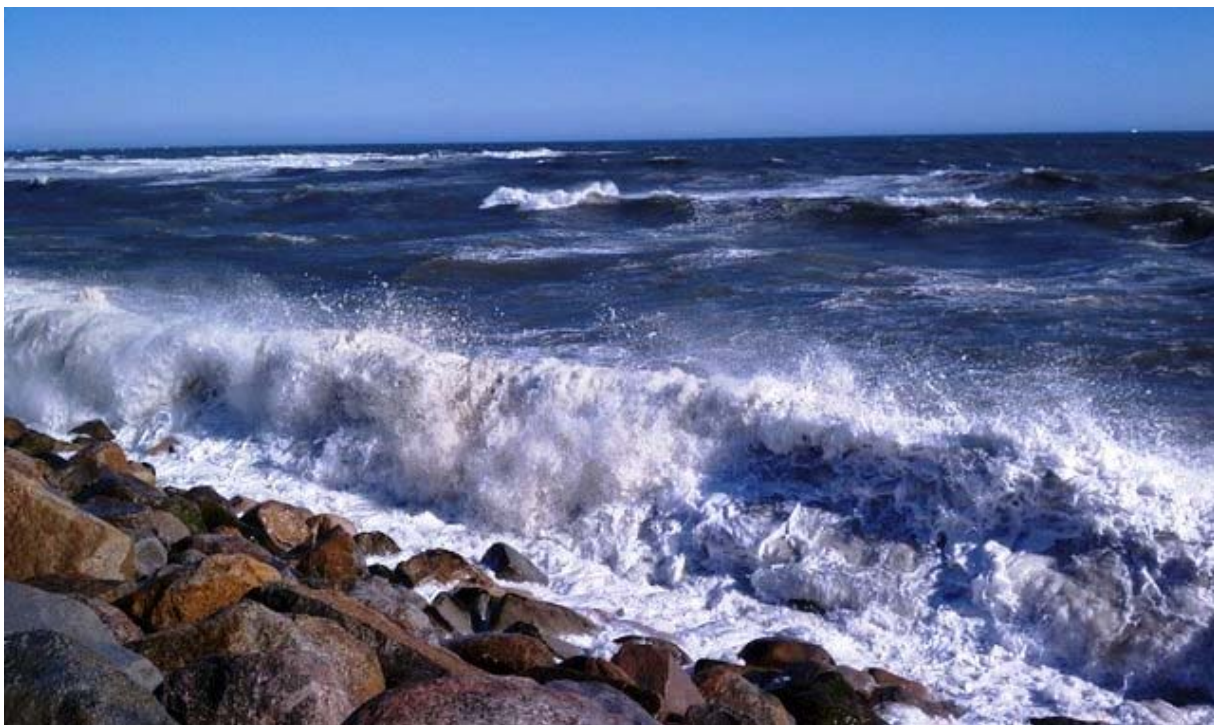
Figure 20. Surf conditions at the Matunuck Beach Trailer Association property on April 17, 2011.

Shoreline Access Needs for Recreational Uses: The Deep Hole parking lot provides an exceptional fee-free, state-managed facility for public access to Matunuck Point. The parking area and two small adjacent undeveloped shorefront lots provides a small area of beach for recreational access to the Matunuck Point Reef. However, in order to participate in the recreational sports which occur at Matunuck, lateral shoreline access is required. Due to the wave environment and strong tidal currents over the reef, kayakers, surfers, windsurfers and kite boarders often end up getting swept down shore, particularly in storm seas that generate the preferred waves on the reef. Shoreline revetments eliminate the beach fringe preventing lateral shoreline access. It is also relatively common for kayakers, surfers, windsurfers and kite boarders to get into trouble in the strong reef currents and wave break. Those familiar with Matunuck Point know from experience to avoid getting trapped in front of the existing shoreline revetments that do not allow for a safe shoreline exit. In these areas, the waves often break directly on the boulder revetments making getting back to shore impossible in rough seas and currents. Many people have seen their gear (surf boards, windsurfers, kites, etc.) destroyed on the existing revetments while trying to get back to shore. There's even a case where a surf fisherman was swept off the reef into Deep Hole and drowned. An existing line of revetments immediately east of Deep Hole, along with the large revetment in front of the Matunuck Beach Trailer Association property, pose significant safety hazards for recreational users in this area when trying to gain the shoreline from the water during high surf conditions. See Figure 20.
