## Small-scale Coastal Adaptation Projects: effective in big ways

# Rhode Island's shoreline is eroding and migrating inland.

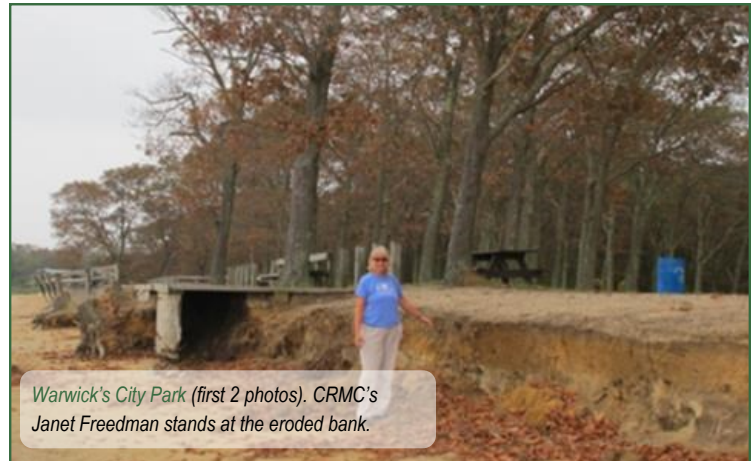
*Warwick's City Park (first 2 photos). CRMC's Janet Freedman stands at the eroded bank.*

At the beach at **Warwick City Park**, erosion had damaged an existing boardwalk. The boardwalk was removed, and the slope reduced to increase the beach area and lessen erosion from waves.

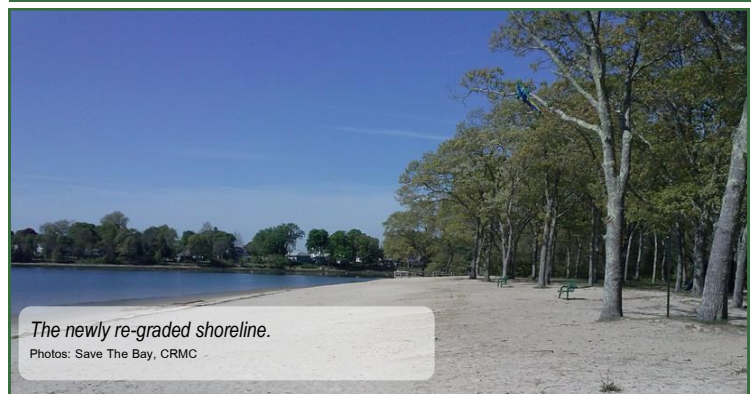
*The newly re-graded shoreline.*  
Photos: Save The Bay, CRMC

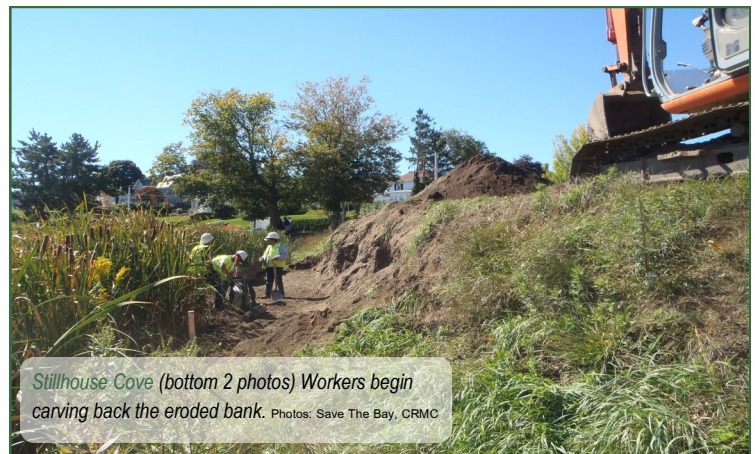
*Stillhouse Cove (bottom 2 photos) Workers begin carving back the eroded bank. Photos: Save The Bay, CRMC*

**Stillhouse Cove**, a small waterfront park in Cranston, had a severely eroded bank which was a safety hazard. The steep bank was carved back to make a gentler slope to reduce wave energy and lessen erosion. Sand-filled coir tubes were added to the bank in a step formation, then covered and planted with native grasses. During recent storms, the upland edge of the beach and grassy park area in **King's Park** in Newport had

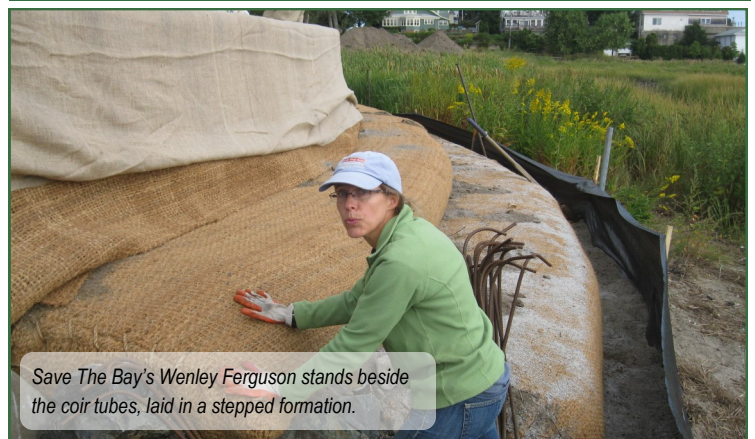
*Save The Bay's Wenley Ferguson stands beside the coir tubes, laid in a stepped formation.*

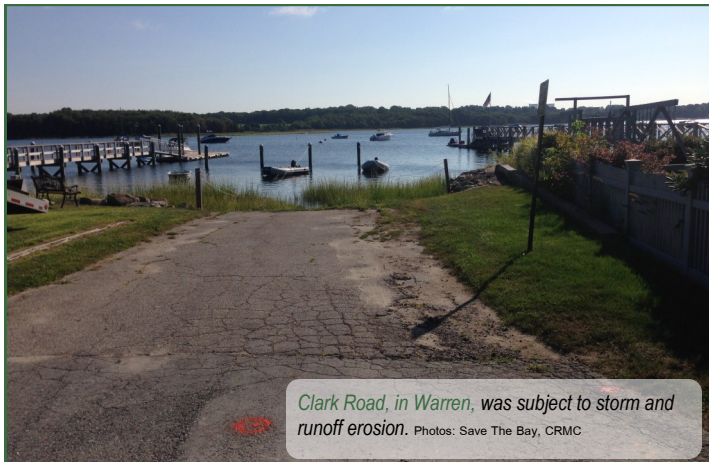
*Clark Road, in Warren, was subject to storm and runoff erosion. Photos: Save The Bay, CRMC*

- ◆ **Kickemuit Avenue, Bristol**- stormwater infiltration added to formerly paved area, shoreline re-graded;
- ◆ **Clark Road, Warren**- pavement removed, coir tubes installed at bank edge, then planted with marsh plants to enhance existing marsh; filter strip installed;
- ◆ **Mill Cove Road, Warwick**- pavement removed, filter strip installed, site planted;
- ◆ **Grove Avenue, Warwick**- pavement removed, a filter strip was installed;
- ◆ **Rock, Pender, and Van Zandt Avenues, Warwick**-pavement removal and filter strip installed.

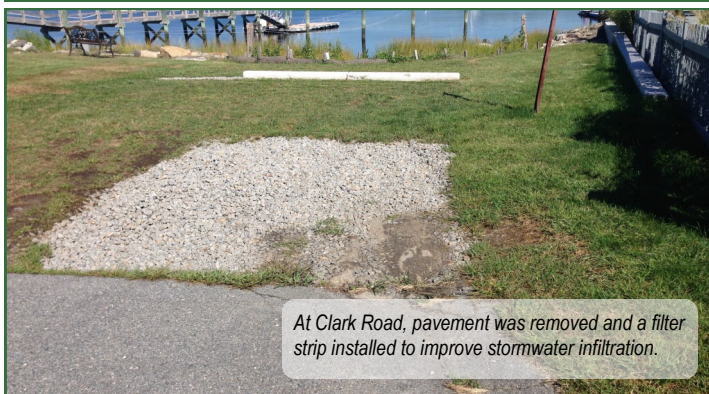
*At Clark Road, pavement was removed and a filter strip installed to improve stormwater infiltration.*

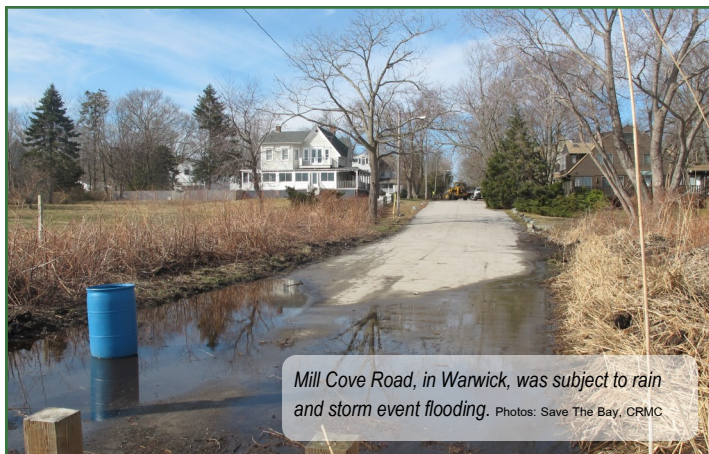
*Mill Cove Road, in Warwick, was subject to rain and storm event flooding. Photos: Save The Bay, CRMC*

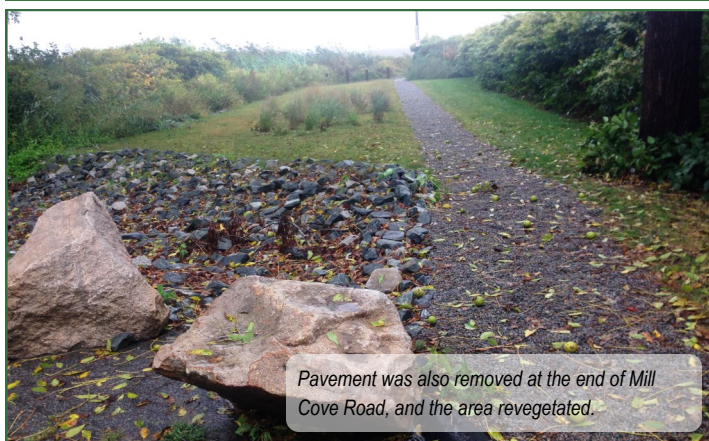
*Pavement was also removed at the end of Mill Cove Road, and the area revegetated.*

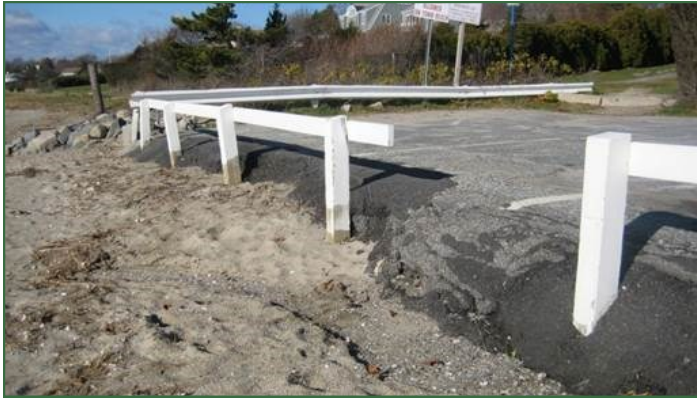
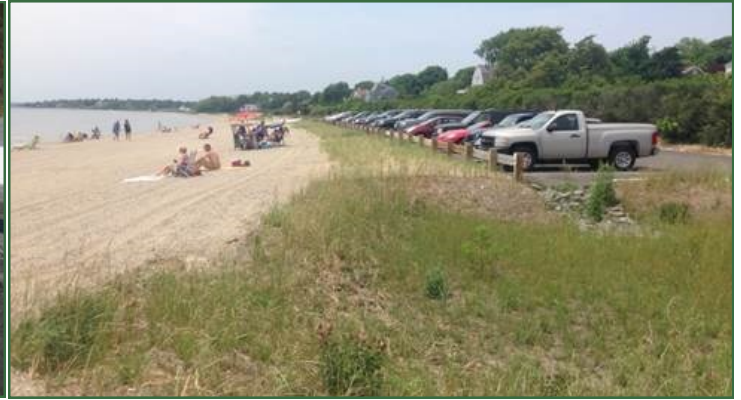
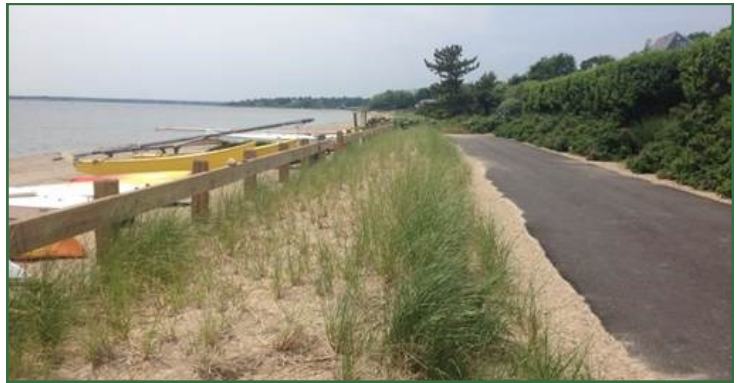
*Pictures of Barrington Beach— (Top left) Before: erosion is evident at the western end of the parking area. (Top right) After: the parking lot is reduced in width and beach grass planted. (Right) After: Parking lot pavement removed, beach grass planted. This project also included the installation of stormwater infiltration practices to address runoff from the adjacent streets. (Photos courtesy of Save The Bay)*

**Barrington Beach** suffered from erosion due to wave energy and stormwater runoff at a number of locations. A section of the parking lot was removed at the western end, the remainder of the lot was moved inland 10 feet, and a dune created and grass planted in the now unpaved area.
