## ALLINS COVE GEOLOGICAL CHANGE AND HABITAT RESTORATION

Janet Freedman  
Coastal Resources Management Council  
Stedman Government Center  
4808 Tower Hill Road  
Wakefield, RI 02879  
[j.freedman@coastal-resources.org](mailto:j.freedman@coastal-resources.org)  
Jon C. Boothroyd, State Geologist  
Department of Geosciences and Rhode Island Geological Survey  
University of Rhode Island  
Kingston, RI 02881  
[jon\\_boothroyd@uri.edu](mailto:jon_boothroyd@uri.edu)

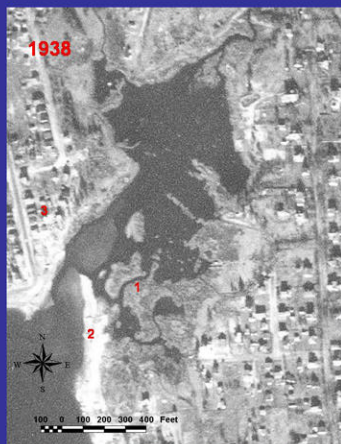
December 1938 aerial Photograph of Allins Cove salt marsh (1) and barrier spit (2). Note the wide inlet between the barrier spit and the headland area (3) to the northwest.

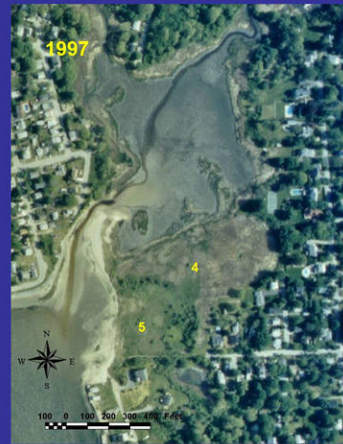
Allins Cove was designated Spoils Area #5 for the Bullocks Pt. Cove navigational dredging project. The bulk of the sediment from that project was hydraulically pumped to Allins Cove. This 1959 photograph (left), taken shortly after completion of the dredging, shows sediment covering much of the Allins Cove salt marsh area. Today this section of the cove consists of Phragmites marsh (4) and upland (5) (above). In addition, the barrier spit has migrated to the northeast, constricting the inlet channel (6). Flood tidal current flow through the channel causes undercutting to the existing salt marsh on the northeast shore of the cove. The rotation of the barrier spit has exposed the Byway Road erosional area to more southerly wave fetch over time, resulting in increased erosion of the bluff
