PLANNING ASSISTANCE TO STATES PROGRAM

Rhode Island Coastal Wetlands Inventory Report

APRIL 2008

**US Army Corps
of Engineers
New England District**

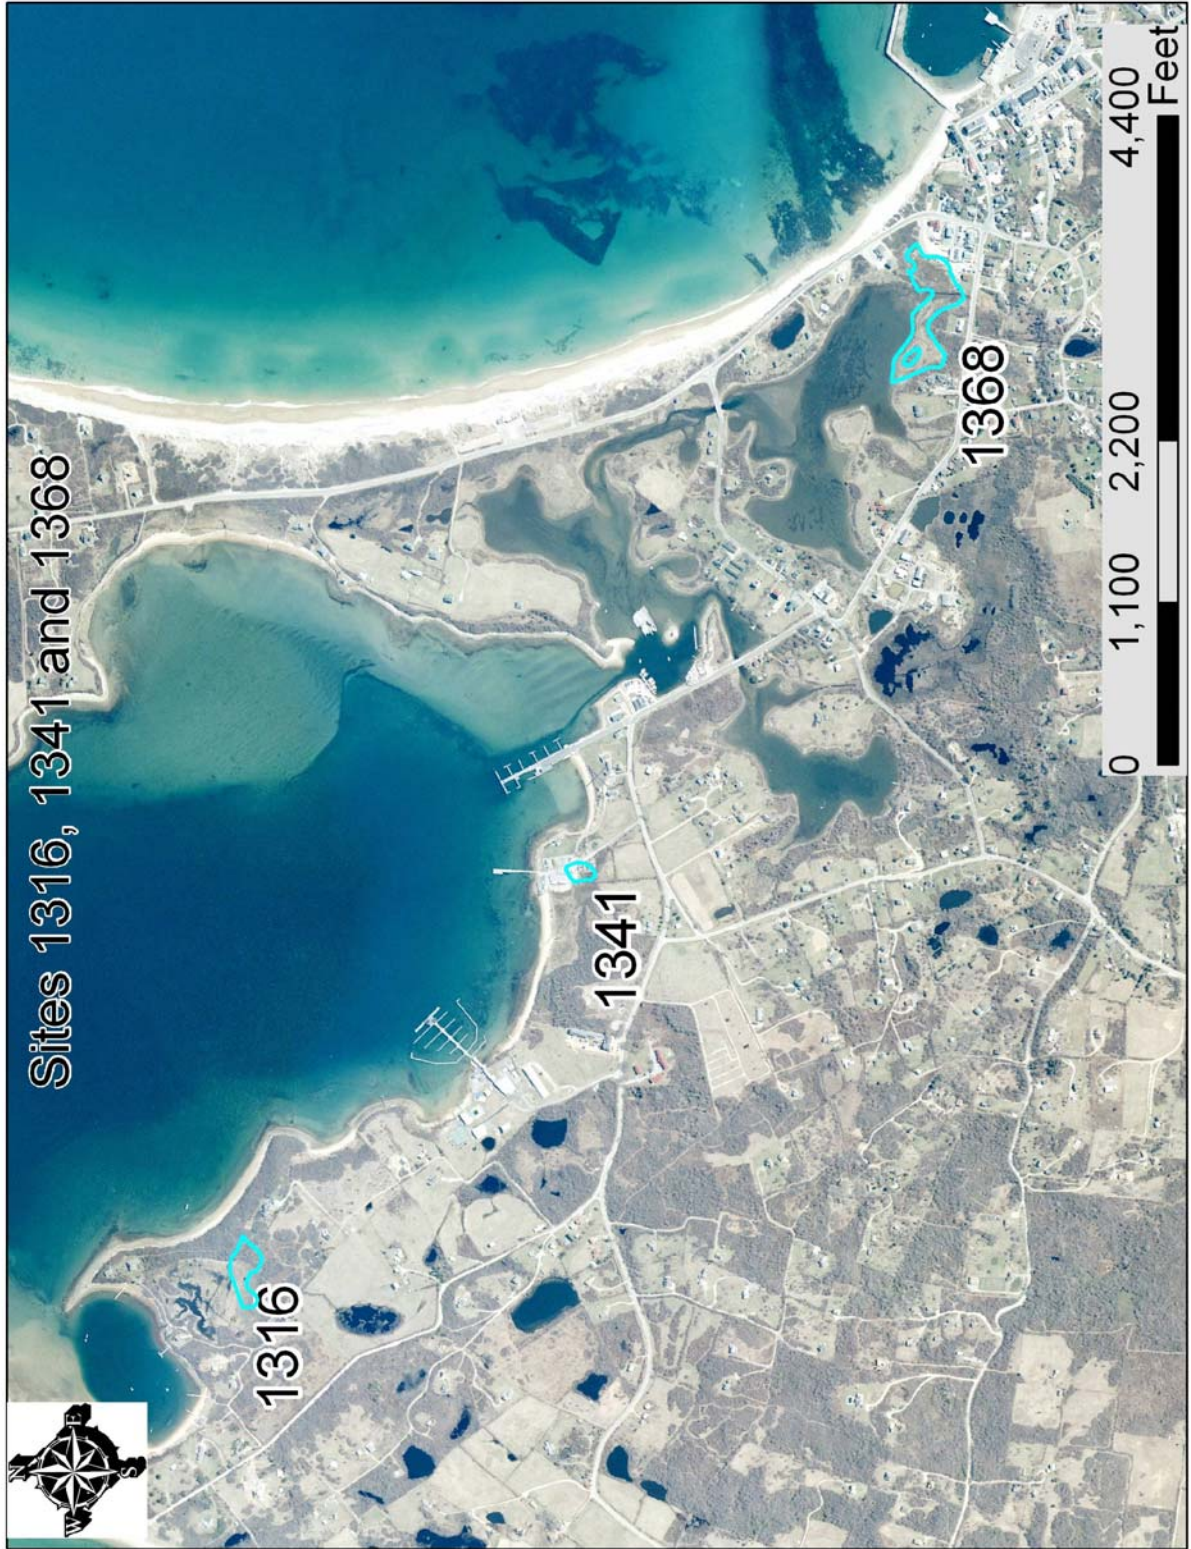
Figure 5: Sites 1316, 1341 and 1368 in New Shoreham.

In New Shoreham, the three sites (**1316, 1341, and 1368**) that contain *Phragmites* abutting nearby local roads were identified as potential restoration sites. Site 1316 is 1.35 in acres and lies south east of Cormorant Cove between two small un-named roads. Site 1341 is approximately 0.43 acres and lies in Veterans Park. Site 1368, the largest site with 4.15 acres, is found between Harbor Pond and Ocean Ave. These sites are shown in Figures 4 and 5. Restoration activities would include *Phragmites* removal and increased flushing of salt water to all three sites.

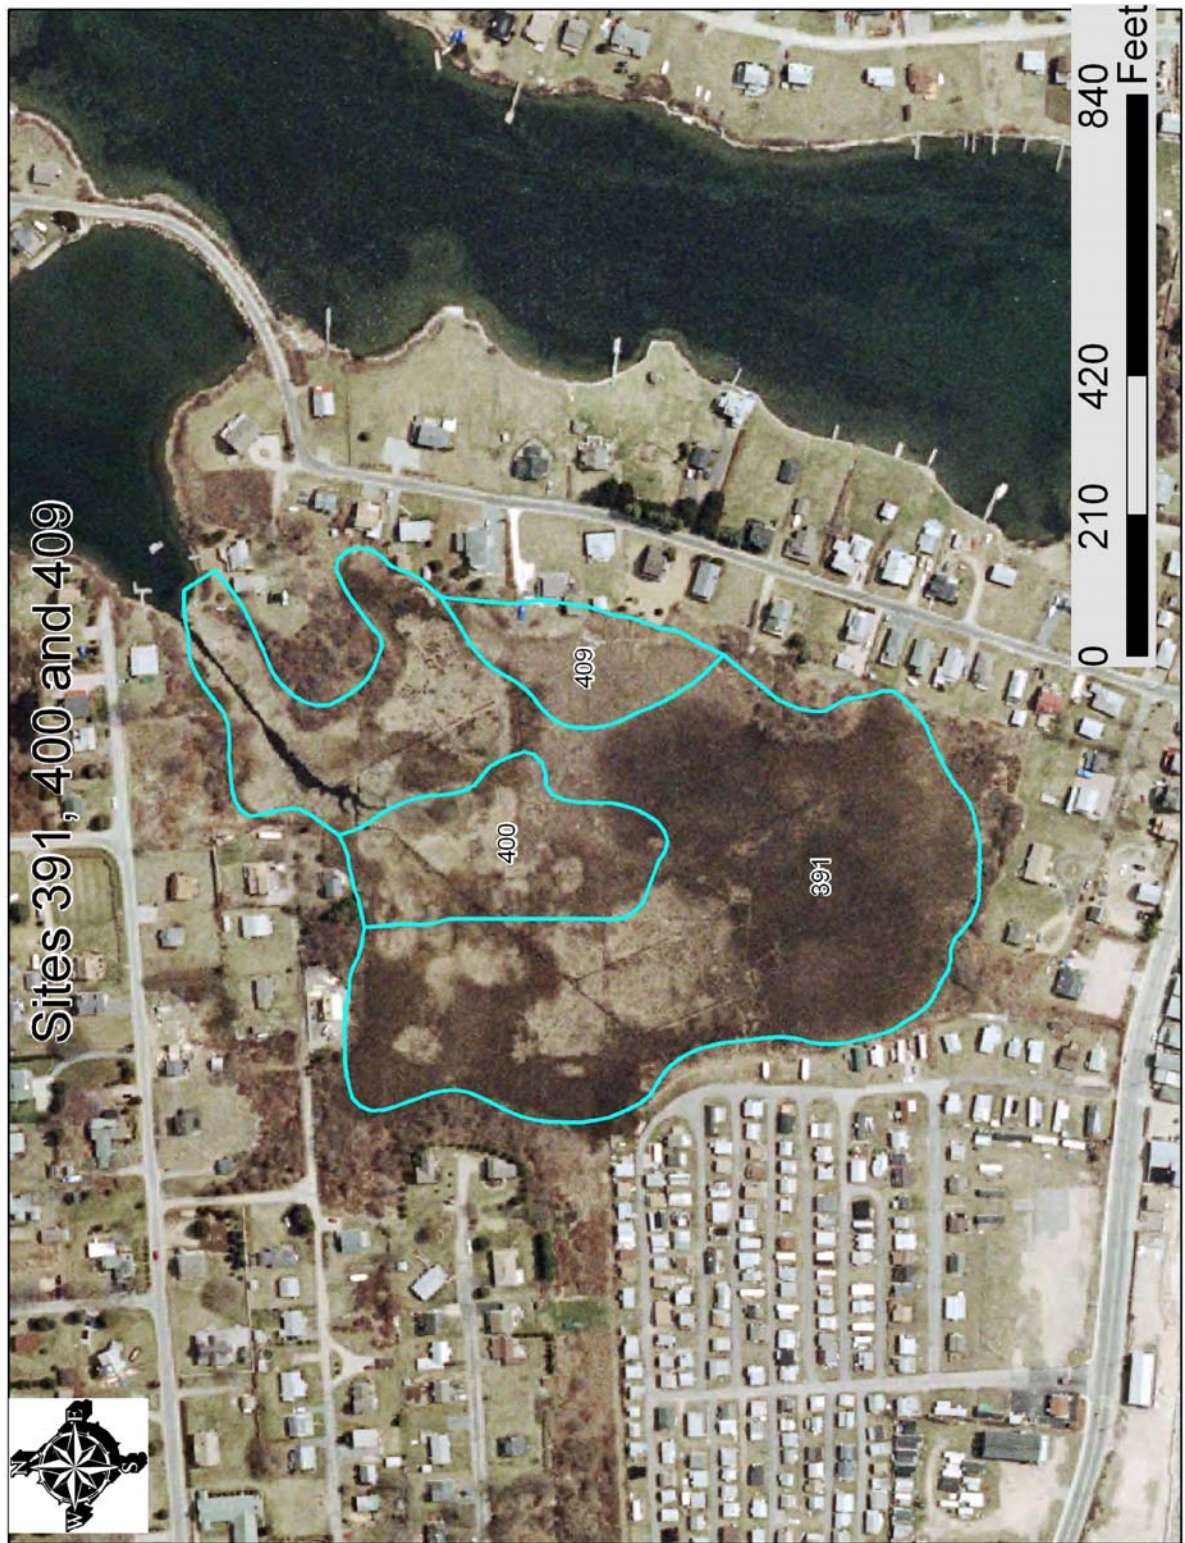
Figure 8: Sites 391, 400 and 409 in South Kingstown.

Sites 391/400/409 – These sites are part of an un-named coastal pond connected to Potter's Pond in Matunuck as shown in Figure 8. The sites are surrounded by residential homes and a trailer park (summer homes) (see Figure C3, Appendix C for view of these sites from the trailer park). The area is dominated by *Phragmites* with some *Spartina* surrounding an open water area (a creek/ditch). At the entrance to the site (391) from Potter's Pond the open water is surrounded by *S. alterniflora*, *S. patens* and *Solidago sempervirens* along the edges with *Phragmites* which dominates the site. The entire site is 11.53 acres (Figure C4, Appendix C). Approximately 200 feet from the entrance to the site there appears to be a restriction of flow caused by upland vegetation encroaching toward both sides of the creek (see Figures C5, C6, and C7 in Appendix C). Within sites 391 and 400 (1.96 acres), the area appeared to have been ditched at one time with *Spartina* growing along the water edges and then transitions to *Phragmites*. Site 409 is 1.10 acres and totally inundated with *Phragmites*. In October of 2006, CRMC had identified a small pocket of cattail in site 409 but none was found by Corps personnel during a site visit at the end of October 2007. Opening the entrance to these sites would allow for better water flow into the area and improve the habitat conditions. Also, due to the large amount of *Phragmites* present, it would probably be necessary to start a *Phragmites* eradication project as well along the outer edges of the sites.

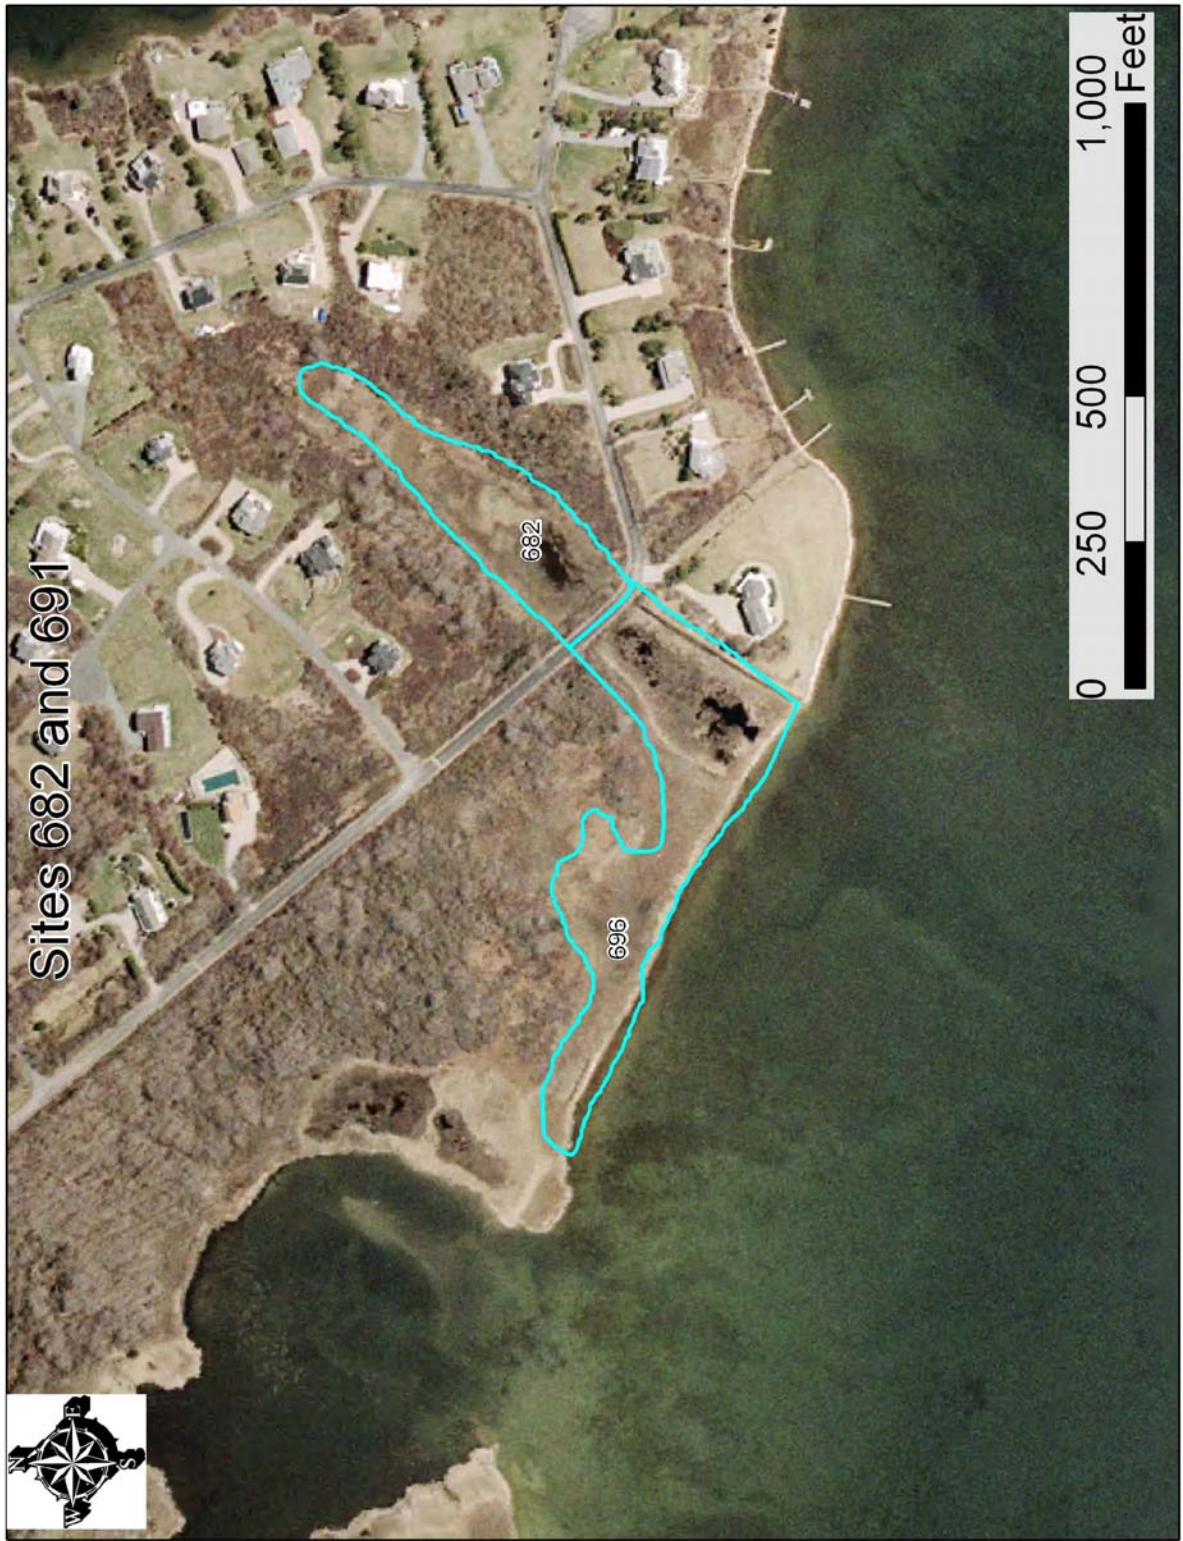
Figure 10: Sites 682 and 696 in Charlestown.

In Charlestown there is a potential restoration area (site 682) between Mud and Foster Coves near Wildflower and Cove Roads (See Figures 9 and 10).

Site 682 – This site is a wetland area surrounded by residences of a private community between Mud and Foster Coves off of Ninigret Pond. The 1.9 acre area is dominated by *Phragmites*. There is also some open water in the site that is surrounded by *Spartina* (Figure C8, Appendix C). There is some *Lythrum salicaria* (purple loosestrife) along the edges of the site by the road. This area is hydraulically connected to site 696 by a culvert under the road (Wildflower Road). The culvert consists of a concrete pipe approximately 3 feet in diameter. At the time of the site visit (10/31/2007, 12:30 pm) the water level within the pipe was about half filled. However, about one-fourth of the pipe was filled with sediment. Also the invert of the pipe seems to be lower on Site 682 side of the road as compared to the opening at site 696 (Figure C9, Appendix C shows a view of the culvert from site 696).

Site 696 has a creek that connects to Ninigret Pond (Figure C10, Appendix C). The salinity at the creek entrance was 25 ppt at about high tide and the salinity at the entrance at both ends of the culvert was 22 ppt. There was no evidence of marine life at the far side of the creek. In this site, *Spartina patens* is found along the edges of the open water and then transitions to *Phragmites*. Adjacent to the roads one can find *Solidago sempervirens* (golden rod), *Baccharis halimolia* (sea myrtle), *Rhamnus* sp (buckthorn), *Cornus amomum* (silky dogwood), *Salix* sp. (willow), *Rosa multiflora* (rose), *Lonicera japonica* (Japanese honeysuckle), *Toxicodendron radicans* (poison ivy), and *Toxicodendron vernix* (poison sumac).

Restoration of site 682 would involve removal of invasive species of *Phragmites* and purple loosestrife and cleaning out the culvert to allow for better flow between the two sites. Repositioning of the culvert may also be necessary.

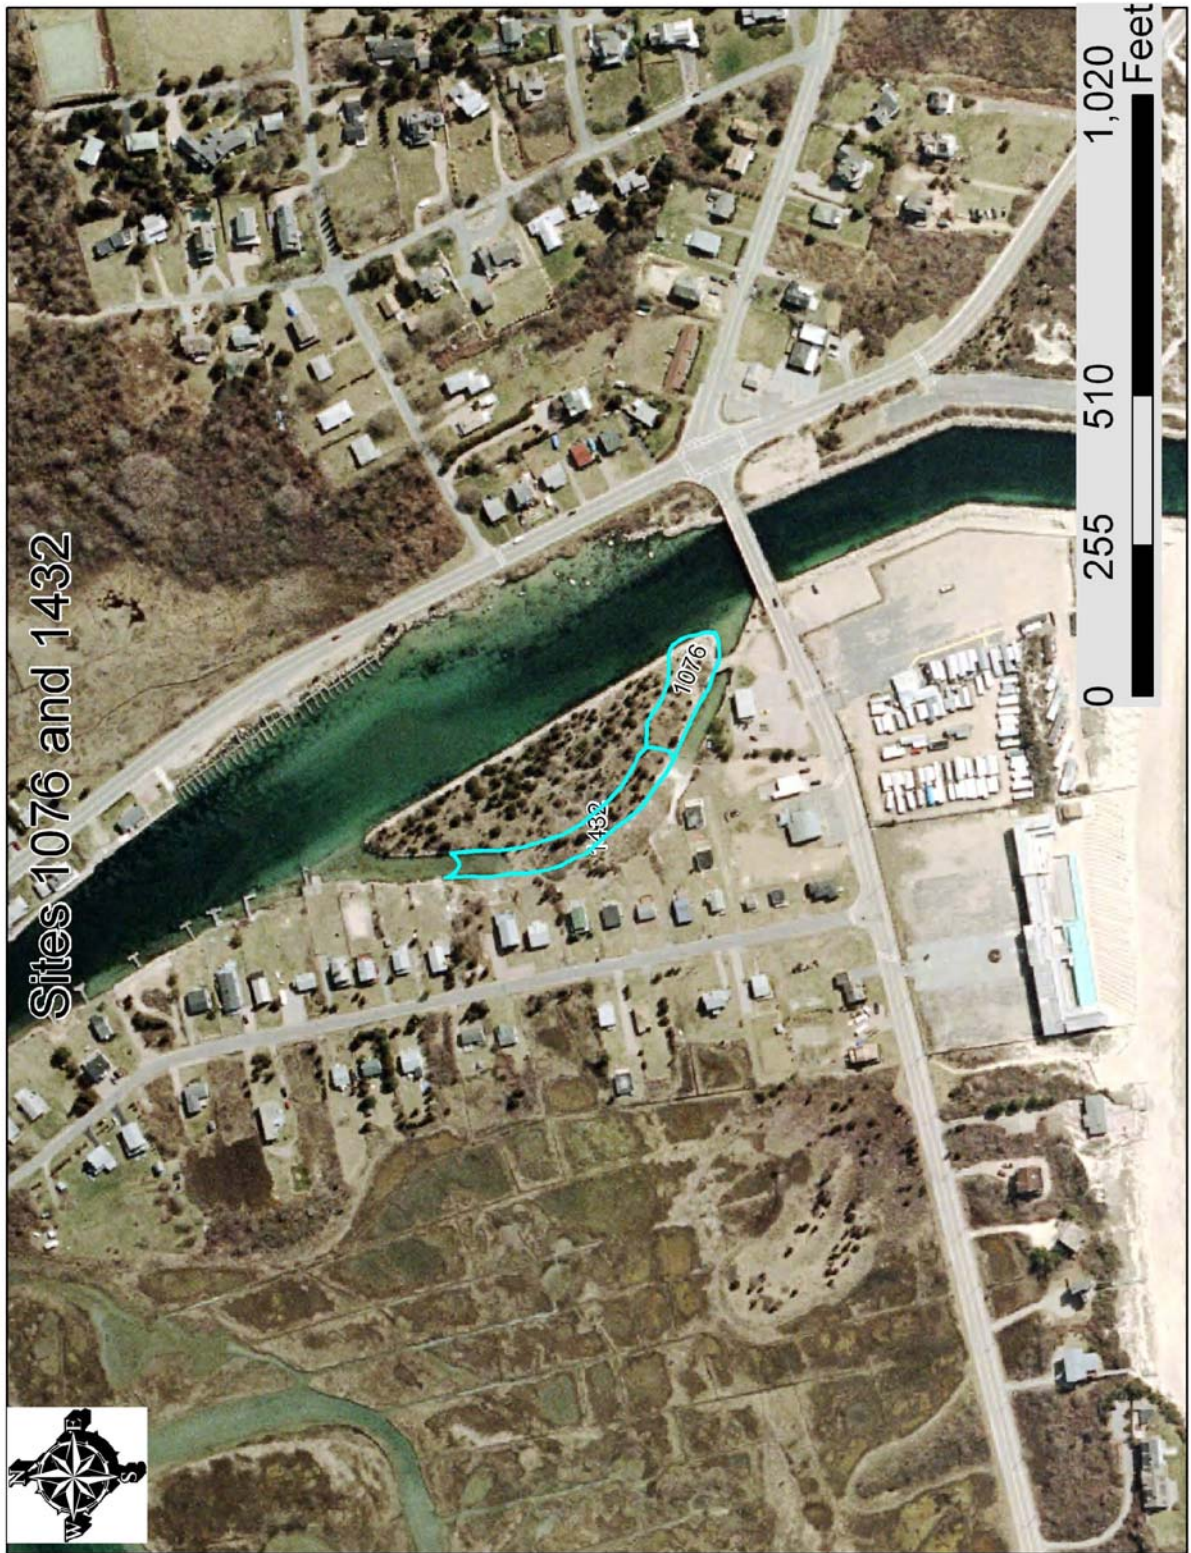
Figure 12: Sites 1076 and 1432 in Westerly.

Sites (1076/1432) –Polygon 1076 was split into two sites - 1076 for the open water (0.53 acres) and 1432 for the filled area (0.45 acres). This site is the entrance of the former inlet into Winnapaug Pond that has filled (silted) in over time. The channel has filled with sediment and *Phragmites* is now dominating the area. *Spartina patens* was also present at the site (see Figure C11, Appendix C). The open water sections appear to have high quality habitat with fishes observed in all areas. The salinity in the breach way and at both ends of the filled area was 33 ppt at the time of the site visit (10/31/2007, 11:40 AM) (Figure C12, Appendix C, shows the entrance into the former channel looking at filled area and Figure C13, Appendix C shows a view of the far end of filled area). The triangle of land between the filled area and the current breach-way is an upland environment consisting of *Juniperus* sp. (Juniper), *Juniperus virginiana* (red cedar), *Salix* sp. (willow), *Andropogon glomeratus* (broom grass) *Toxicodendron radicans* (poison ivy), *Solidago sempervirens* (goldenrod), *Myrica cerifera* (wax myrtle), *Comptonia peregrine* (sweet fern), *Limonium nashii* (sea lavender), *Lonicera japonica* (Japanese honeysuckle), *Baccharis halimolia* (sea myrtle), and lichens (encrusting and folious) (see Figure C14, Appendix C).

Dredging the area will restore flows to the old inlet, but it will not increase the amount of wetland in the area since by dredging an area of fill, a new area of open water is created. Sites 1076 and 1432 are shown in Figures 11 and 12.

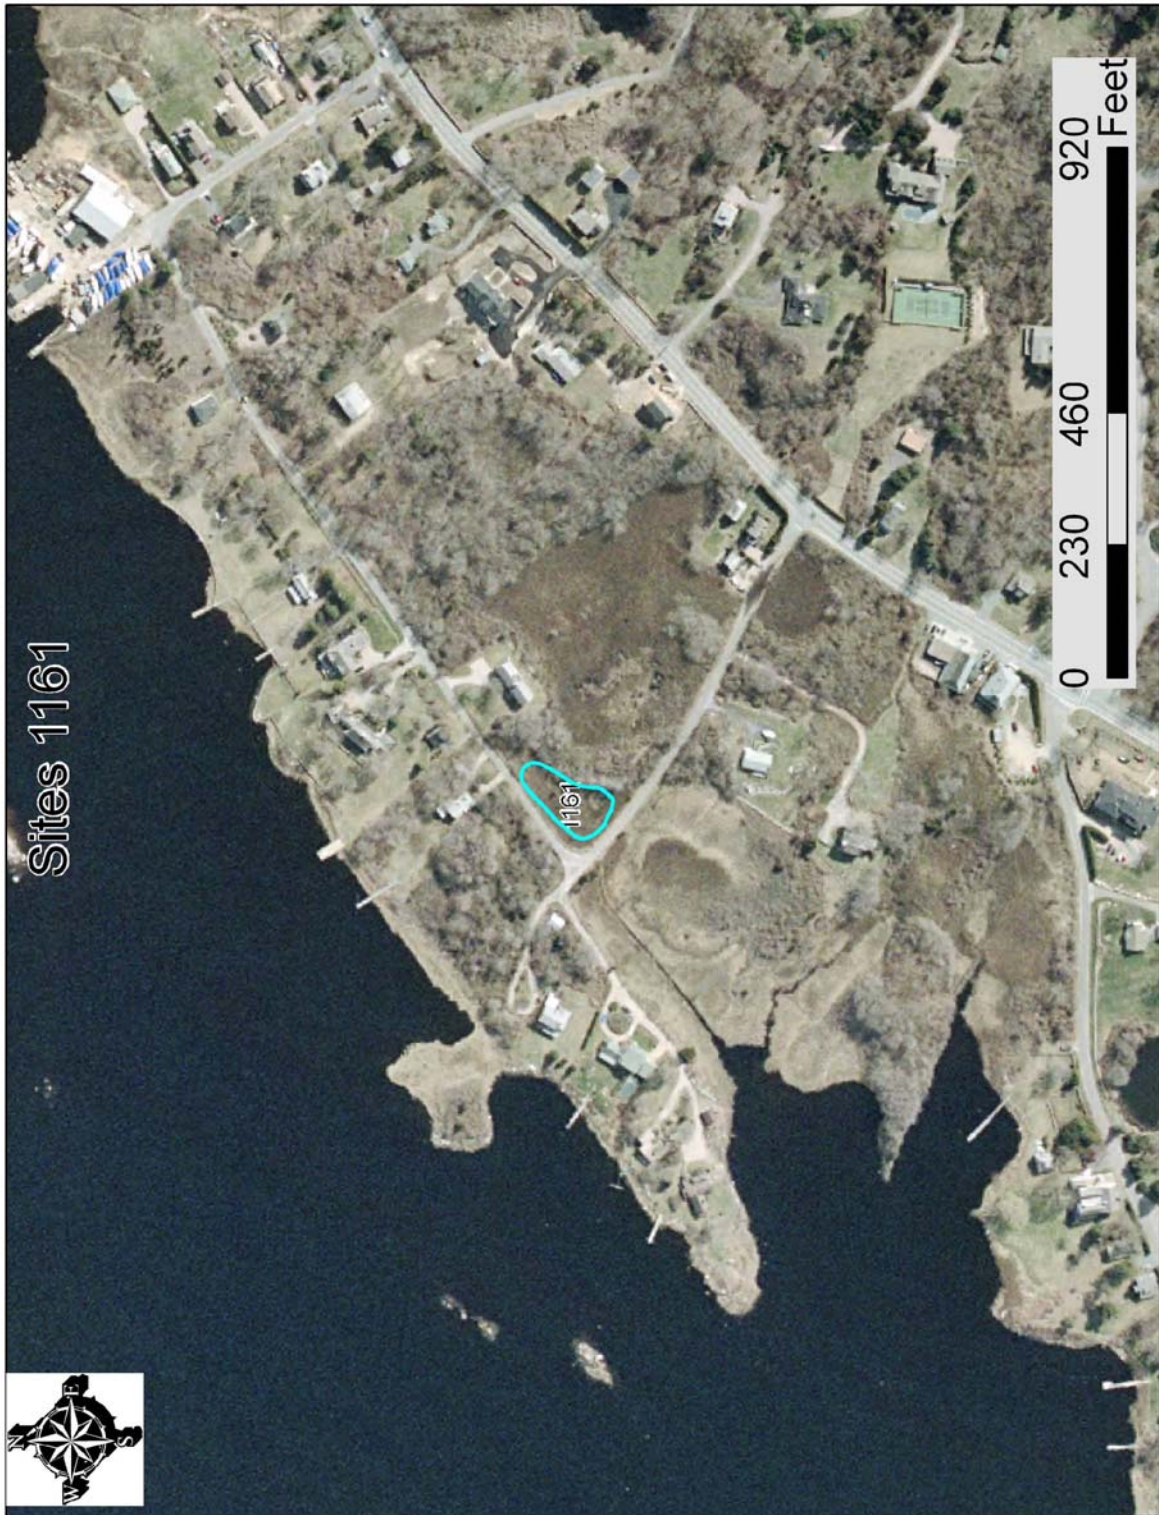
Figure 13: Site 1161 in Westerly.

Site 1161- Site 1161 is about one quarter of an acre in size and is located in western Westerly, north of Potter Cove, between Breen Road and Pasadena Avenue off of the Pawcatuck River as shown in Figure 13. The site is connected to sites 1165 (5.13 acres) and 1167 (1.54 acres) located on the other side of Breen Road. Adjacent to site 1161 is site 1160 (2.52 acres). The land between sites 1160 and 1161 appears to be of higher elevation. An existing culvert under Watch Hill Road (Route 1A) diverts water from the roadway into site 1160 likely contributing to the growth of *Phragmites australis* that dominates most of the site (CRMC field notes record culvert as not functioning properly). Site 1161 is also predominantly *Phragmites* (Figure C15, Appendix C). There is some *Toxicodendron radicans*, *Salix* and *Erigeron strigosus* along the edges of site. There is a box culvert with a pipe about 12 inches in diameter (see Figure C16, Appendix C) that runs under Breen Road that connects this site to site 1165. There is ponded water by the culvert with a salinity of about 22 ppt at the time of sampling (10/31/2007, 10:15 AM) during an incoming tide (closer to low tide) (Figure C17, Appendix C).

Sites 1165 and 1167 are across Breen Rd from site 1161. The end of the culvert in 1165 that connects to site 1161 is a box culvert with an iron pipe that has partially collapsed (see Figure C18, Appendix C). Site 1165 is dominated by *Phragmites* with some *Solidago sempervirens* along the outer edges with *Myrica cerifera*, *Rosa palustris*, *Vitis* sp. and *Eunymous* (planted) along roadside areas that parallel site 1165. At the entrance to the creeks leading from Potter Cove there is *Spartina alterniflora* with *S. patens* behind it with *Phragmites* up at the road (Breen Rd) (see Figures C19 and C20, Appendix C). The salinity at the entrance of the creek from Potter Cove was about 28 ppt at the time of sampling (it was early in the incoming tide on 10/31/2007 at 10:15 AM) with evidence of a healthy marine environment (limpets, mussel shells, blue crab, and brown algae on the rocks) in the area. Site 1167 also has *S. alterniflora* along with *S. patens* in the higher marsh areas gradually giving way to grass then more *S. patens* and then a small upland area closer to the road (Breen Rd.). The upland area had thick growth of pines and red cedar present, making it difficult to access the area to get more details. The upland area west of site 1165 also had *Rhamnus* sp. (buckthorn) and *Cornus amomum* (silky dogwood) so it is probable that these species were also within the upland area of site 1167 (Figure C21, Appendix C).

Restoration of site 1161 would require *Phragmites* removal from this site and increased flushing of the area with salt water so the water does not just pond by the culvert.

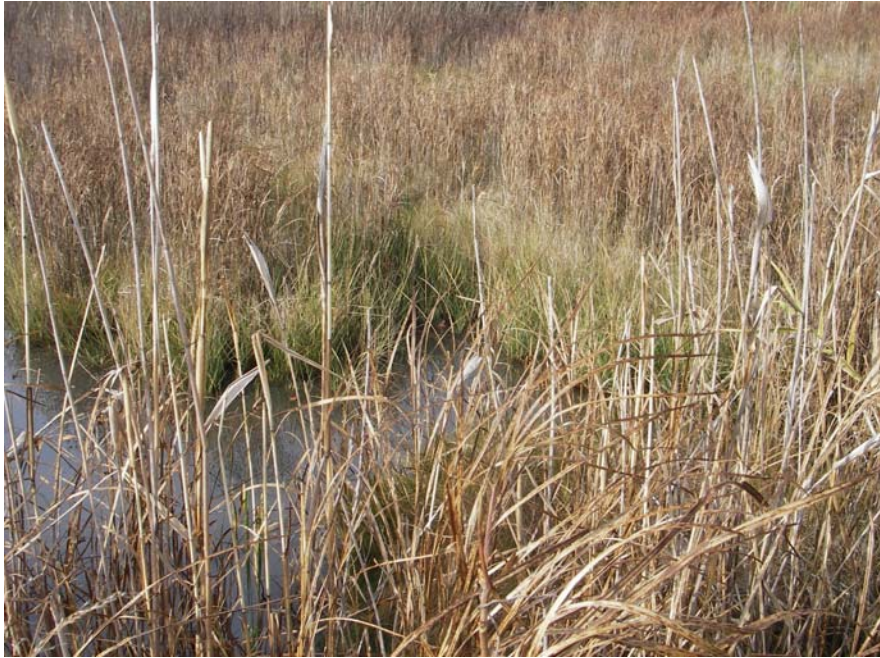
Site 158 – This site is located off of Point Judith Pond between Pond St and Billington Ave. It consists of a small area of open water (salinity ~16 ppt) with *Spartina patens* along water edges and *Phragmites* (see Figures C1 and C2 in Appendix C). Along the road side there was *Toxicodendron radicans*, *Solidago sempervirens* and some *Rosa multiflora*, *Celastrus scandens* (Bittersweet) and *Myrica* sp. The entire site is approximately 2.26 acres in size. There was no visible culvert connecting this area to the Point Judith Pond across the street (see Figure C2 in Appendix C), however, it was noticed that some water seemed to be seeping through to the area. Sites 160 (0.95 acres) and 163 (5.83 acres) have direct input from the Point Judith pond by a creek but there is probably little to no flow into site 158. Site 160 (the site closest to 158) was wet, but there was no standing water present about 2 hours into the outgoing tide. Site 160 had *Spartina alterniflora* and *S. patens* in the center of the site surrounded by *Phragmites* along the perimeter areas. *Solidago sempervirens* and *Juncus* were observed along the roadside (Figure 7).

Figure C1: Site 158- area off of Point Judith Pond by Pond St. and Billington Ave. showing open water surrounded by with *Spartina* and *Phragmites*.

Restoration of site 158 would involve building a culvert under Pond Street from Point Judith Pond to the site. If a culvert already exists, it needs to be repaired/enlarged to allow for increased flow. Also due to the large amount of *Phragmites* in the area, a *Phragmites* eradication program might be necessary.

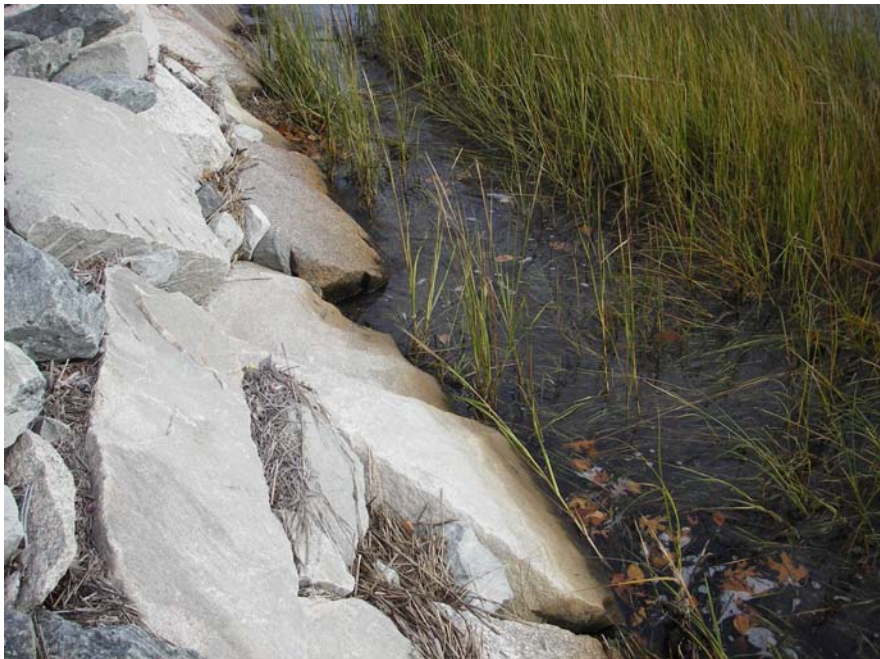
Figure C2: Across the street from Site 158, there is no obvious culvert but water is seeping under the road.

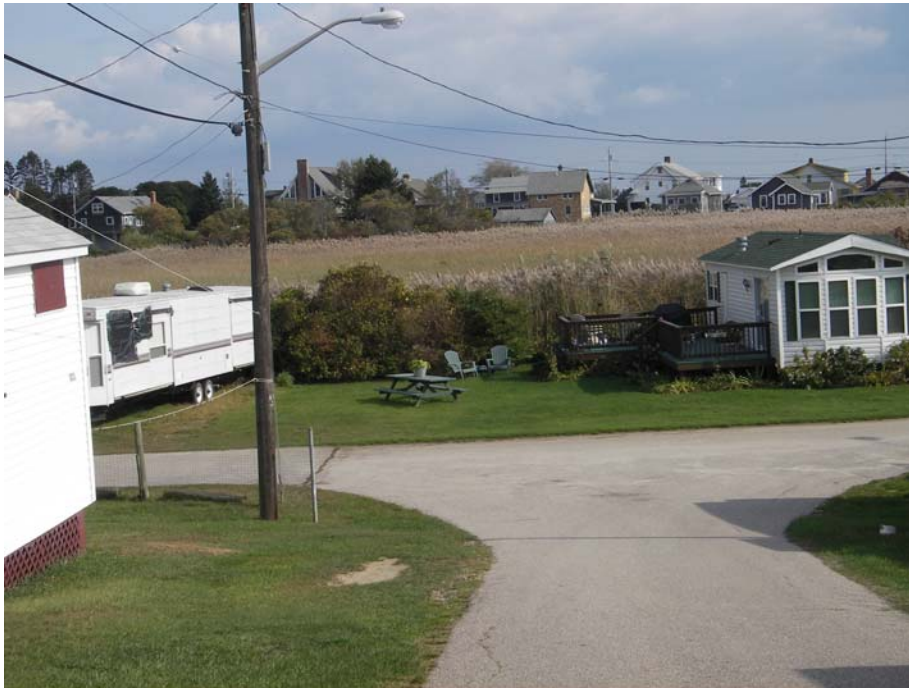
Figure C3: Site 391/400/409, view of site from trailer park.

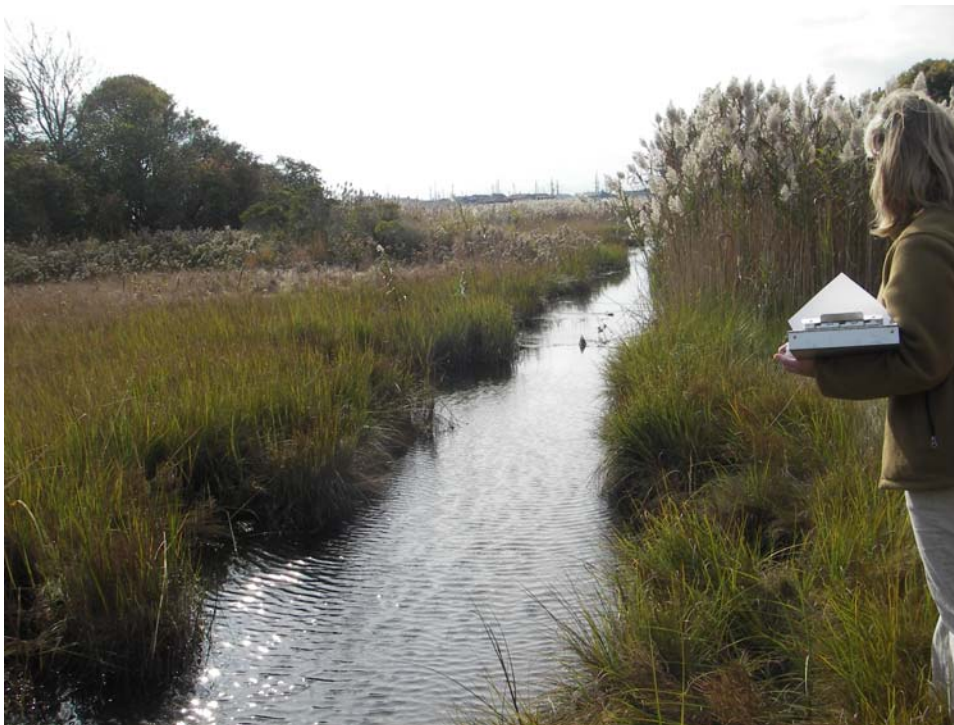
Figure C4: Site 391/400/409, view of the site from entrance off of Potter's Pond.

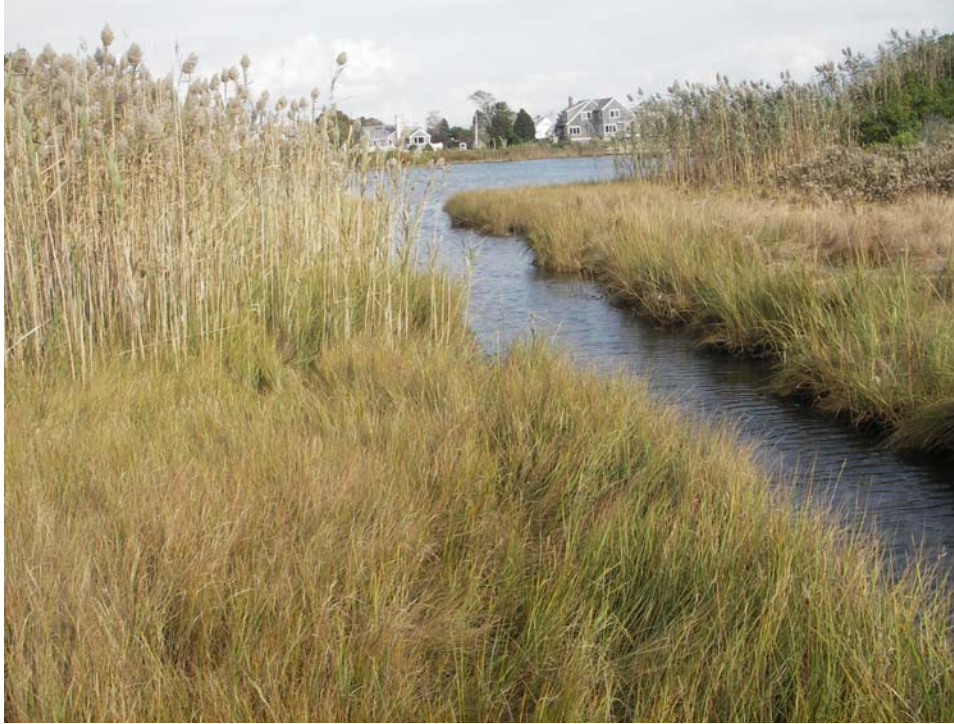
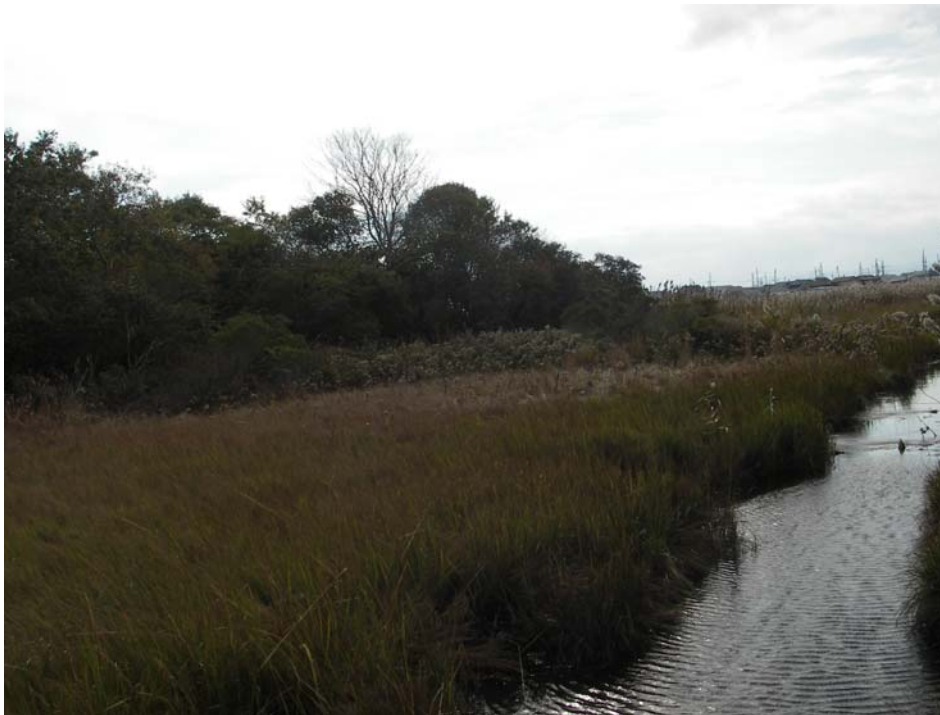
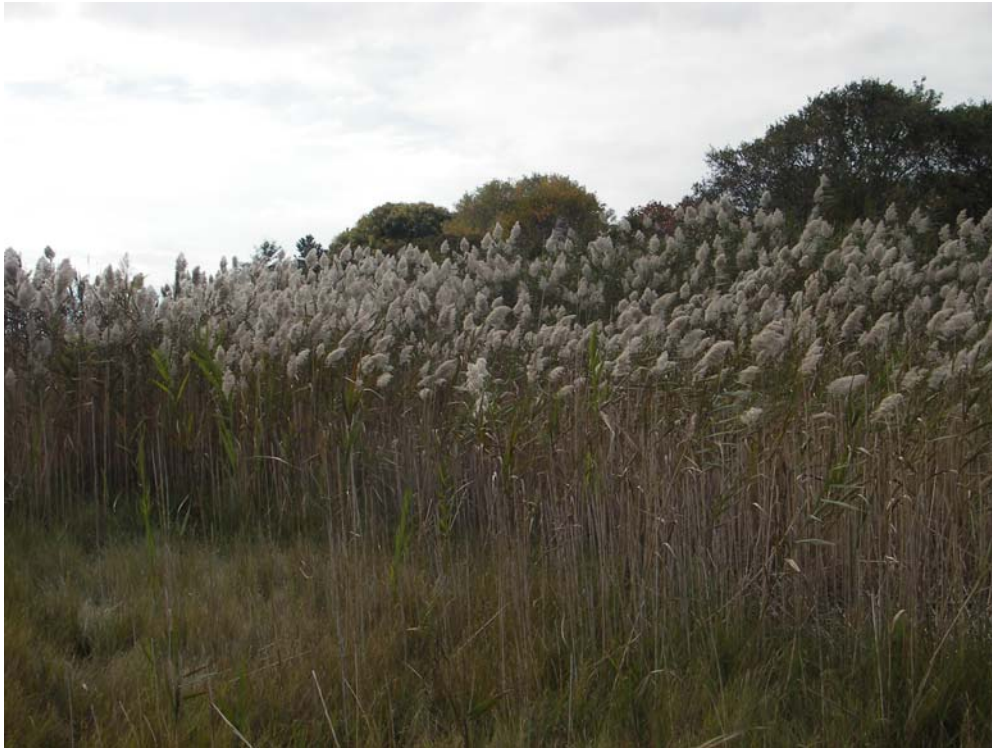
Following figures C5, C6 and C7 shows sites 391/400/409 with views of constriction within entrance channel with upland vegetation.

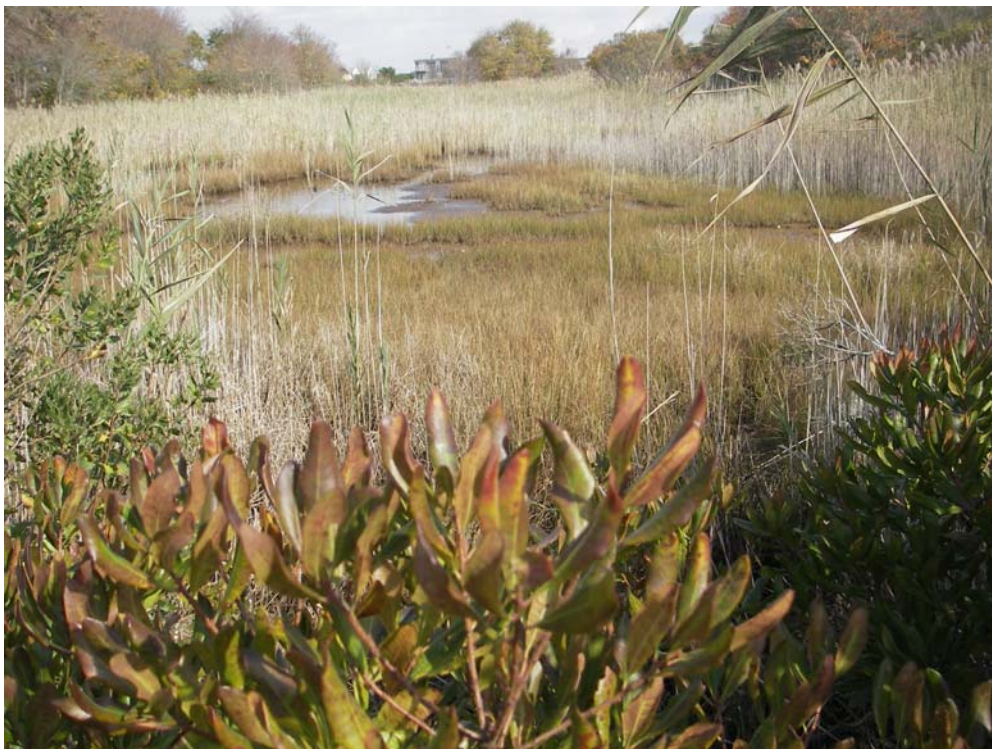
Figure C8: Site 682- wetland area between mud and Foster Coves off of Ninigret Pond.

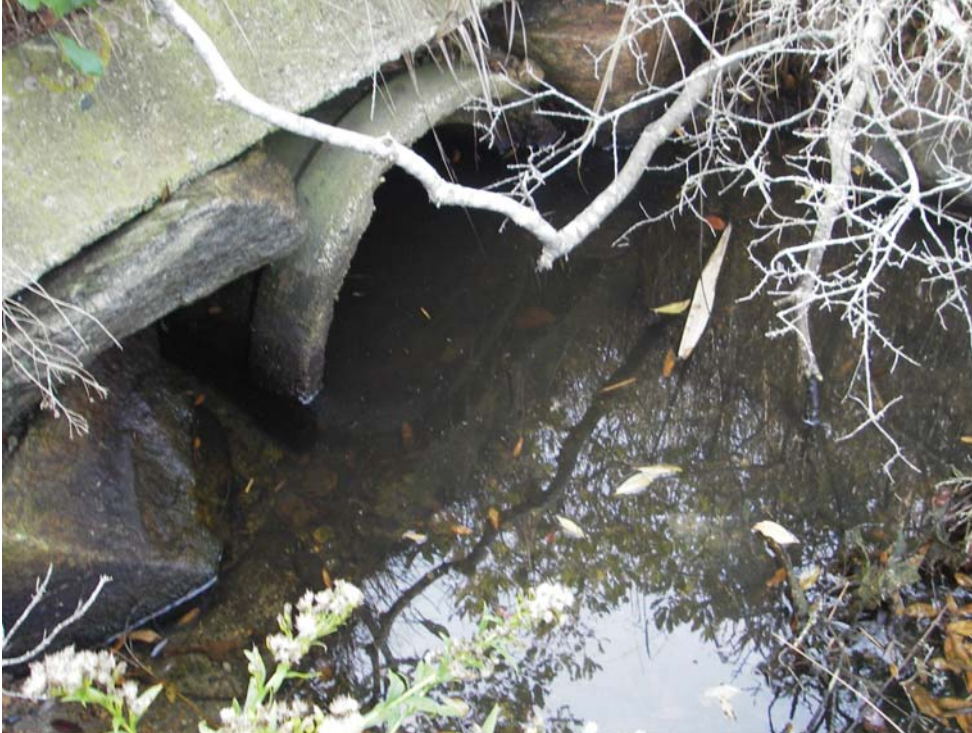
Figure C9: View of Site 696 across the street from Site 682, showing a culvert that leads into the wetland area.

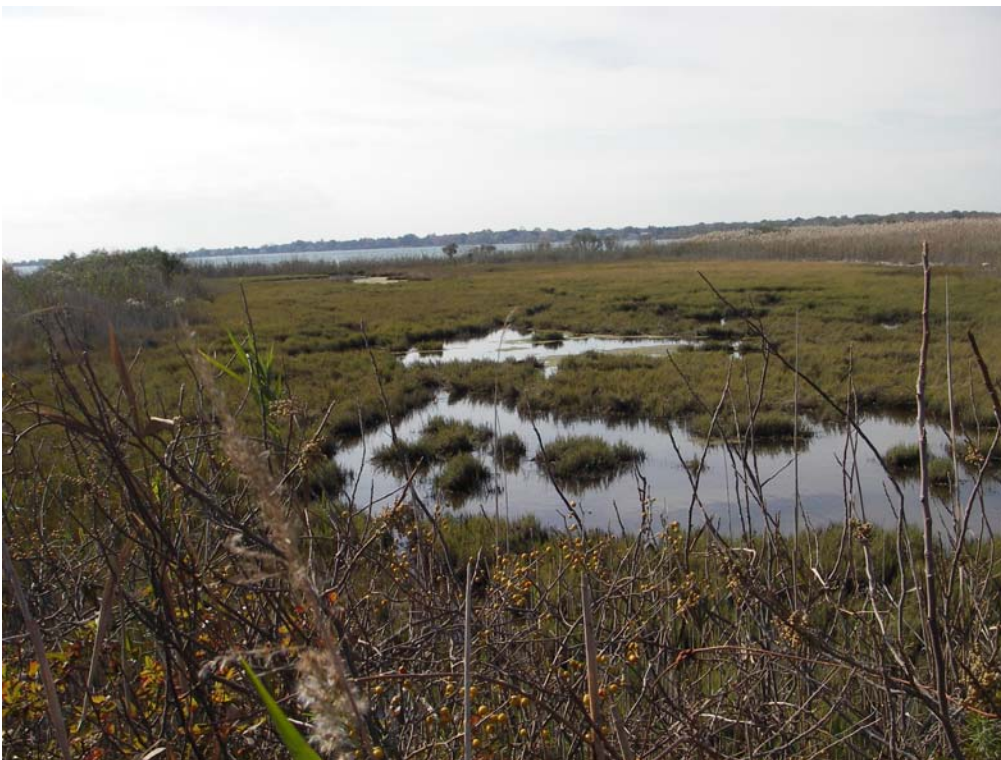
Figure C10: View of Site 696 with Ninigret Pond in the background. In foreground is the creek and open water in site 696 that provides water for wetland 682.

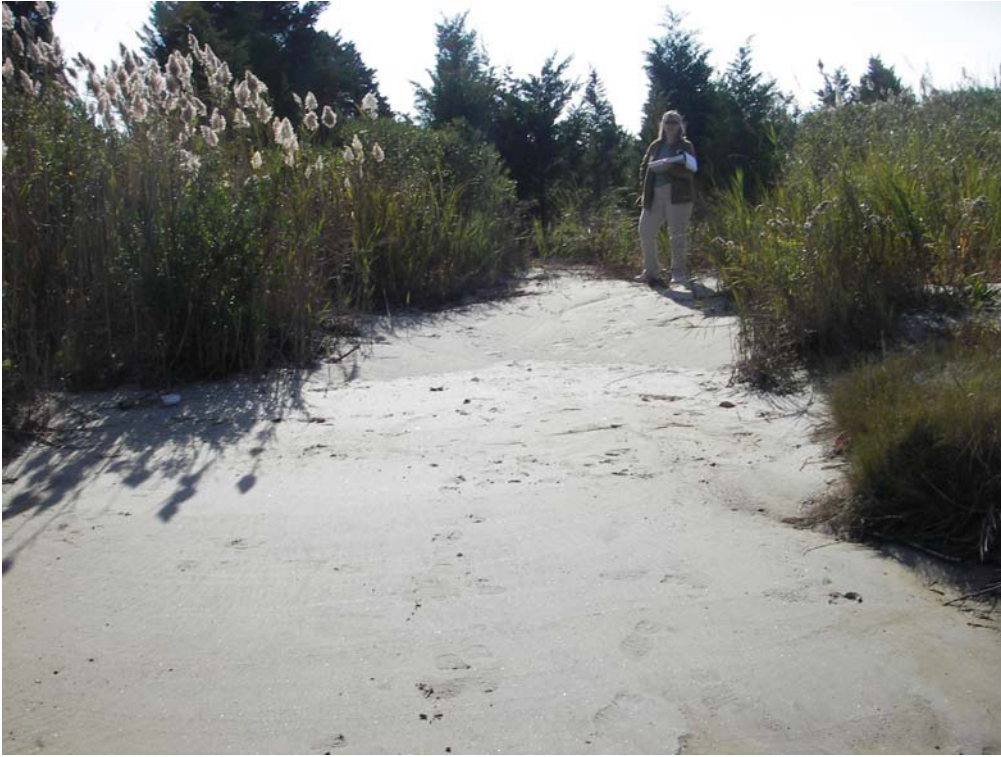
Figure C11: Site 1432- showing filled area of former inlet into Winnapaug Pond with *Phragmites*.

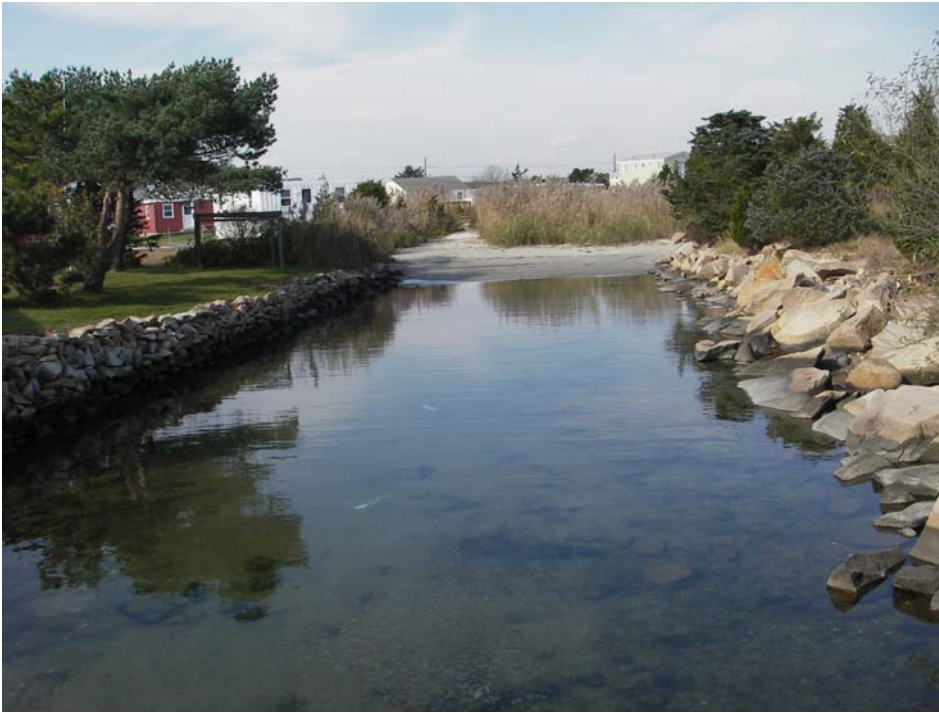
Figure C12: Sites 1076 and 1432, looking down the old breach way to the filled area.

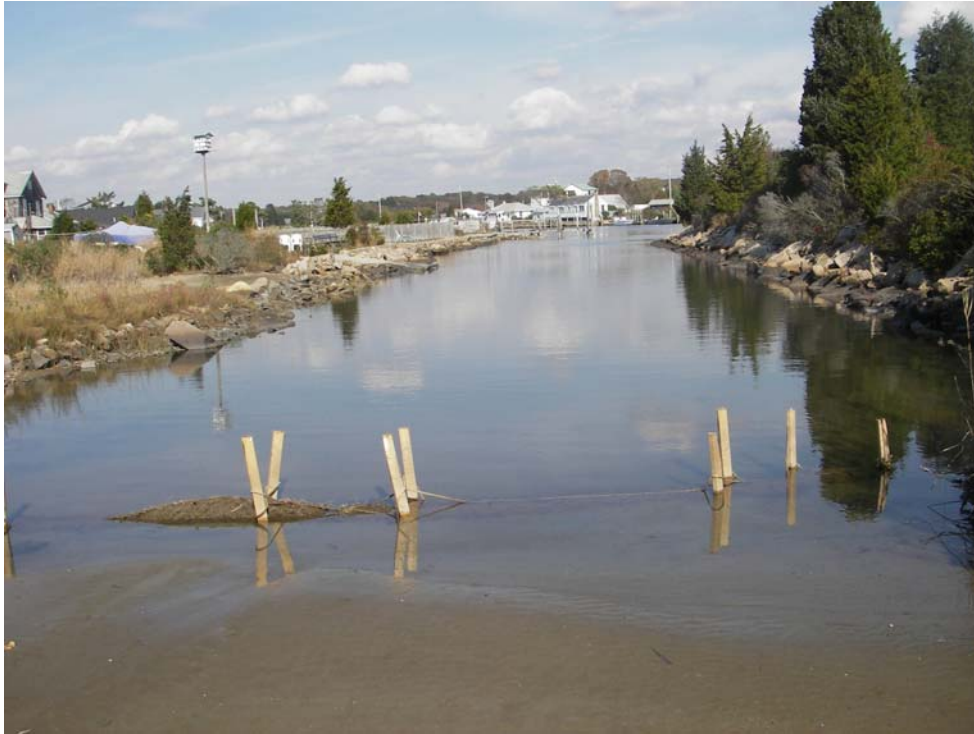
Figure C13: Site 1432- looking from far end of filled area into former inlet to Winnapaug Pond.

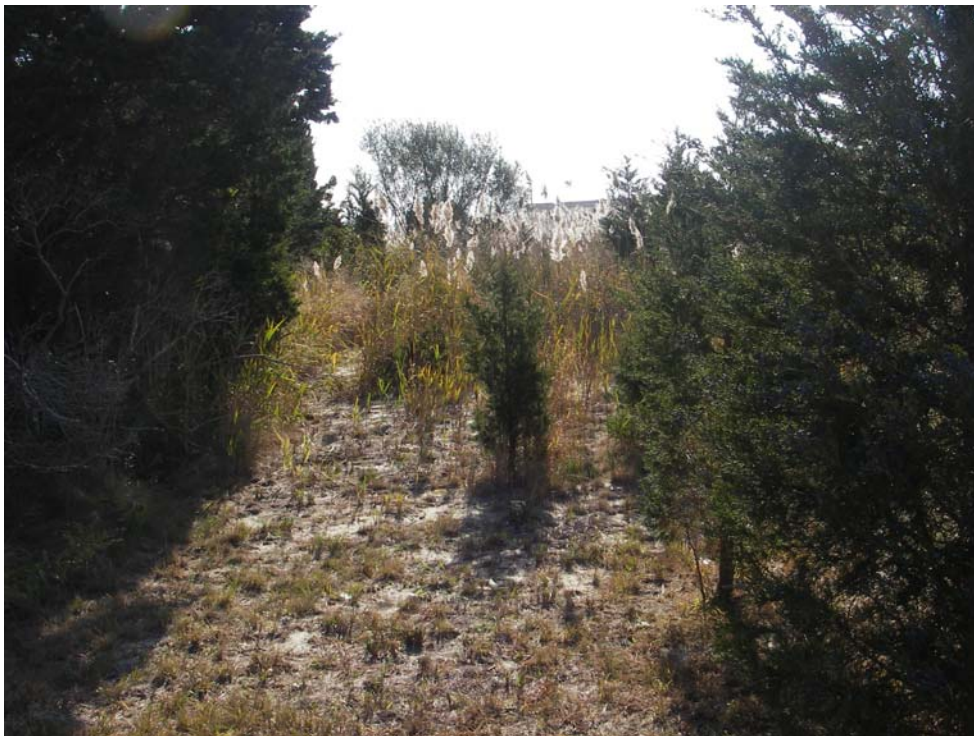
Figure C14: Upland area connected to site 1432.

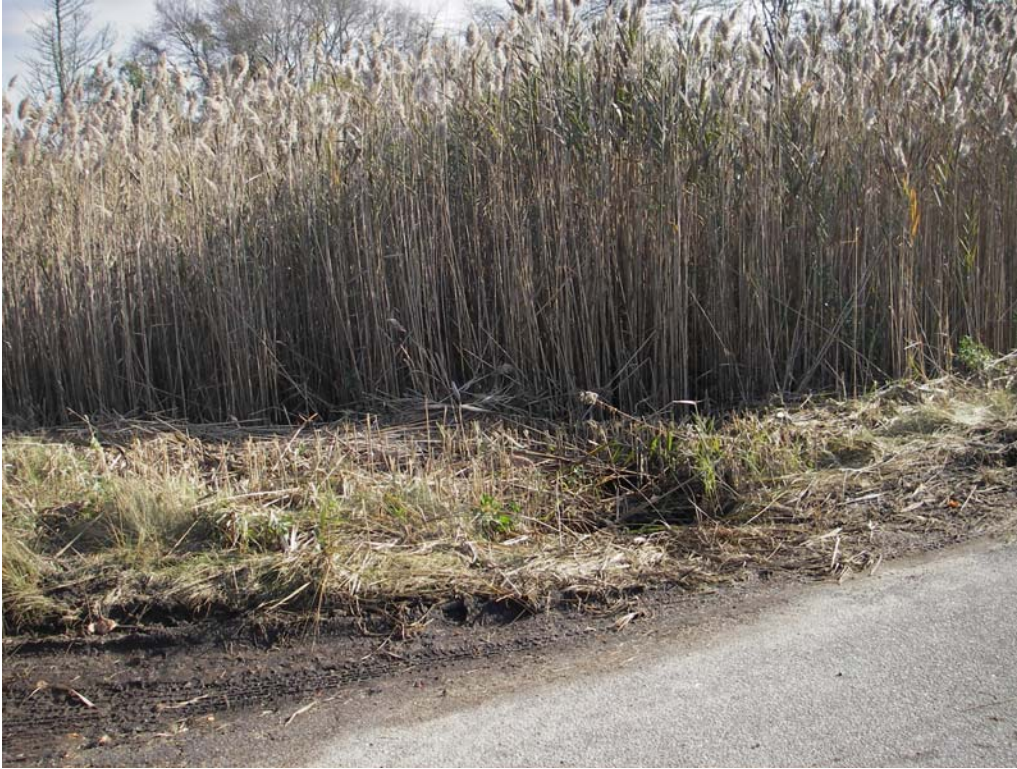
Figure C15: Edge of Site 1161, showing area covered by *Phragmites*.
