PLANNING ASSISTANCE TO STATES PROGRAM

Rhode Island Coastal Wetlands Inventory Report

APRIL 2008

**US Army Corps
of Engineers
New England District**

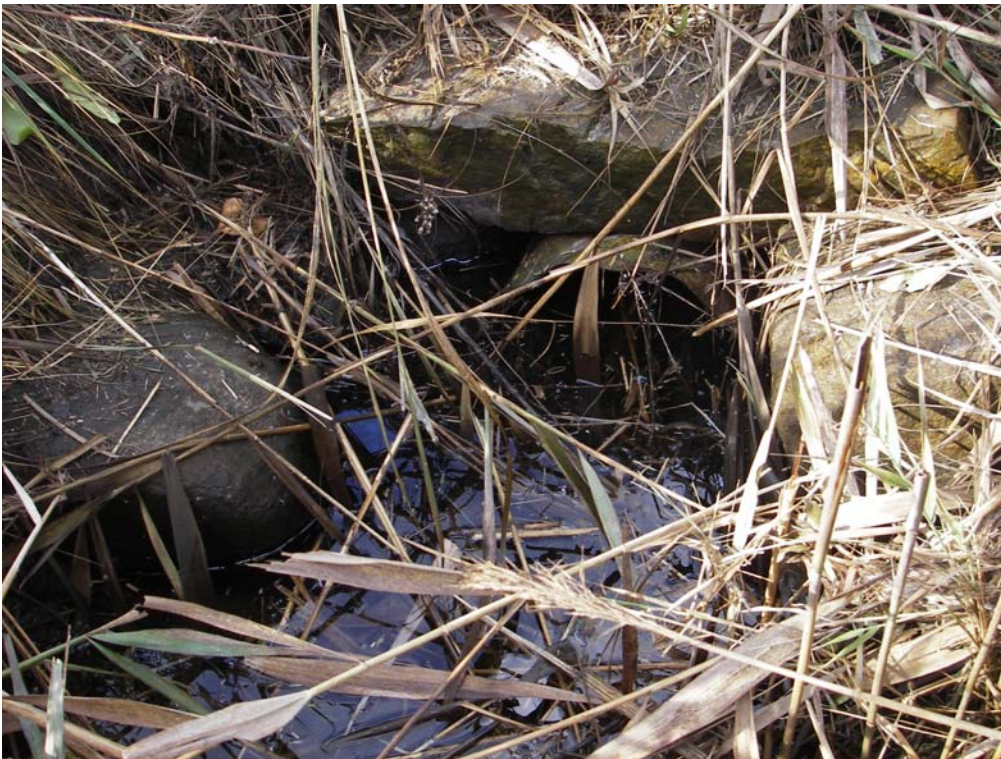
Figure C16: Site 1161- view of the culvert allowing flow into and out of the site.

Restoration of site 1161 would require *Phragmites* removal from this site and increased flushing of the area with salt water so the water does not just pond by the culvert.

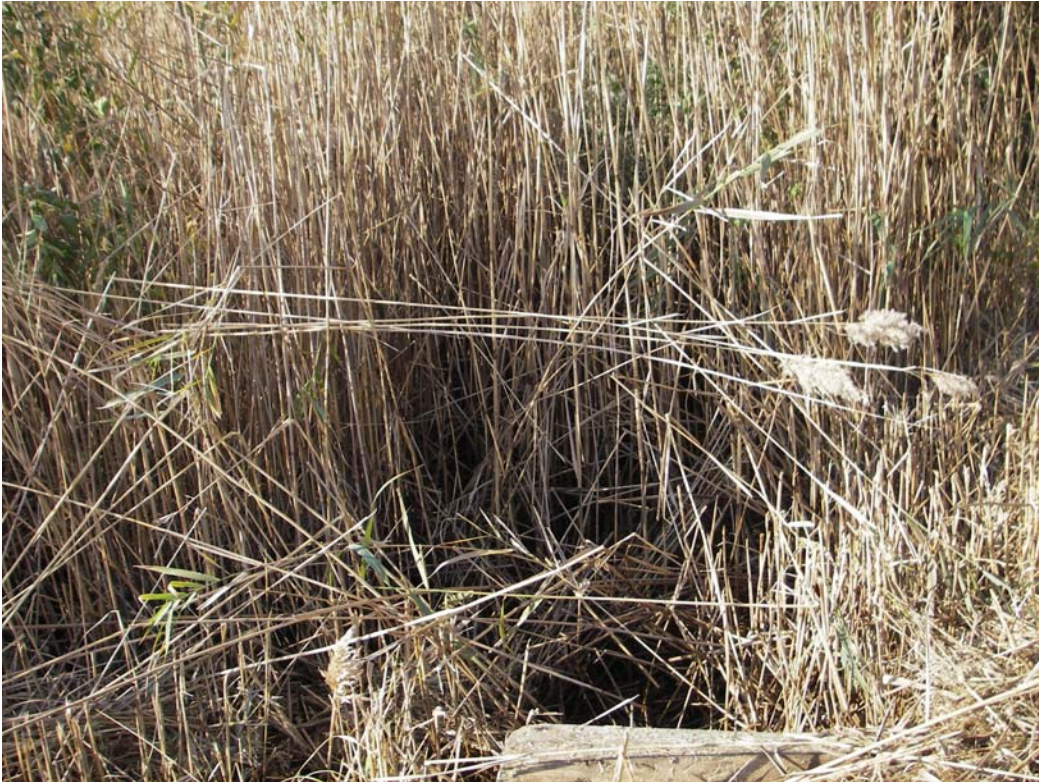
Site 1161- Site 1161 is about one quarter of an acre in size and is located in western Westerly, north of Potter Cove, between Breen Road and Pasadena Avenue off of the Pawcatuck River as shown in Figure 13. The site is connected to sites 1165 (5.13 acres) and 1167 (1.54 acres) located on the other side of Breen Road. Adjacent to site 1161 is site 1160 (2.52 acres). The land between sites 1160 and 1161 appears to be of higher elevation. An existing culvert under Watch Hill Road (Route 1A) diverts water from the roadway into site 1160 likely contributing to the growth of *Phragmites australis* that dominates most of the site (CRMC field notes record culvert as not functioning properly). Site 1161 is also predominantly *Phragmites* (Figure C15, Appendix C). There is some *Toxicodendron radicans*, *Salix* and *Erigeron strigosus* along the edges of site. There is a box culvert with a pipe about 12 inches in diameter (see Figure C16, Appendix C) that runs under Breen Road that connects this site to site 1165. There is ponded water by the culvert with a salinity of about 22 ppt at the time of sampling (10/31/2007, 10:15 AM) during an incoming tide (closer to low tide) (Figure C17, Appendix C).

Figure C17: Site 1161- edge of culvert box with ponded water and most of the site being covered by *Phragmites*.

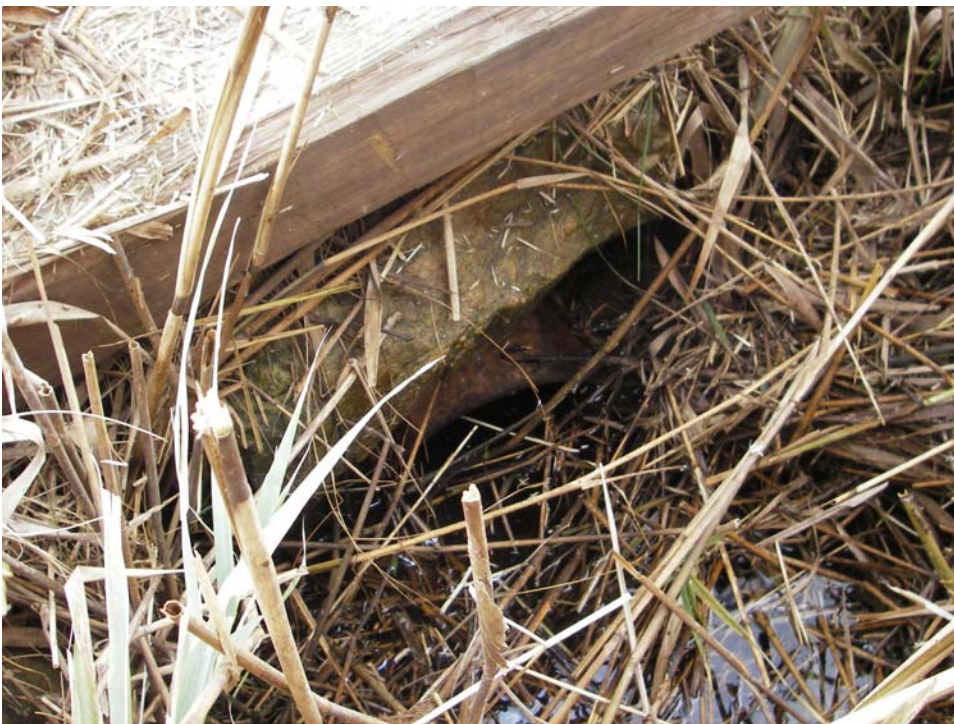
Sites 1165 and 1167 are across Breen Rd from site 1161. The end of the culvert in 1165 that connects to site 1161 is a box culvert with an iron pipe that has partially collapsed (see Figure C18, Appendix C). Site 1165 is dominated by *Phragmites* with some *Solidago sempervirens* along the outer edges with *Myrica cerifera*, *Rosa palustris*, *Vitis* sp. and *Eunymous* (planted) along roadside areas that parallel site 1165. At the entrance to the creeks leading from Potter Cove there is *Spartina alterniflora* with *S. patens* behind it with *Phragmites* up at the road (Breen Rd) (see Figures C19 and C20, Appendix C). The salinity at the entrance of the creek from Potter Cove was about 28 ppt at the time of sampling (it was early in the incoming tide on 10/31/2007 at 10:15 AM) with evidence of a healthy marine environment (limpets, mussel shells, blue crab, and brown algae on the rocks) in the area. Site 1167 also has *S. alterniflora* along with *S. patens* in the higher marsh areas gradually giving way to grass then more *S. patens* and then a small upland area closer to the road (Breen Rd.). The upland area had thick growth of pines and red cedar present, making it difficult to access the area to get more details. The upland area west of site 1165 also had *Rhamnus* sp. (buckthorn) and *Cornus amomum* (silky dogwood) so it is probable that these species were also within the upland area of site 1167 (Figure C21, Appendix C).

Figure C18: Site 1165- culvert leading into Site 1161 across the road.

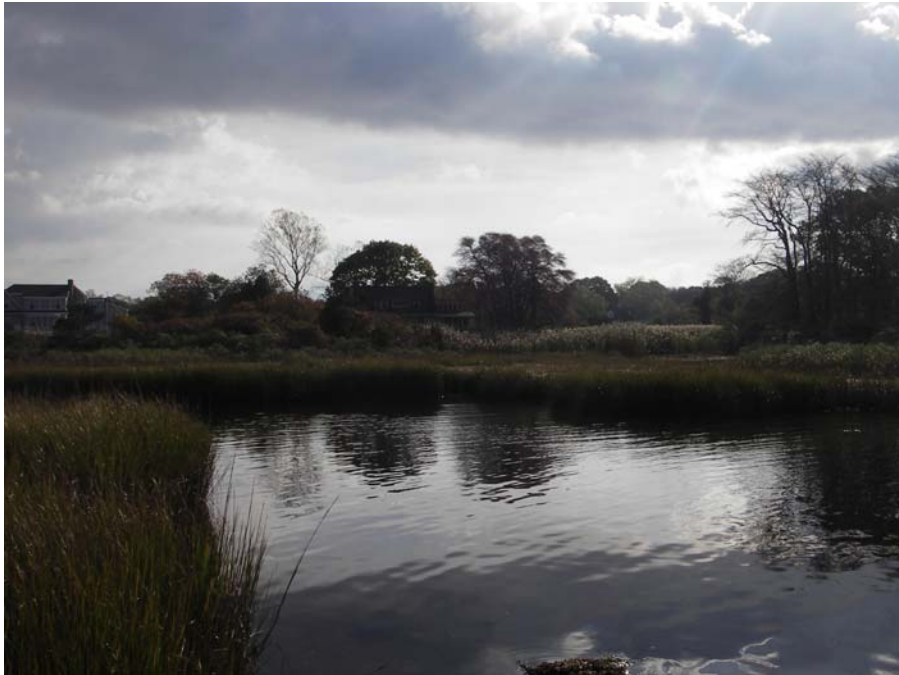
Figure C19: Entrance to creeks from Potter Cove leading into sites 1165 and 1167, showing healthy marsh with some upland and *Phragmites* in the background.

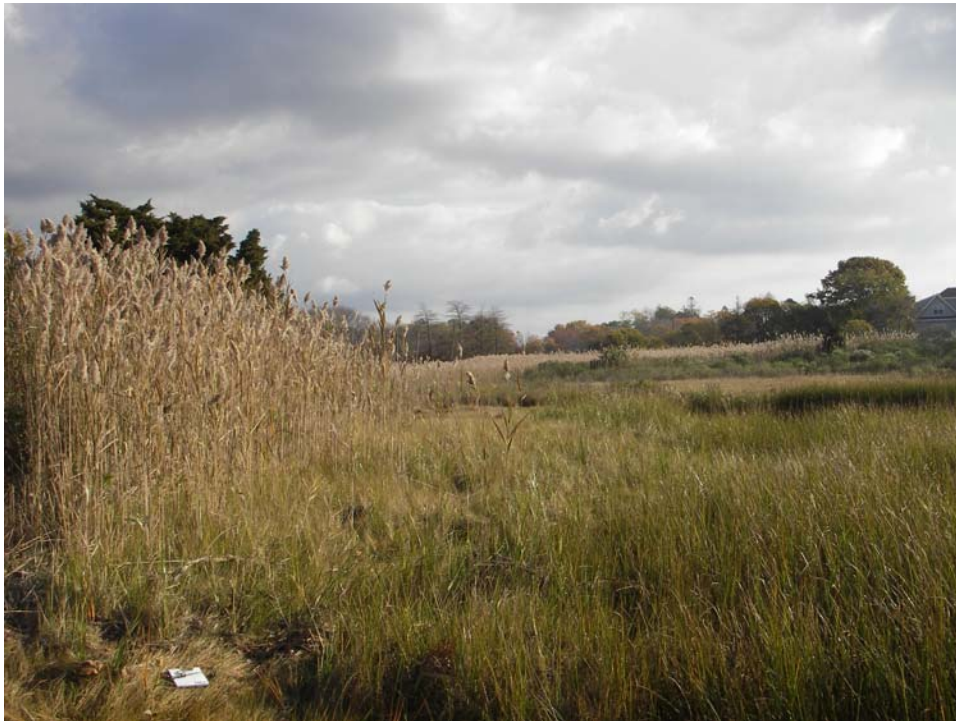
Figure C20: Close-up view of sites 1165 and 1167 (the background view of Figure C19).

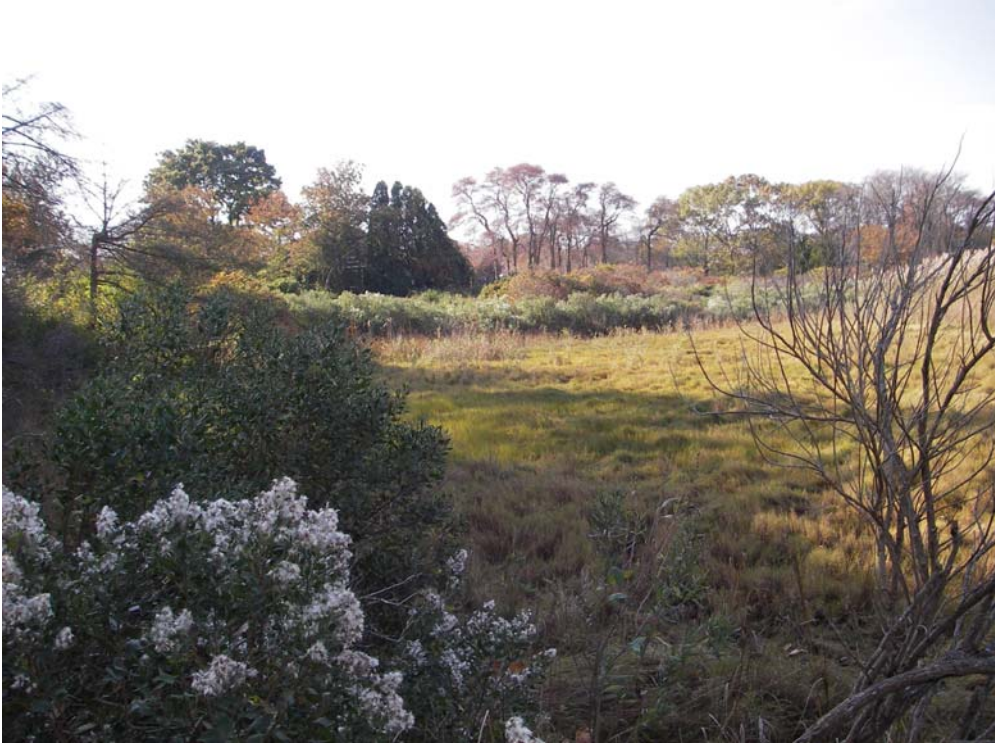
Figure C21: Upland area west of Site1165.
