## Natural Resource Services, Inc.

Assessment of Salt Marsh Restoration  
Required Pursuant to  
CRMC Assent 2007-06-075

Maritime Way  
North Kingstown, Rhode Island

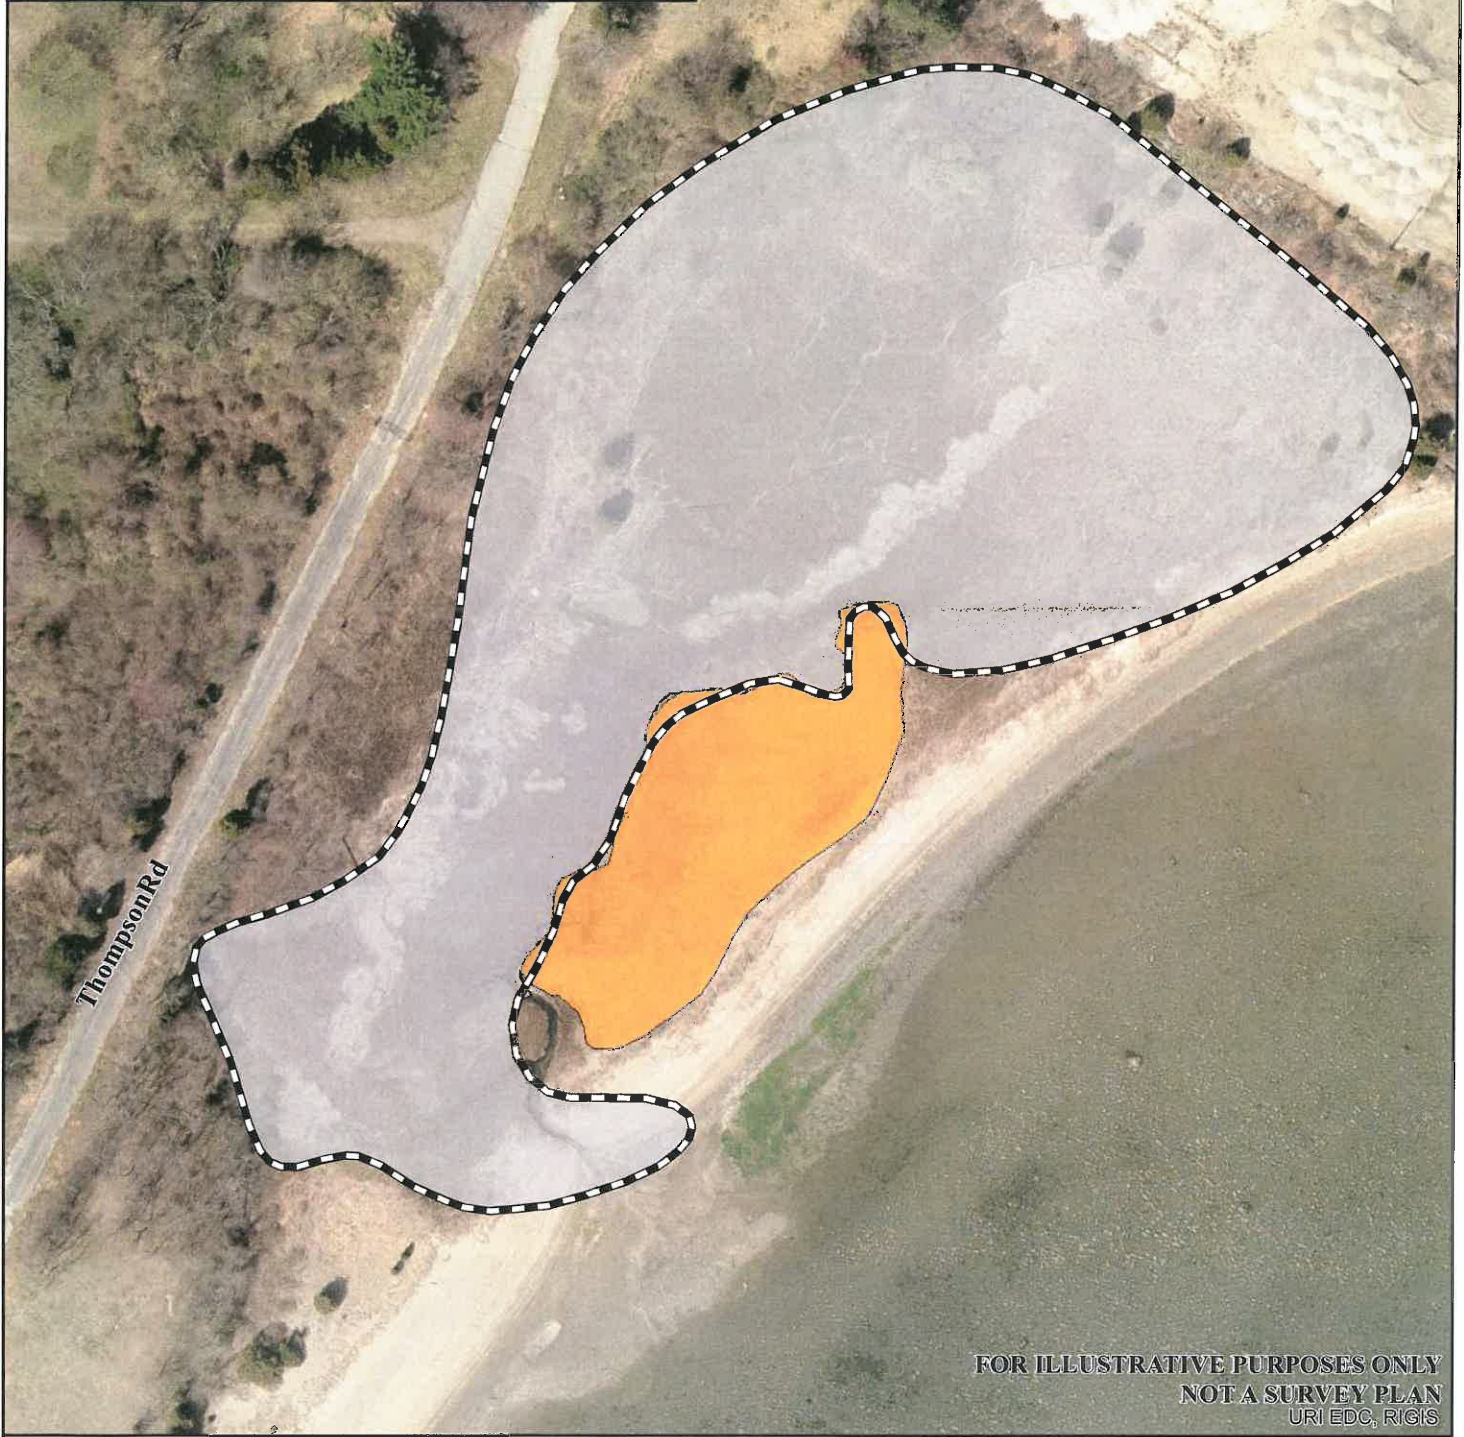
**Figure 1:**  
**Pre-Restoration Site Conditions**

Figure 1 is a graphic created from the original site development plan submitted to the CRMC with the assent application (Garofalo & Associates, June 5, 2008). The Garofalo plan included the mapped limits of the remnant salt marsh contained within a larger wetland consisting exclusively of common reed. The restoration area limits represented on the graphic are within the NRS delineated contiguous freshwater wetland limits as of 2007. This graphic provides the baseline area of salt marsh present prior to the salt marsh restoration effort.

CRMC Approved Restoration Limit
-

Limit of Salt Marsh Vegetation = +/- 22,884 sq ft
-

Limit of Common Reed = +/- 166,571 sq ft

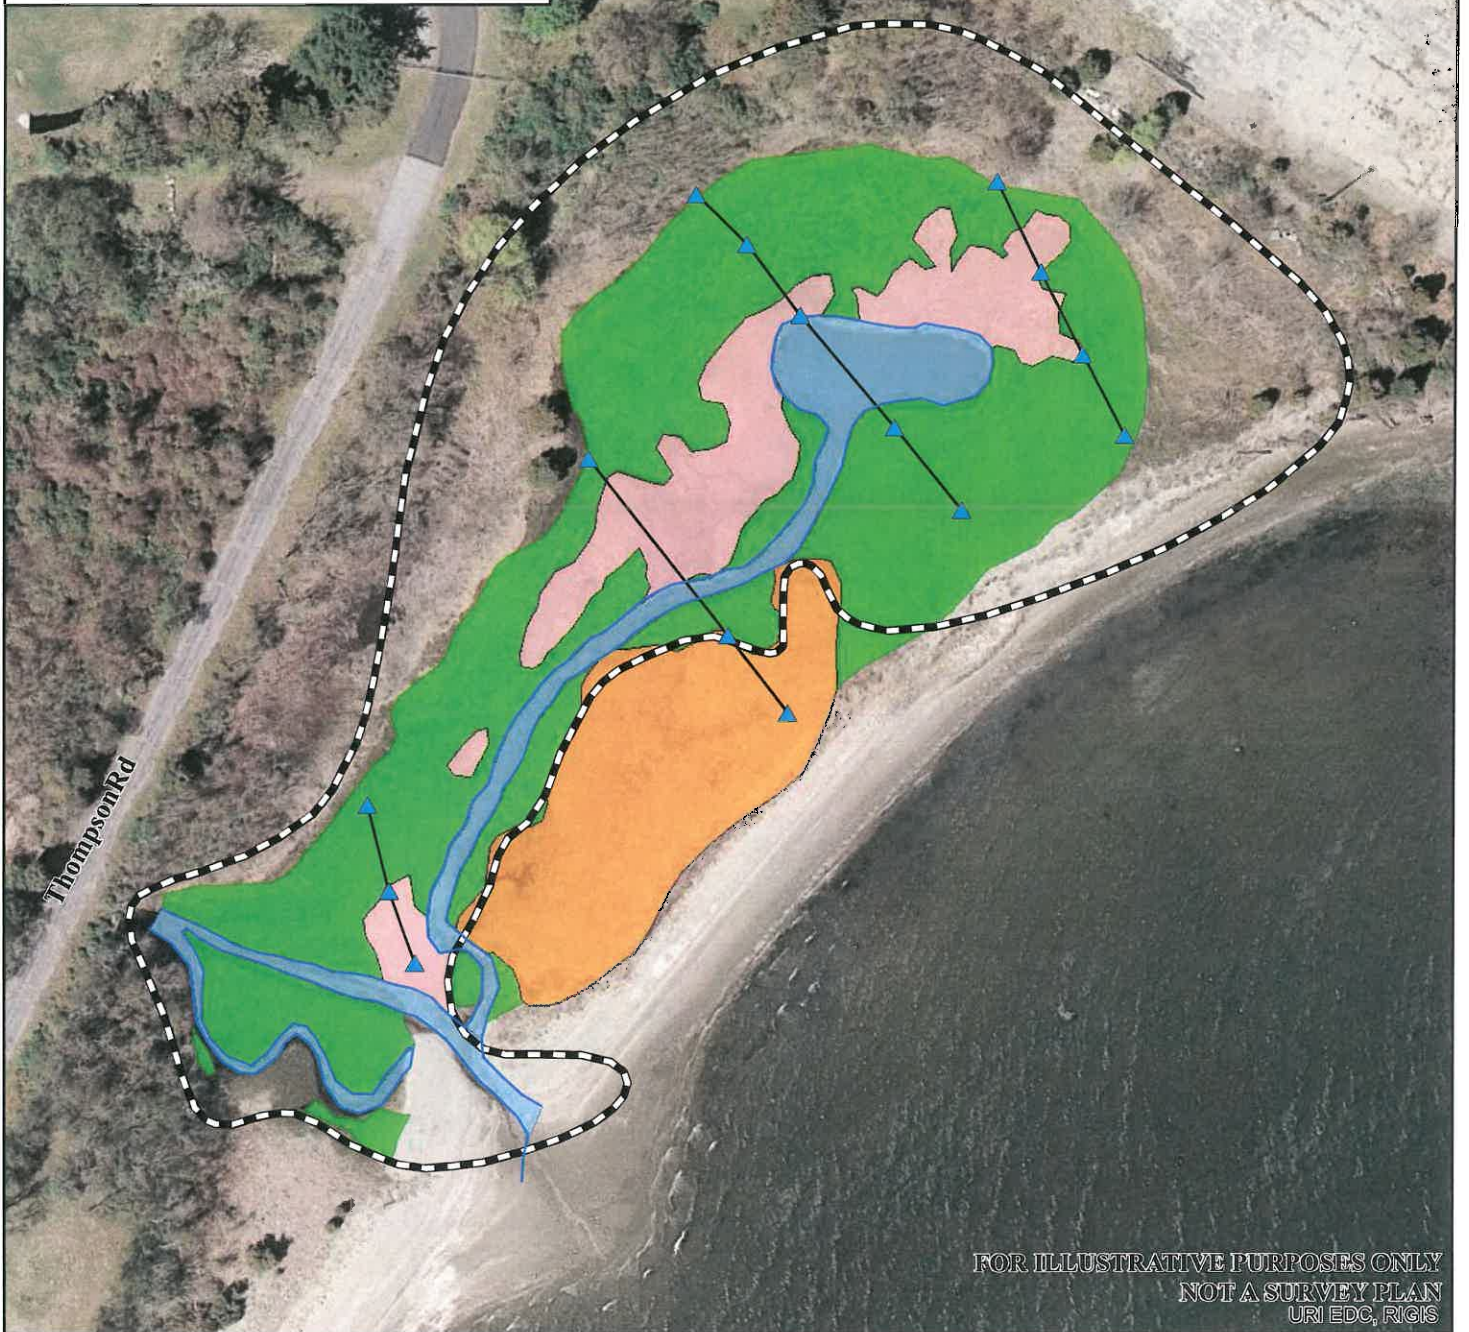
**Figure 2:**  
**Post-Restoration Site Conditions**  
**July 14, 2010**

Figure 2 represents the conditions present within the salt marsh restoration area as of July 14, 2010 (approximately 18 months post-construction). The graphic clearly depicts the constructed breach, tidal channels and tidal pool. The non-vegetated mudflat and areas with early colonizing vegetation (*Salicornia europaea*) were mapped at that time and the area of each zone is listed on the graphic.

Early Colonizing Vegetation  
= +/- 68,813 sq ft
-

Mud flat = +/- 17,814 sq ft
-

Open Water = +/- 9,827 sq ft
-

Limit of Salt Marsh Vegetation  
= +/- 22,884 sq ft

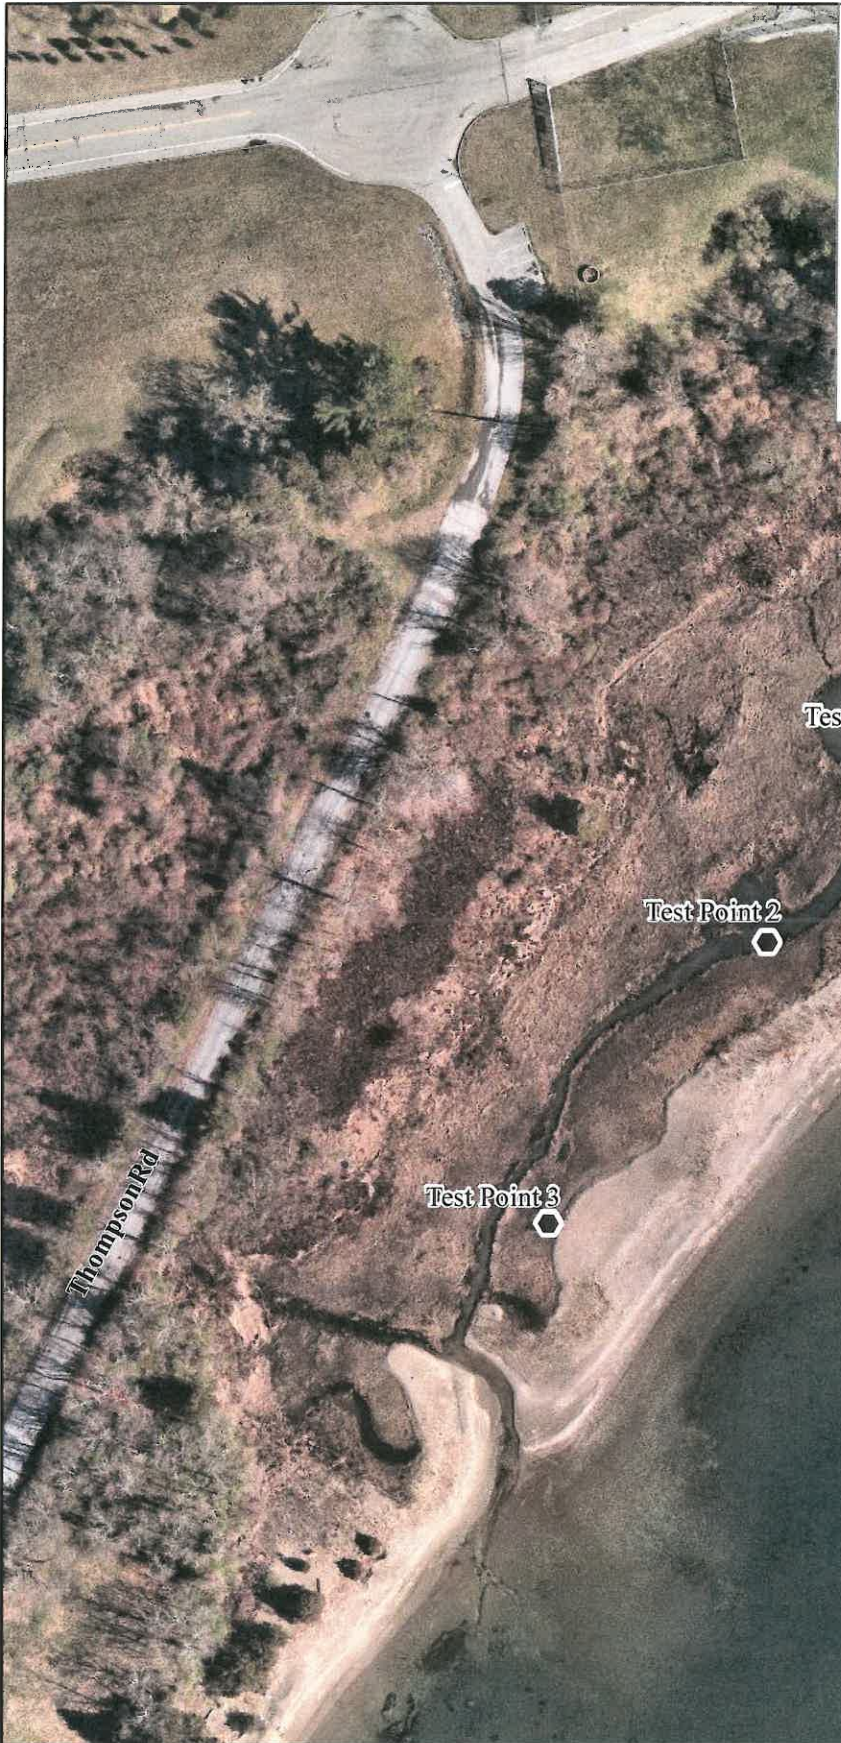
**Figure 4:**  
**Salinity Testing at Low Tide**

The restoration design included a restored tidal breach, tidal flow channels and interior tidal pool. Two sills were incorporated into the main tidal channel to ensure that a sufficient volume of water was retained within the tidal pool during low-tide. As part of the NRS monitoring, salinity levels were recorded within the tidal channel and tidal pool at low-tide. The salinity levels were at 23-27 parts per thousand, consistent with normal bay water (see Figure 4).

Test #		
	1	2	3
Testing Location			
1	25	25	25
2	23	25	25
3	27	27	27

Testing performed from 9 - 9:45 AM on 8/8/2022  
 using a Vista Model A366ATC Salinity Refractometer  
 Readings are in parts per thousand  
 Low Tide on 8/8/2022 at 10:11 AM

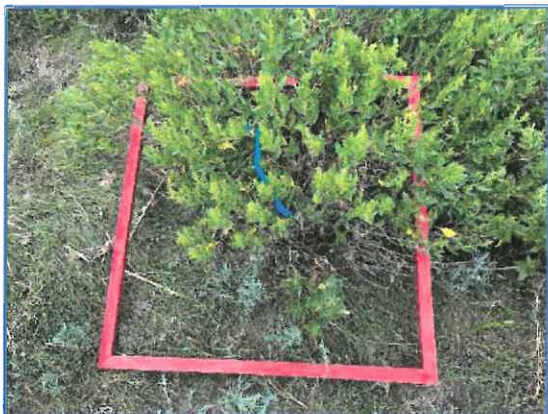
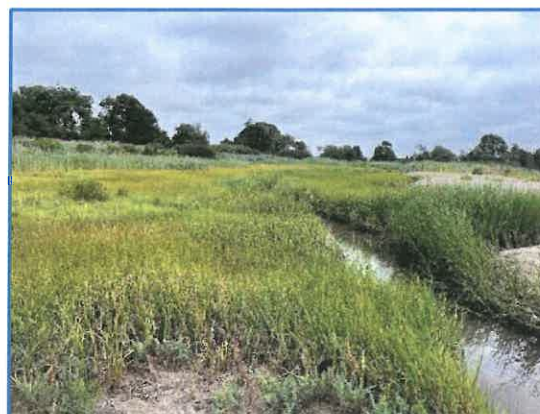
*Looking north from Plot 1A*

Transect 1 – Plot A		
<u>Species</u>	<u>Percent Cover</u>	<u>Remarks</u>
Iva frutescens	50	Areas of exposed sand present
Spartina patens	25	
Salicornia europaea	10

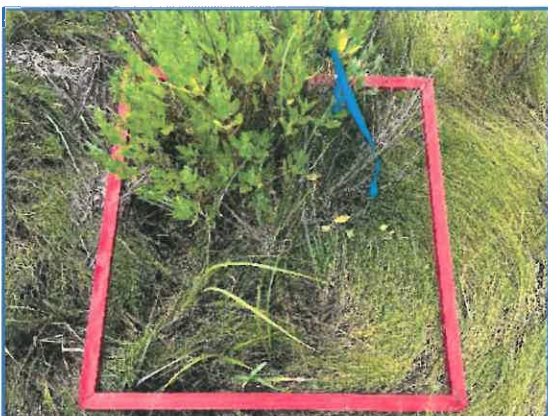
**Transect 1 – Plot C**

<u>Species</u>	<u>Percent Cover</u>	<u>Remarks</u>
Spartina patens	75	
Palustris australis	25

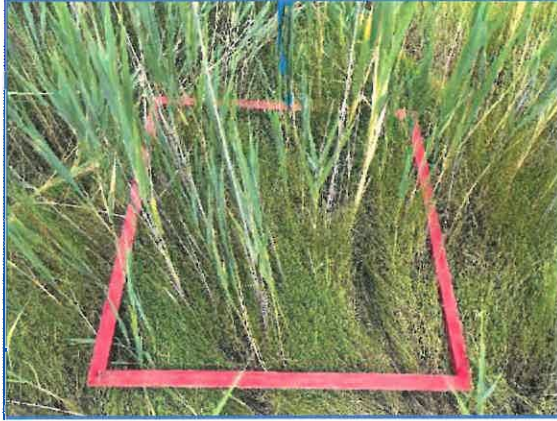
**Transect 2 – Plot A**

<u>Species</u>	<u>Percent Cover</u>	<u>Remarks</u>
Unvegetated		Located adjacent to current high tide wrack line

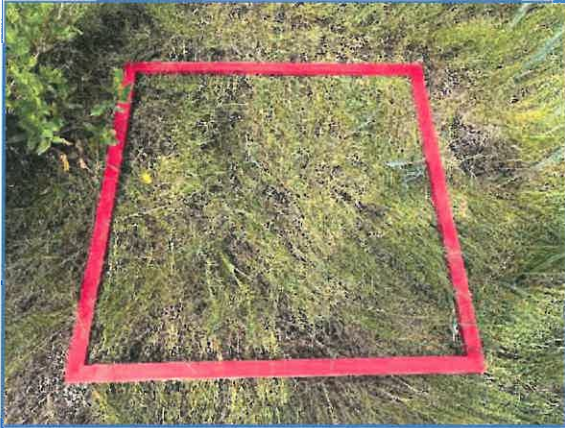
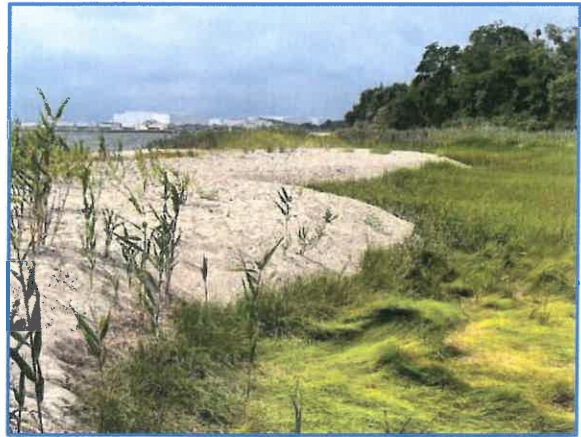
*Dune accretion in marsh south of Plot 2B*

It is important to point out that data plots established within the dune back in 2009 now occur at or below the mean higher high tide limit along the beach. There is clear evidence that the barrier has migrated landward over the last 14 years. This dune migration has resulted in the loss of salt marsh in the eastern portion of the restoration area.

<u>Species</u>	<u>Percent Cover</u>	<u>Remarks</u>
Spartina patens	98	Some Iva frutescens at base of adjacent dune
Palustris australis	2

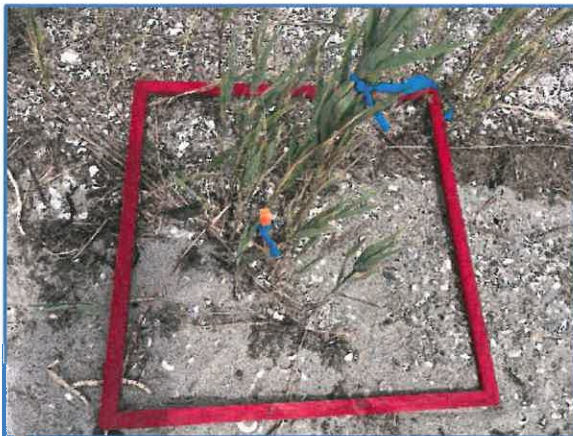
**Transect 3 – Plot B**

<u>Species</u>	<u>Percent Cover</u>	<u>Remarks</u>
Spartina alterniflora	80	Some mudflat exposure

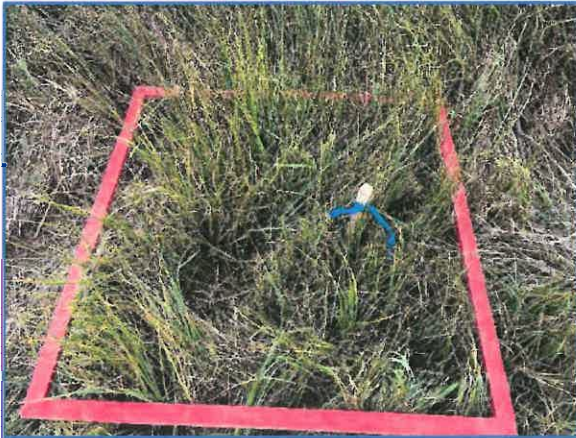
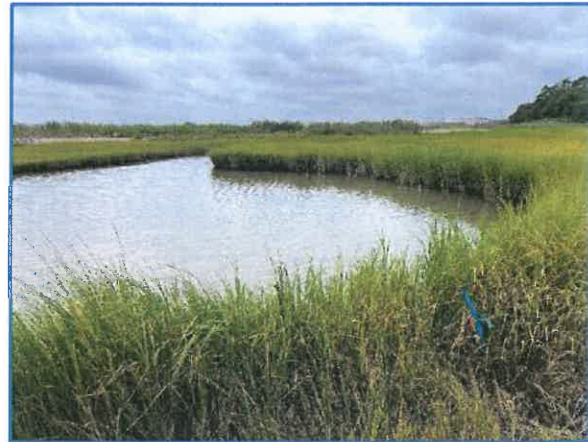
*Looking south from Plot 3C*

<u>Species</u>	<u>Percent Cover</u>	<u>Remarks</u>
Spartina alterniflora	100

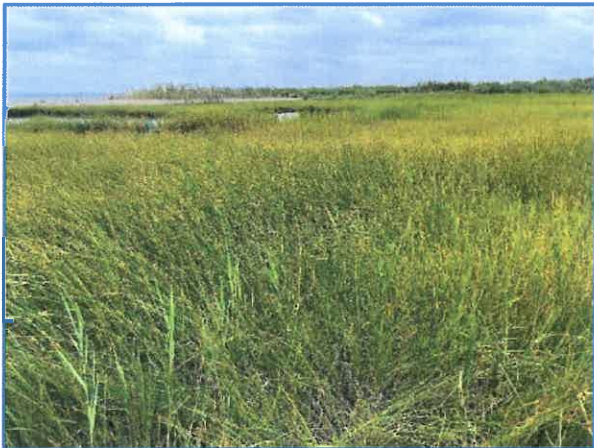
*Looking southeast from Plot 3D*

<b>Transect 3 – Plot D</b>		
<u>Species</u>	<u>Percent Cover</u>	<u>Remarks</u>
Juncus gerardii	50	
Palustris australis	50

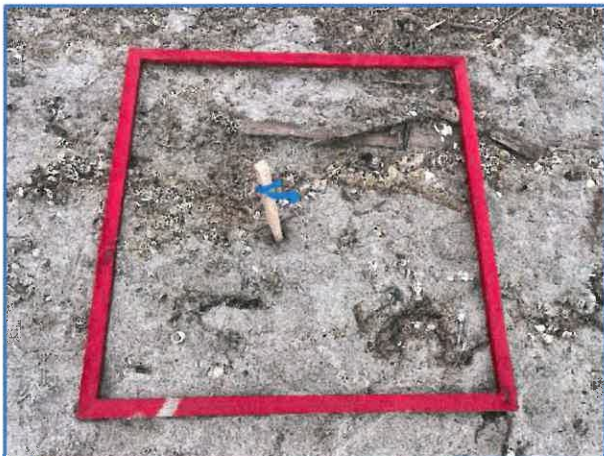
**Transect 4 – Plot B**

<u>Species</u>	<u>Percent Cover</u>	<u>Remarks</u>
Spartina patens	95	
Palustris australis	5

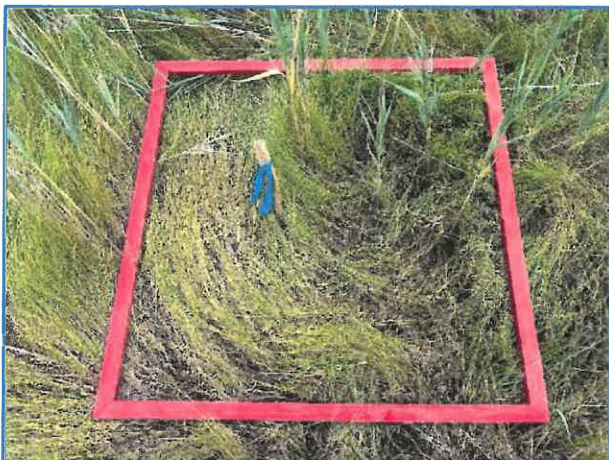
**Transect 4 – Plot C**

<u>Species</u>	<u>Percent Cover</u>	<u>Remarks</u>
Spartina alterniflora	40	
Palustris australis	60

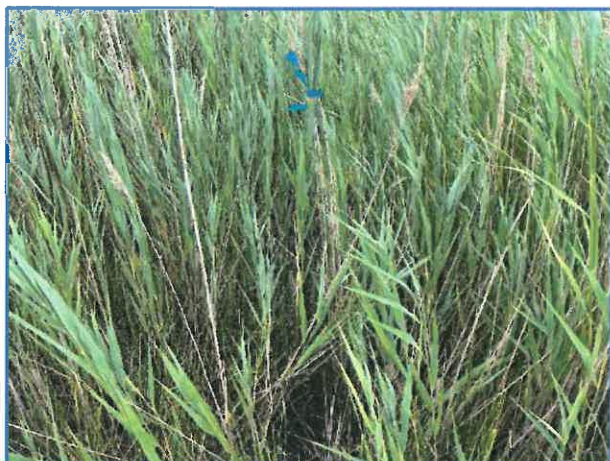
**Transect 4 – Plot D**

<u>Species</u>	<u>Percent Cover</u>	<u>Remarks</u>
Juncus gerardii	10	
Palustris australis	90
