Bluff Erosion Rates in Complex Glacial Stratigraphy, Block Island, RI

Janet Freedman

RI Coastal Resources Management Council

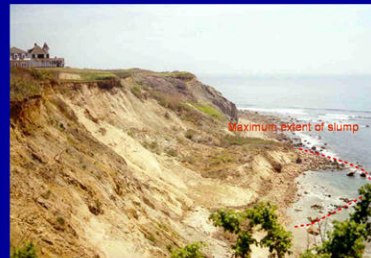
Slump block in critical erosion area, note the extent of erosion after a month

A catastrophic slope failure in April 2001 occurred along a section defined as a critical erosion area along the south shore of Block Island. In days, the sediment that jutted into the ocean was eroded from the block, revealing an underlying clay layer that had weakened under the weight of the saturated upper strata.

Calculated erosion rates in this section averaged 1.5 feet per year. This one catastrophic event represented 23 to 27 years of erosion, close to the predicted rate.
