# **BRUSH NECK COVE AQUATIC ECOSYSTEM RESTORATION WARWICK, RHODE ISLAND**

## **FEASIBILITY REPORT AND ENVIRONMENTAL ASSESSMENT**

**US Army Corps  
of Engineers®**  
New England District

Authority: WRDA Section 206  
Date: November 2010

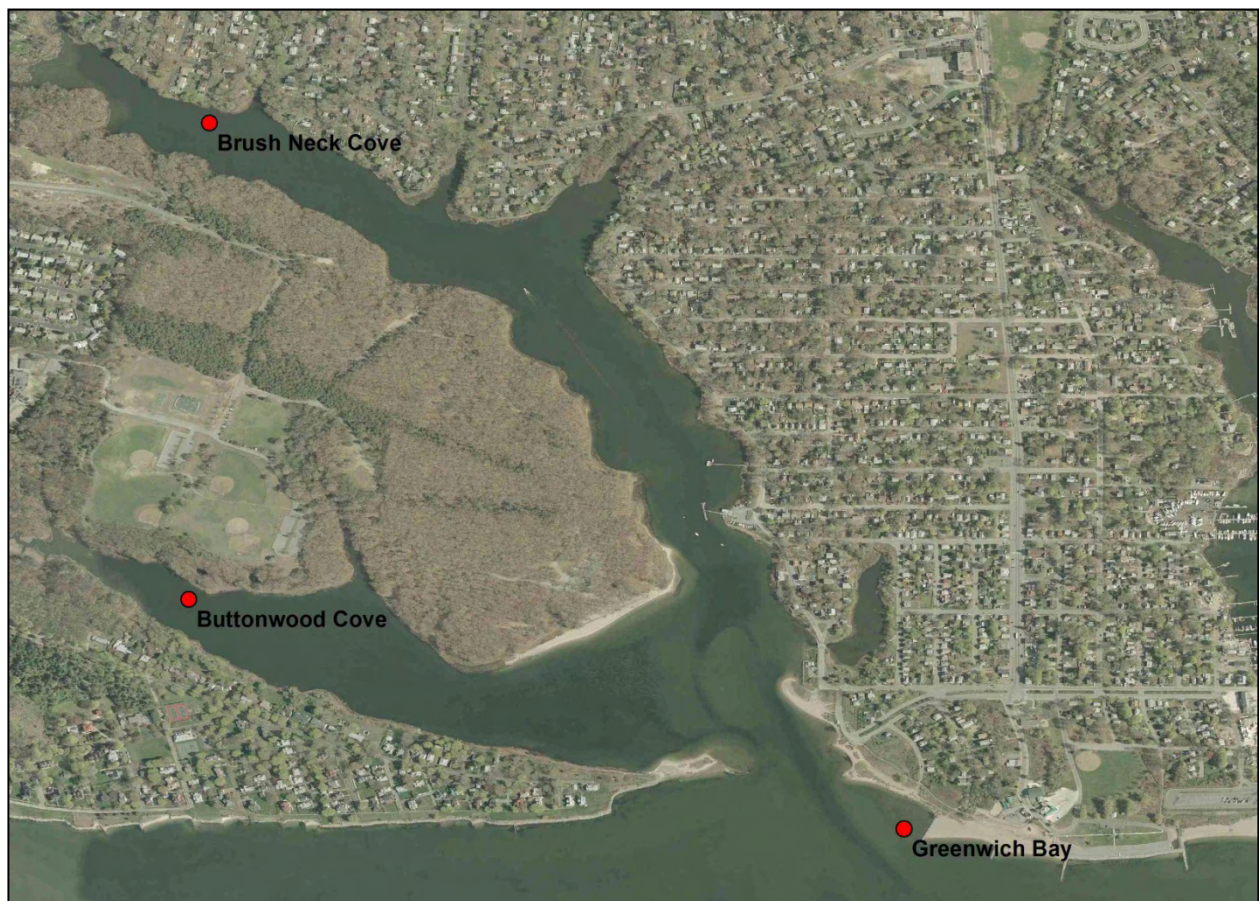
Figure 7. Tide Survey Data Collection Locations

Tidal flushing within the study area was evaluated using a tidal survey conducted on August 25, 2006. Tide elevations were measured at three locations in the Brush Neck Cove/Buttonwoods Cove system. The locations are provided in Figure 7.

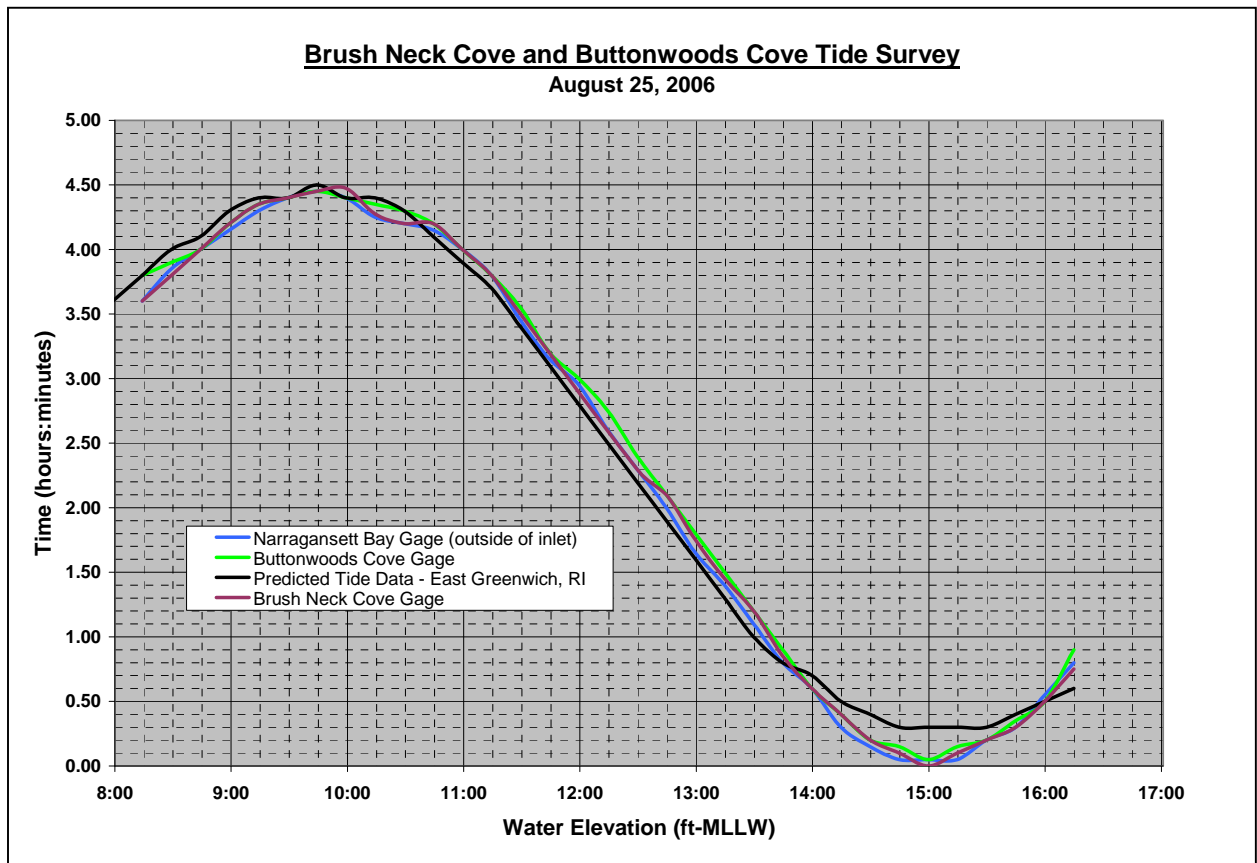
**Figure 8. Tide Survey Data Plot**

Tide elevation data were manually recorded approximately every 15 minutes. These data are plotted in Figure 8, with the predicted tide data for East Greenwich, RI provided on the plot as well. These data show that there is no reduction in tide range from Narragansett Bay into the Cove system. All three measurement points are almost identical with regards to tide range and phase (no lag between high and low tides). This tide elevation survey further demonstrates that there is no tidal restriction in the system, and that the Cove system experiences 100% of the possible tidal flushing possible.

The results of the mapping and the tidal elevation investigations indicate that the existing shoaling condition at the entrance does not restrict the tidal exchange within the coves. These data suggest that dredging the inlet for the single purpose of increasing cove flushing would not provide significant ecosystem restoration benefit. After consultation with the design team and the sponsor, the study efforts were redirected to improve habitat and water quality by removing accumulated sediment/organic material within the coves.

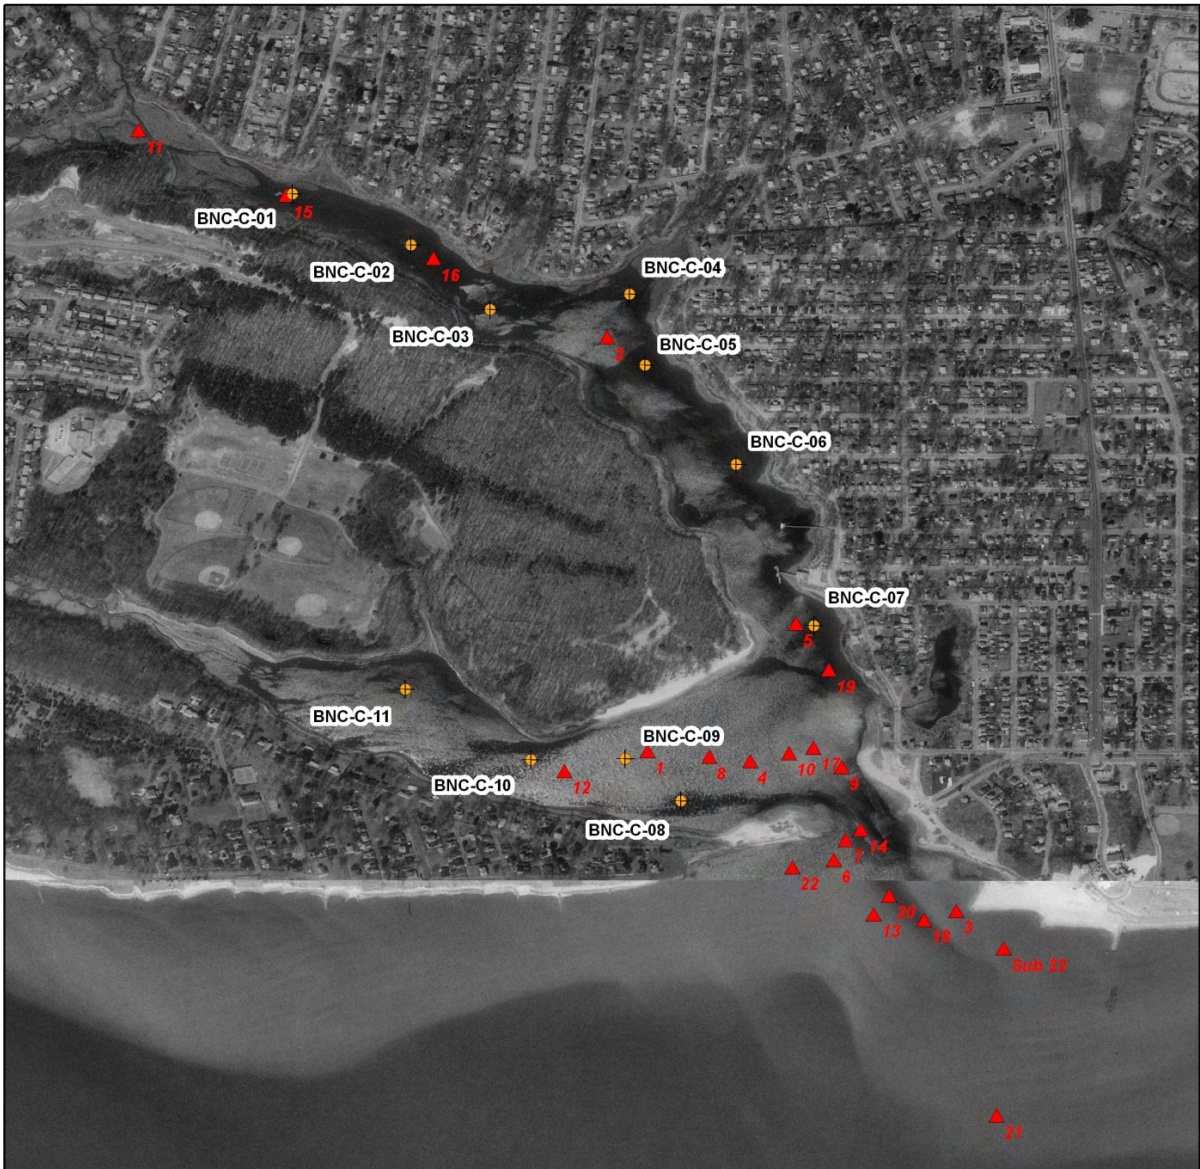
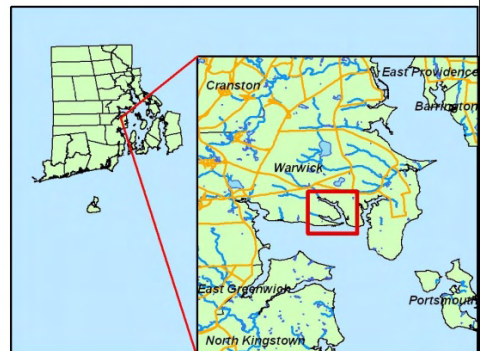
Figure 9. Sediment Sample Locations in Brush Neck Cove and Buttonwoods Cove

### Brush Neck Cove Sediment Sampling Plan

Sediment Grainsize Sample Location, July 2006

- 2006 Survey - The Corps collected sediment samples from 22 stations in Brush Neck Cove, Buttonwoods Cove and a portion of Greenwich Bay in 2006 to assess grain size (Figure 9). The 22 stations were sampled with a 2-inch diameter push-core sampler to a depth of approximately 1.5 feet. The grain size distribution graphs are presented in Appendix A.

- 2007 Survey – Battelle collected a total of 11 sediment cores within Brush Neck and Buttonwoods Coves in 2007 to characterize the physical and chemical nature of the sediment for disposal. Penetration into the sediment for each of the sampling locations was 10.0 feet and core recovery ranged from 7.0 to 9.3 ft with an average of 8.4 ft. Results of the physical and chemical analysis are provided in Appendix A of this report. Physical features included grain size analysis and visual observation of cores. Identification of coarse substrate within the cores would serve as an indicator of the historic elevation of the cove and would provide the optimal dredge depth to

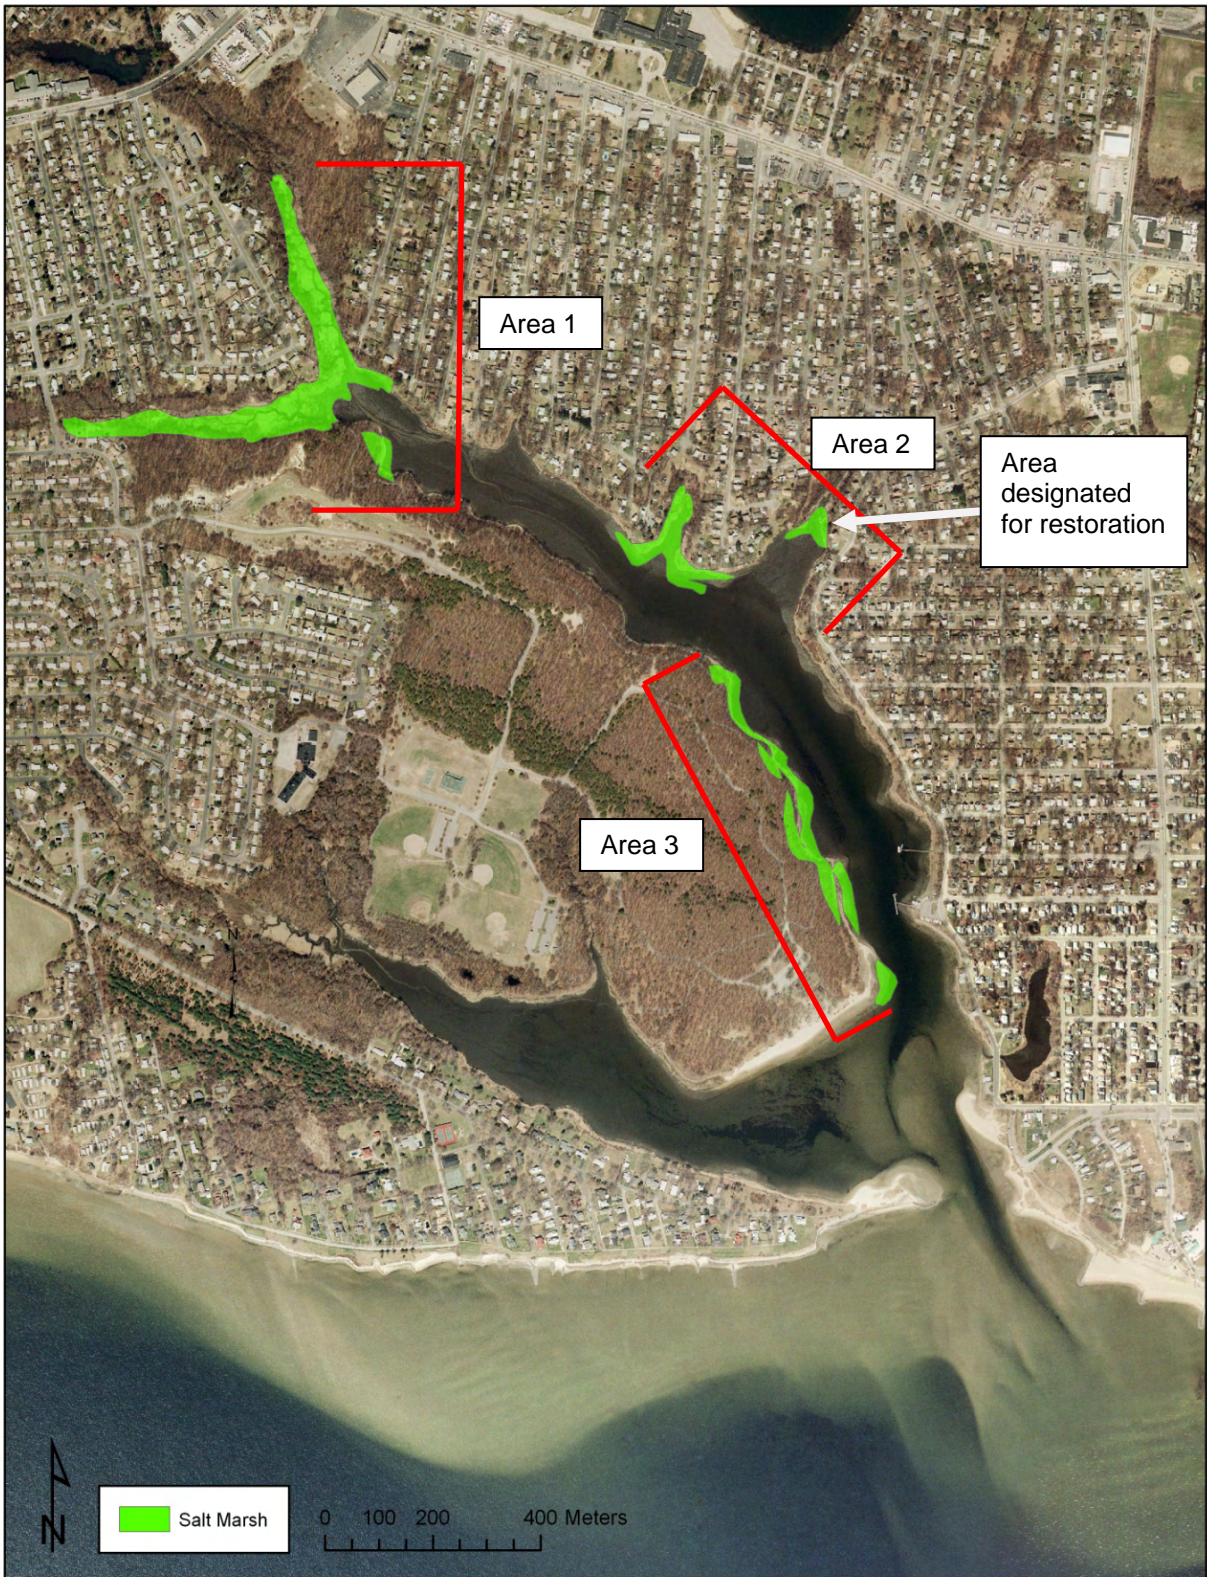
Figure 12. Brush Neck Cove Salt Marsh

The Corps examined aerial photographs and wetland maps to identify existing salt marsh habitat and locate areas for potential salt marsh creation. Figure 12 shows the existing salt marsh habitat. The salt marsh areas depicted are a hybrid of salt marsh delineated in 1996 and brackish marsh delineated in 1988.

RICRMC considers all salt marsh in Brush Neck Cove to be high quality with the exception of a small area in Area 2 described above (Figure 12). This small area, less than an acre, is designated for restoration.

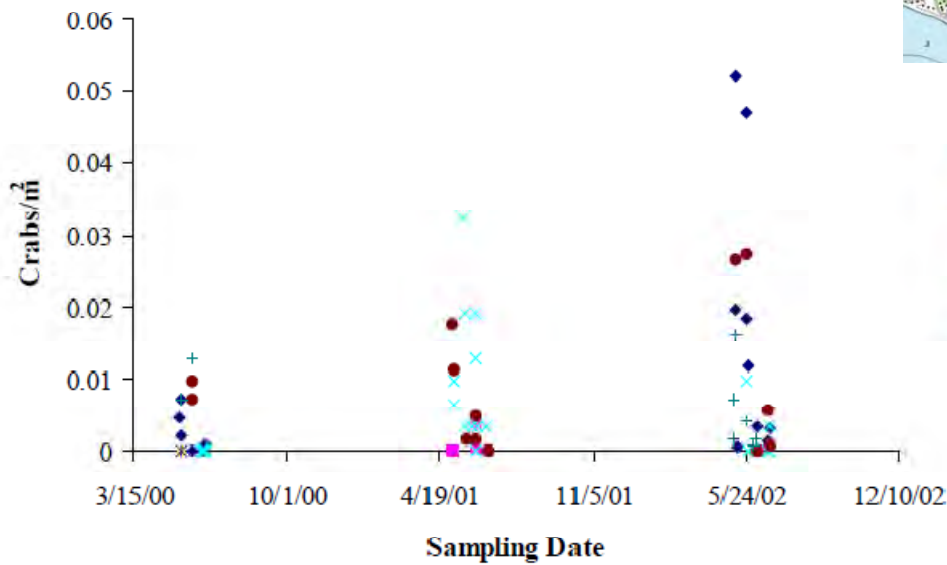
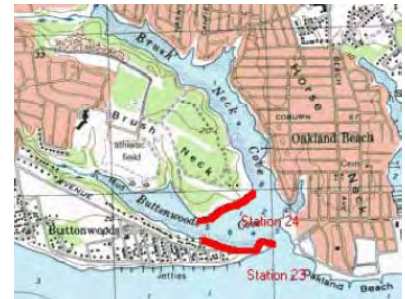
Figure 13. Horseshoe Crab Abundance and Density in Greenwich Bay (modified from CRMC 2005; originally from RIDEM)

### Horseshoe Crab Abundances in Greenwich Bay

### Horseshoe Crab Densities in Greenwich Bay
