2021 Tier 1 Mapping of Submerged Aquatic Vegetation (SAV) in Rhode Island and Change Analysis

April, 2022

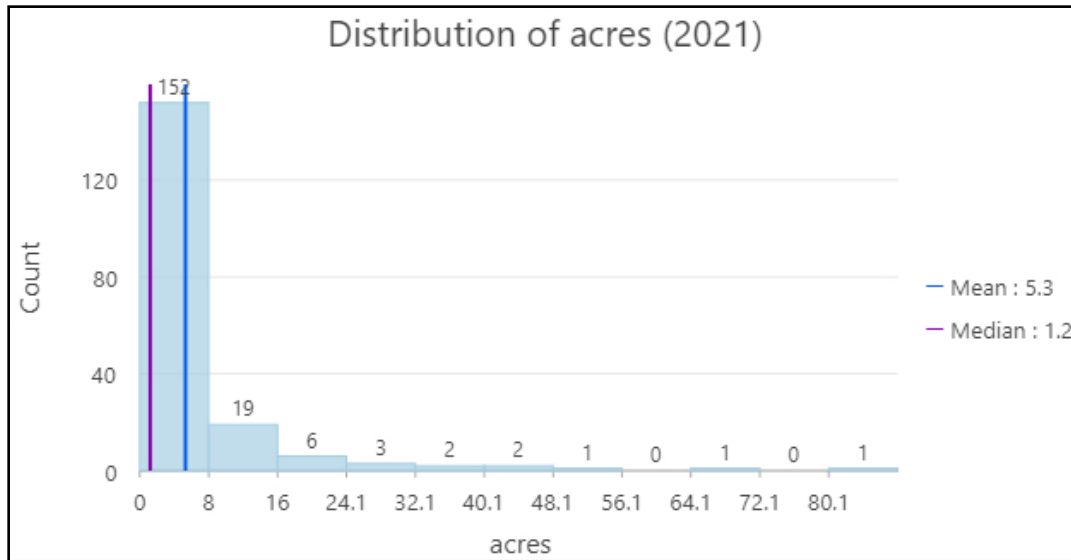
Figure 2. A large majority of the polygons were ≤ 8 acres according to a histogram of the distribution of the size (in acres) of the polygons mapped in 2021. The minimum mapping unit was 0.02 acres (1000 ft²), but 79% of the polygons were ≥ 0.25 acres.

of SAV, we mapped 187 polygons of SAV totaling 999 acres in coastal Rhode Island (Figures 2 and 3). In addition, the SAV mapping for 2021 had a user's and producer's accuracy of 83%.

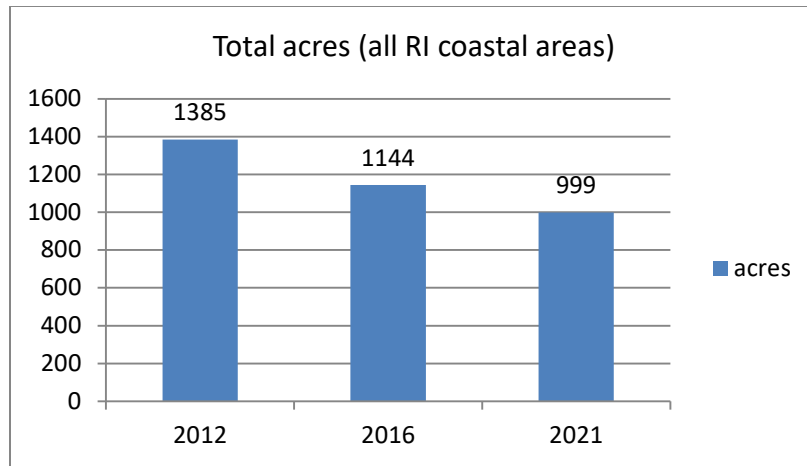
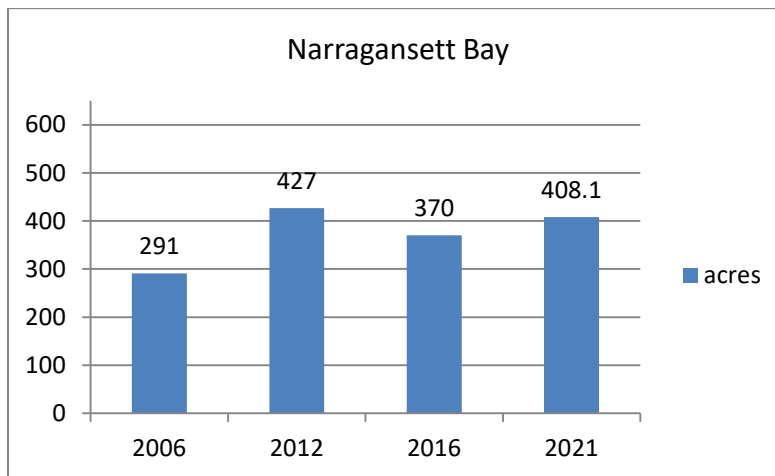
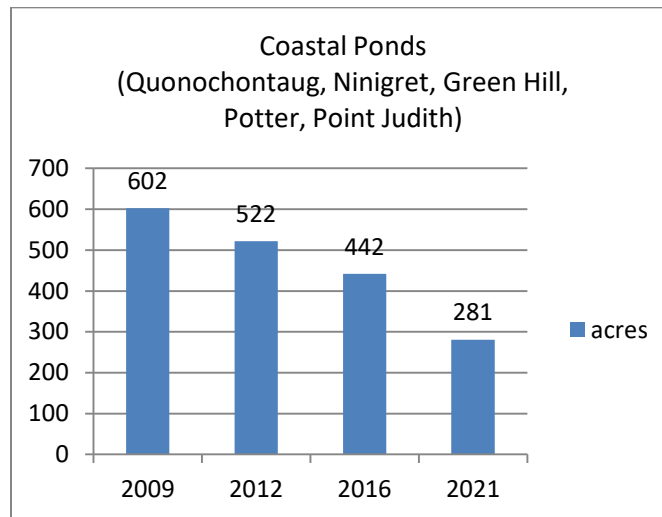
Figure 3. The SAV trends for all of Rhode Island, Narragansett Bay, and the coastal ponds.

The 999 acres mapped in 2021 corresponds to a general decrease of SAV in all of the study area of about 28% since the RI Eelgrass Mapping Taskforce began mapping all coastal RI waters in 2012 (Figure 3). Most of the declines in SAV during this time period have occurred in the coastal ponds (or lagoons) along the south shore of RI and in the Narrow River (Figures 3 and 4)

However, over that time span in Narragansett Bay, SAV acreages have been relatively consistent (with the exception of a slight decrease in 2016) over the four mapping efforts in 2006, 2012, 2016, and 2021 (Figure 3). And in fact, generally the Bay has sustained the observed increase in SAV since the first comprehensive survey of SAV in 1996 (Bradley et al., 2017). The west passage of Narragansett Bay, in particular, has seen increases in eelgrass since 2012 (Figure 5).

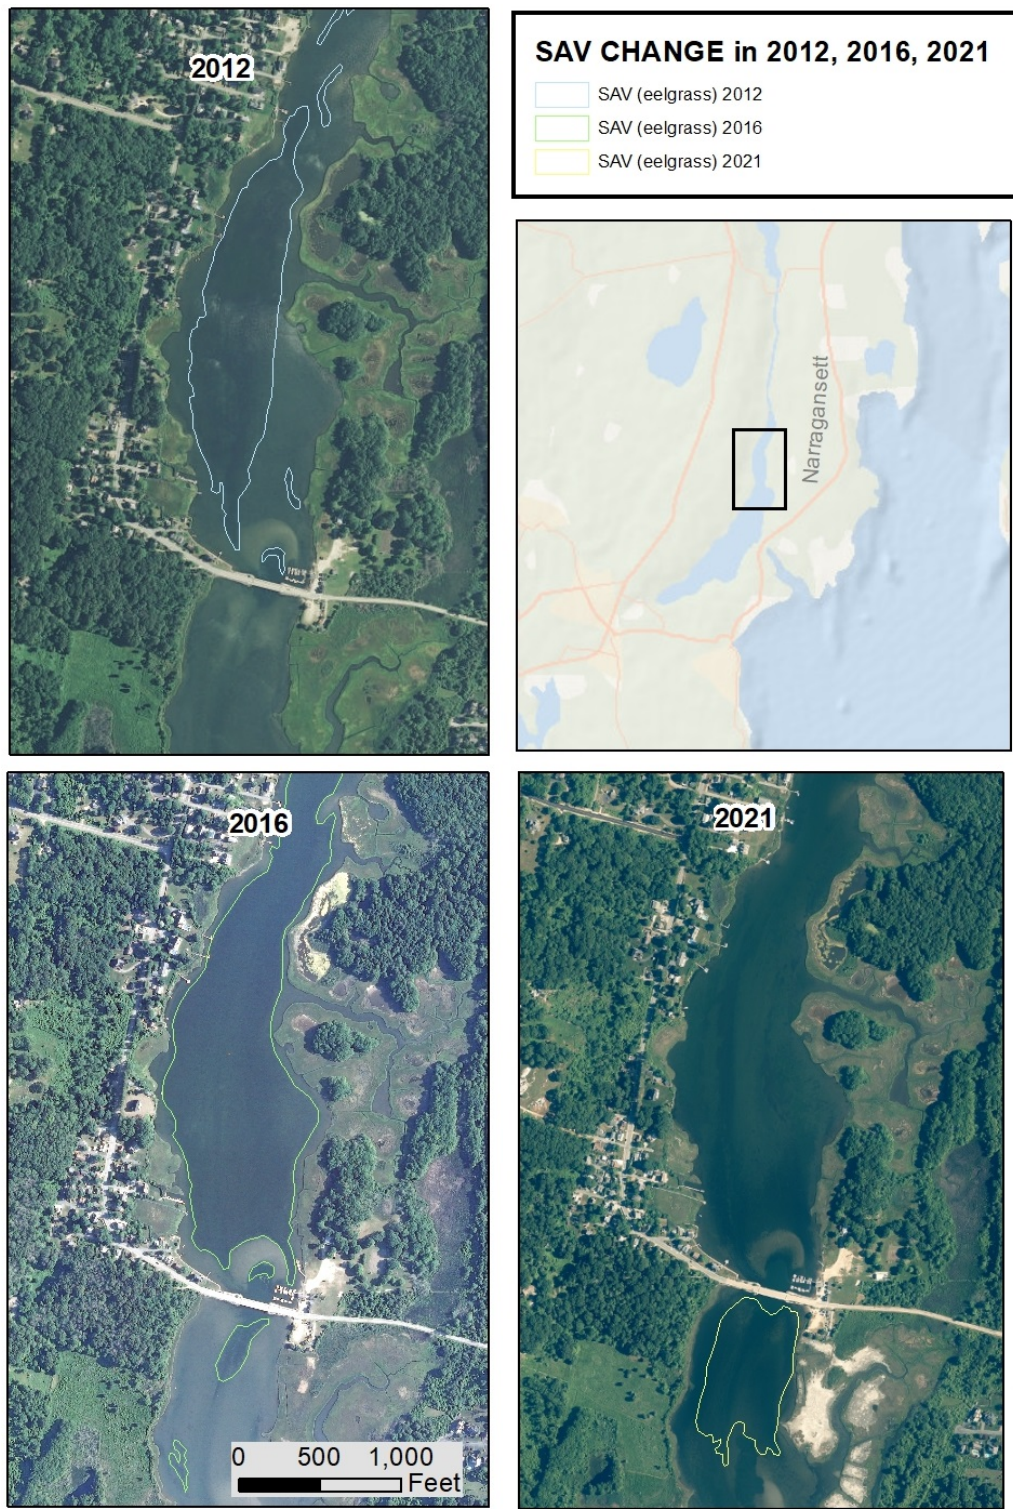
Figure 4. The acreage of eelgrass in the Narrow River has declined considerably since 2012 as noted with the lack of any photo-signature of eelgrass in the 2021 aerial imagery. Field surveys in 2021 confirmed the lack of eelgrass in this area.

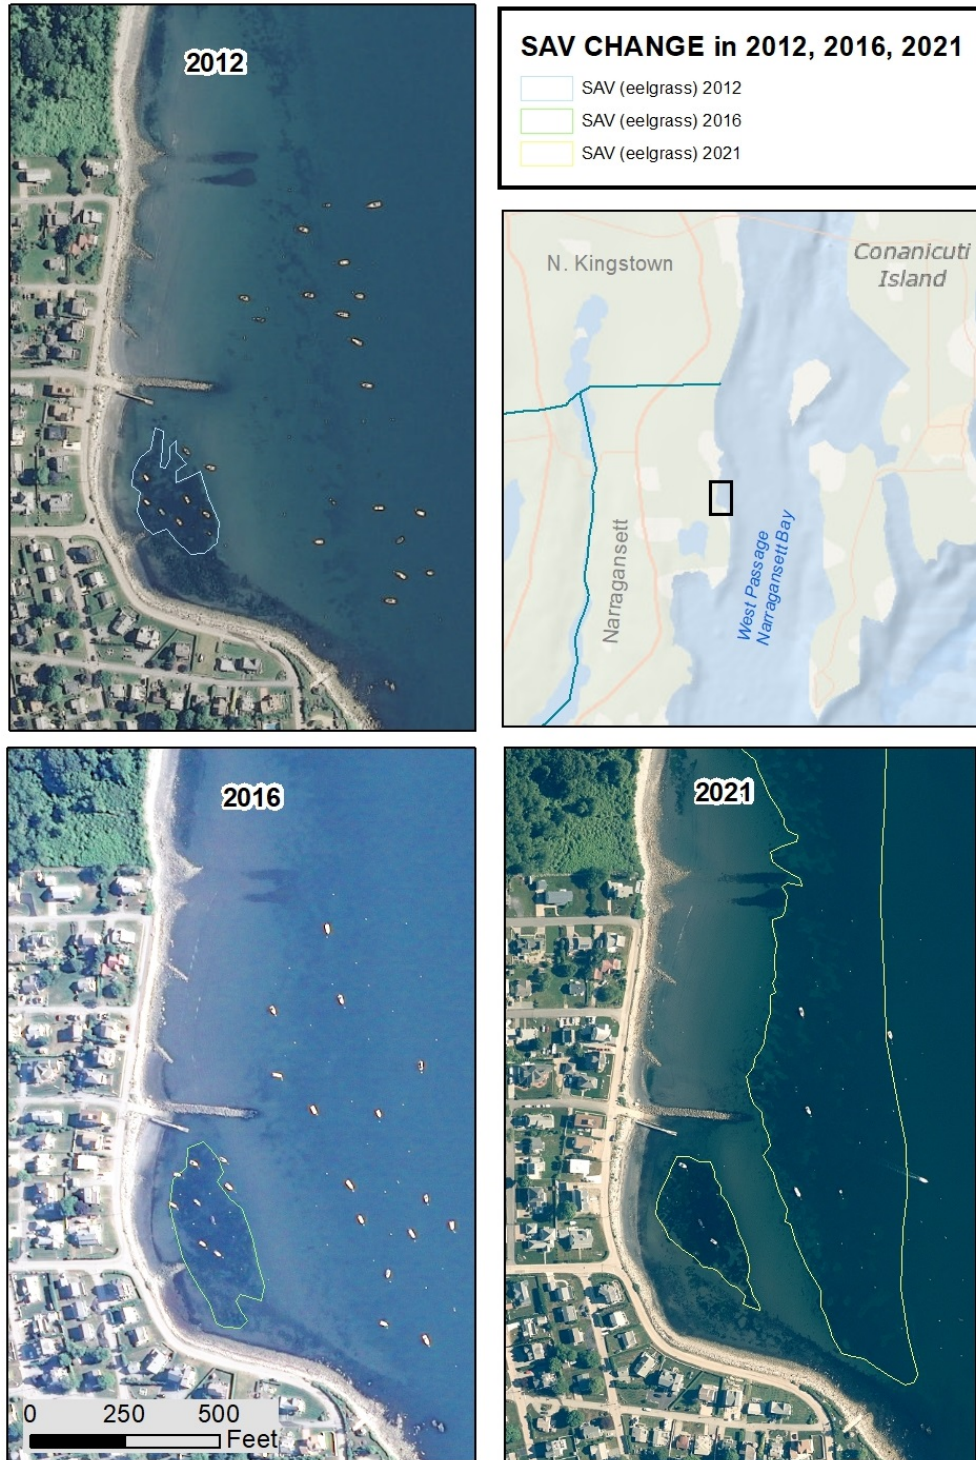
Figure 6. The acreage of eelgrass in the west passage of Narragansett Bay increased in 2021 as noted by the dark photo signature in 2021 and verified with field surveys. Note the lack of a photo-signature of eelgrass in the mooring field in 2012 and 2016.
