# **MATUNUCK COASTAL AREA REPORT**

**Storm Related Shoreline Impacts (1939 – present)**

**South Kingstown Planning Department**

**April 2010**

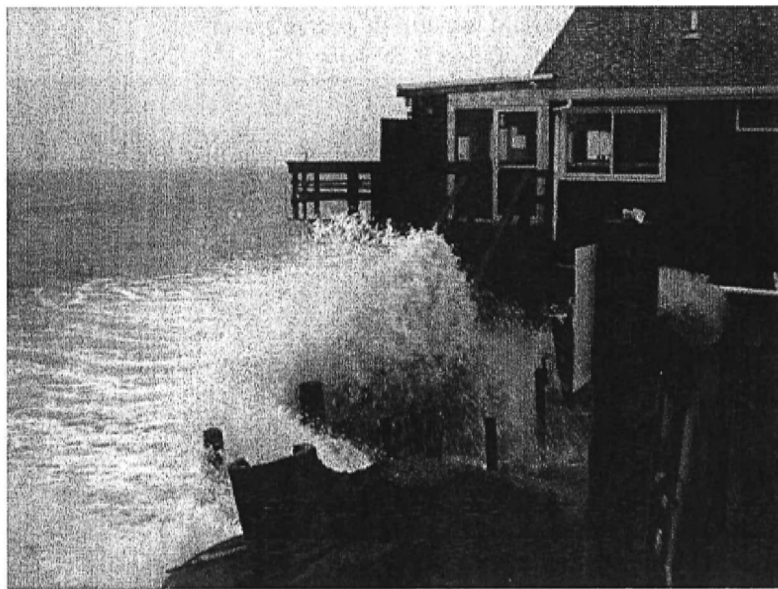
The most recent storm events of March and April 2010 have further exacerbated erosion of the natural coastal features, particularly in the Matunuck shoreline area. Wave action during the moon high tide of the late March storm caused considerable coastal erosion and damage to both commercial and residential properties.

Wave Inundation @ Matunuck (March 30, 2010)  
Photo Courtesy of Michael McKenna

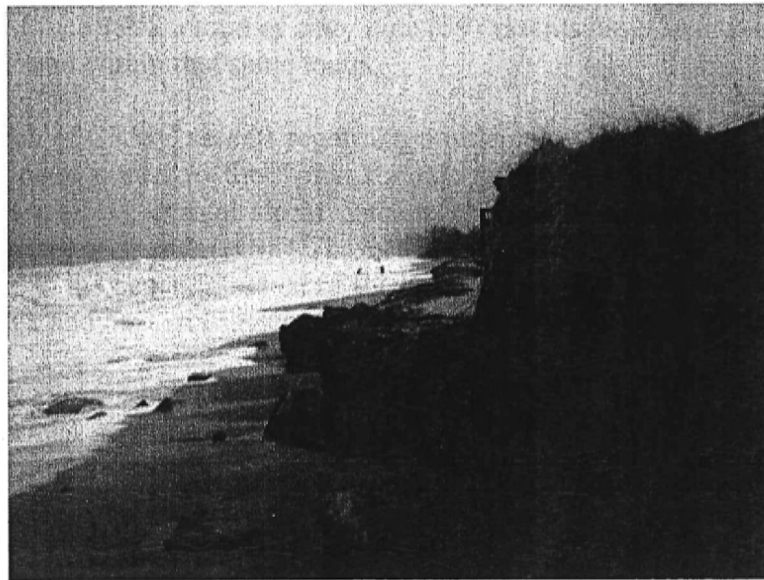
The March/April 2010 storm events also resulted in significant erosion to both the exposed beach and upland escarpment. At this time it does not appear that the Town Beach, in its present condition, could serve as a viable summer recreational facility. Considerable natural sand accretion will need to occur, or a municipal sand replenishment effort will have to be undertaken, before the beach could be useable by the public.

Erosion to Escarpment @ Town Beach (March 2010)  
Photo Courtesy of Michael McKenna
