## APPLICATION FOR STATE ASSENT

| Project Location <u>Barrington Bridge #123</u> <u>RI-114 (County Rd), Barrington, RI</u> | | File No. (CRMC USE ONLY)<br><u>2025-02-078</u> |

### BARRINGTON BRIDGE NO. 123 UNDERWATER REPAIRS

**Rehabilitation of Bridge Group 15F –  
Barrington Bridge No. 123**

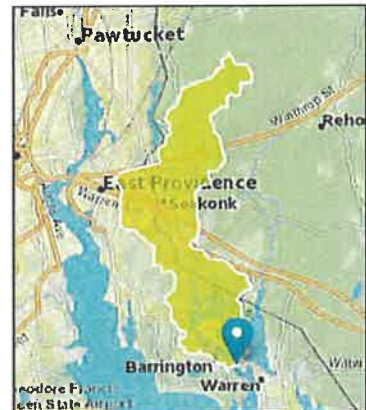
The watershed for the Barrington Bridge was determined to be 16.0 mi<sup>2</sup> (square miles) per USGS Stream Stats, as depicted in the graphic to the right. The peak flows expected within the Barrington River from rainfall-runoff per statewide regression equations returned from the USGS StreamStats Program were relatively insignificant compared to the peak flows that occur as the result of the tidal cycles; both normal and storm surge conditions. For example, the peak flow generated from the normal cycle was determined to be 2,700 CFS (cubic feet per second) per the current hydraulic model, while the peak flow expected as a result of rainfall-runoff during the 100-year storm event was less than 1,000 CFS. As such, it was determined that the rainfall-runoff flow conditions of the Palmer River could be neglected during this analysis and the focus of the analysis could be placed upon the tidal conditions that develop at the bridge.

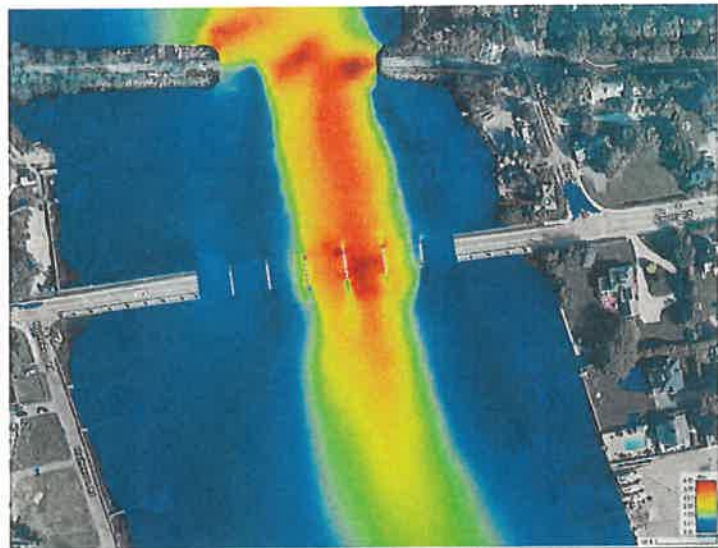
The results of the model computations revealed that highest flow velocities occurred during the two surge events; 10-year storm surge event and 100-year surge event. The peak velocities during both events were generally the same while the peak depths during the 100-year event were notably larger. The graphic to the right depicts the velocity profile that develops across the bridge during the 10-year storm surge event. During both surge events, peak flow velocities were variable across the bridge ranging from 1.5 to 4 fps (feet per second); flow velocities were higher between piers 3 and 6 with the highest velocities occurring between piers 4 and 5.

The table to the right provides the peak flow velocities and depths across the bridge during the most hydraulically critical (highest velocity) time step of the 100-year storm surge event.
