Date: November 24, 2025 Job No.: 24.11433.00  
To: Kevin Aguiar, PE, Senior Vice President  
Cc: Benjamin Boynton, PE, Senior Project Manager  
Laura Krause, Senior Project Manager  
From: Jonathan Niro, PWS, Project Manager  
Tyler Drew, Scientist  
Anna Haznar, Staff Scientist  
Subject: **Tidewater Landing Phase 1B**  
**CRMC File No. D2025-04-090**  
**Vegetation and Wildlife Habitat Assessment**

Tidewater Landing APC

Pawtucket, Rhode Island

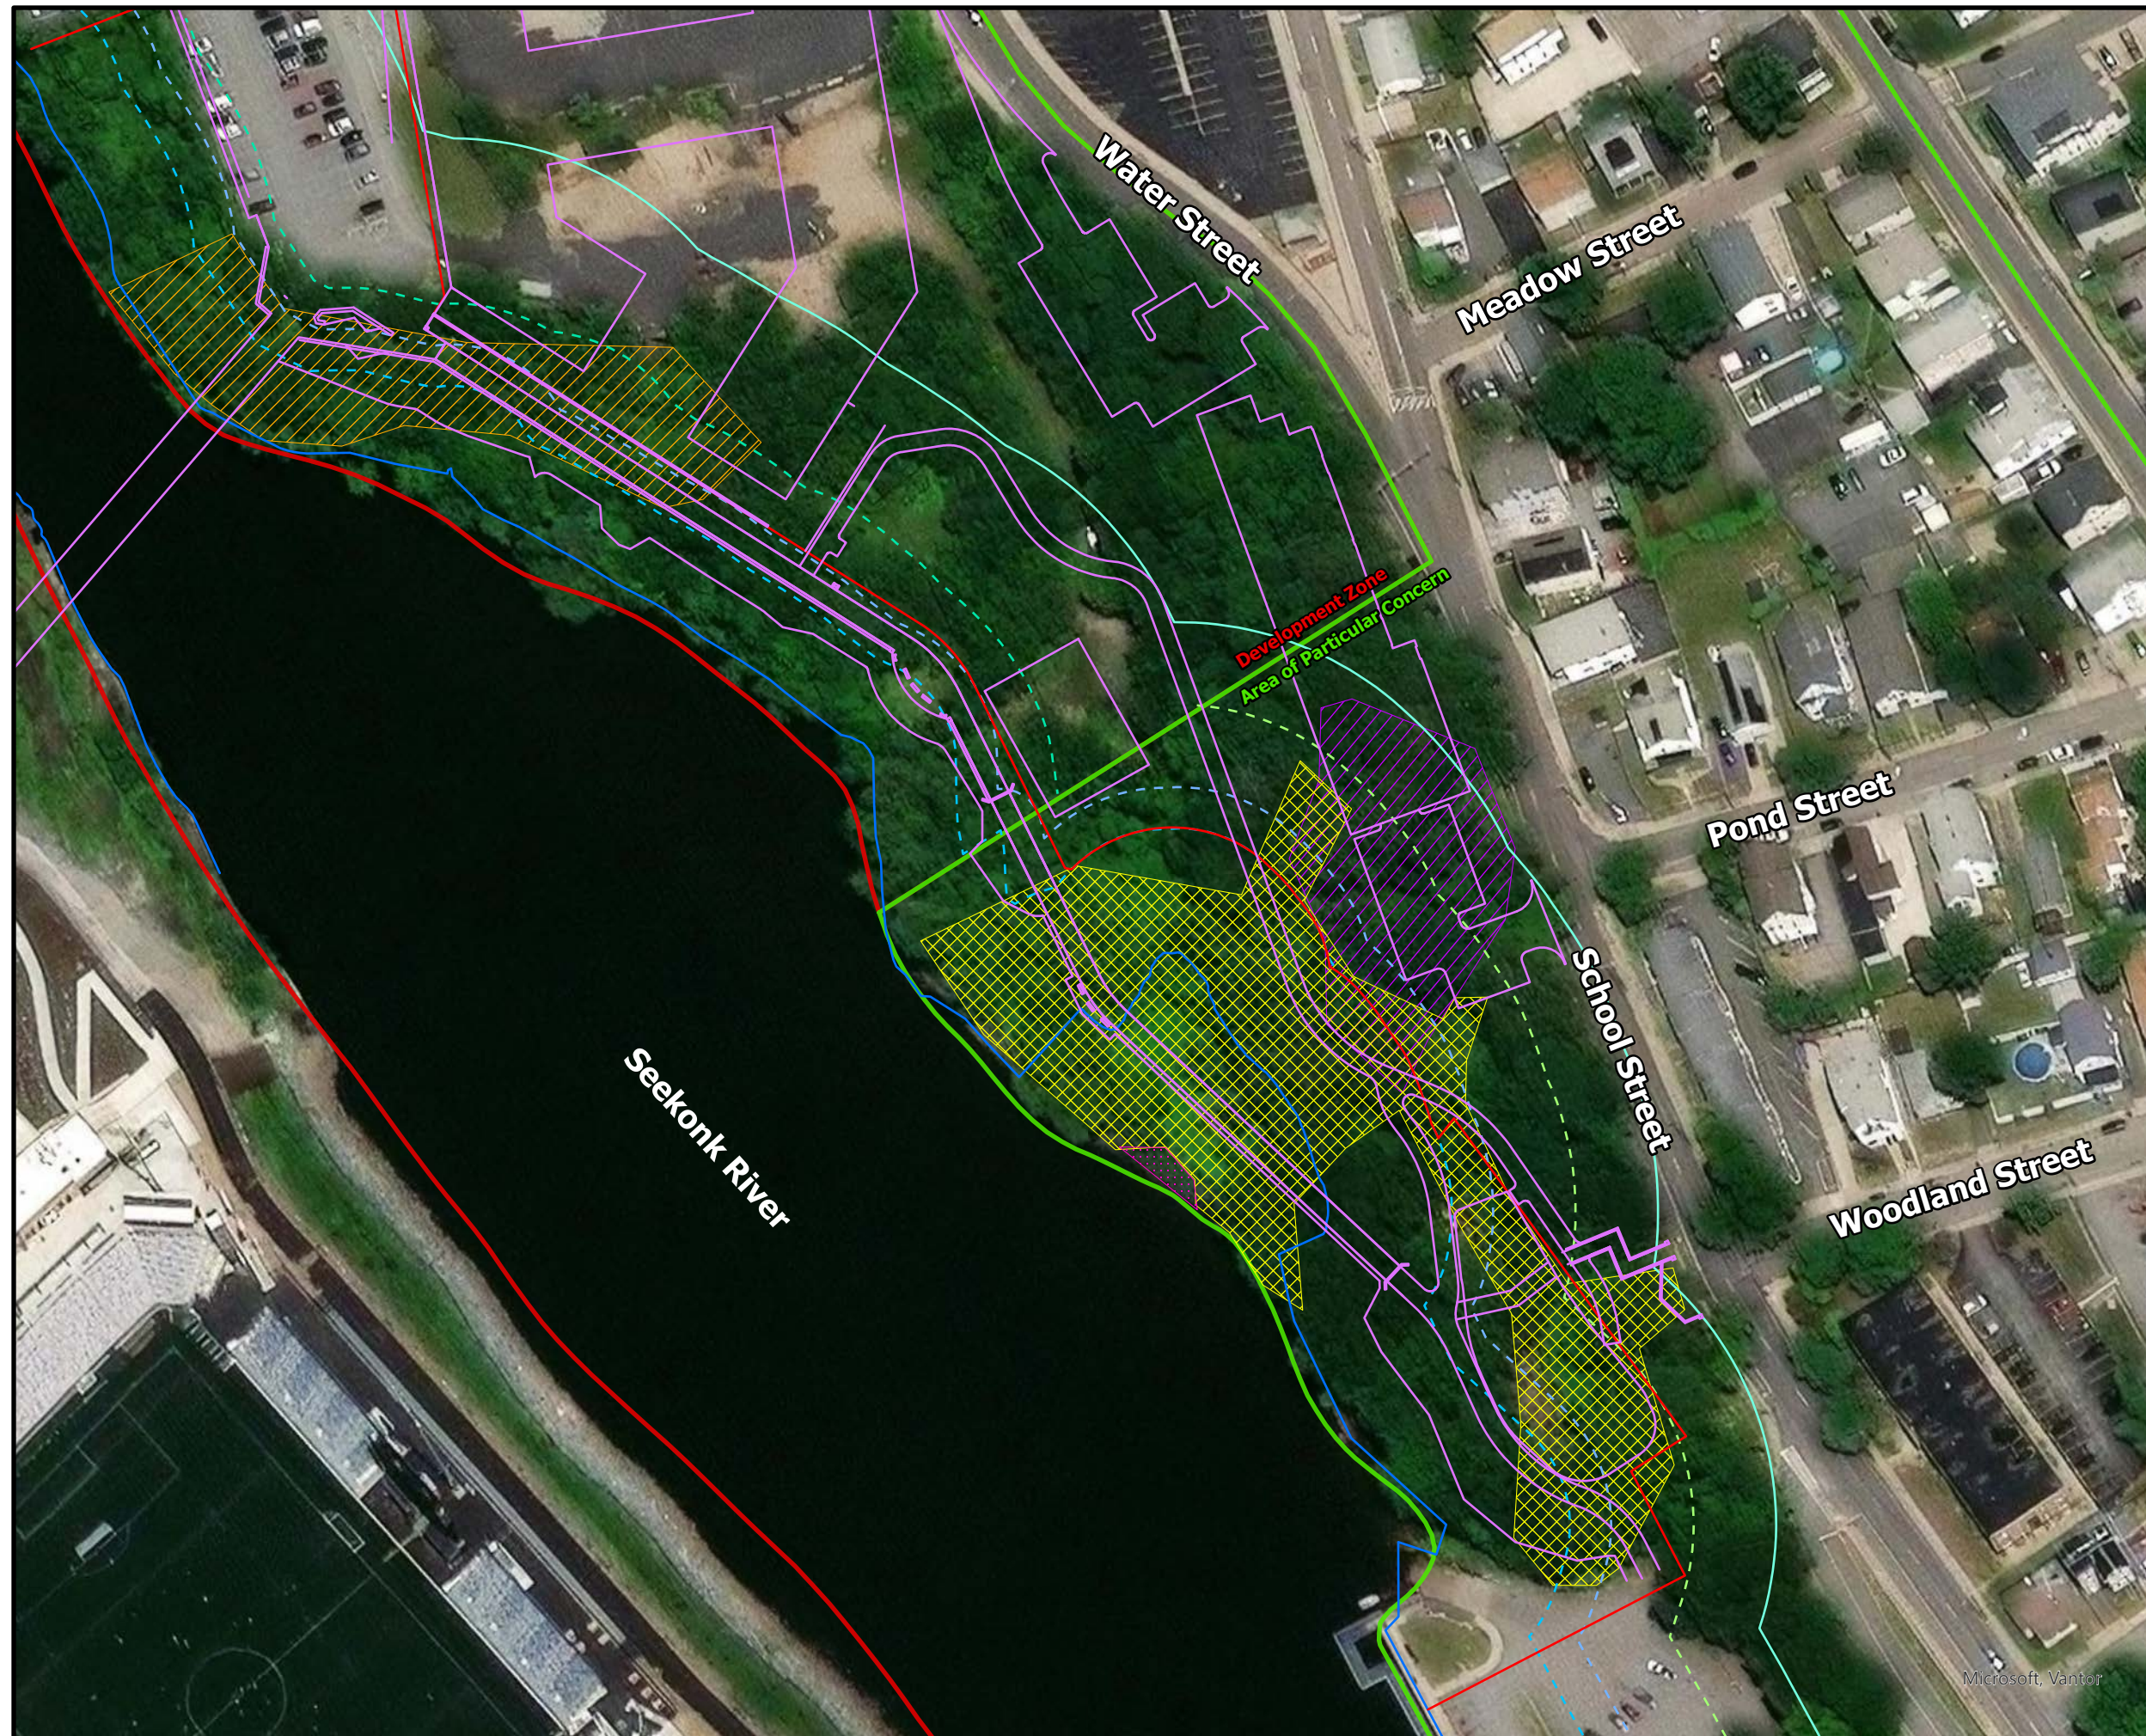
**Figure 2**  
**Understory Assessment**  
**Tidewater Landing**  
**Pawtucket, RI**

The RIISC invasive species list was consulted to identify invasive plant species on the Site. Generally, invasive plant species make up a large percentage of the vegetation identified during the assessment (Photos 1 through 5 and Photo 13). While the tree canopy is generally mixed, approximately 26% of tree species identified during the assessment were listed as invasive, with an additional 36% of trees listed as non-native. Understory species in the shrub and herbaceous layer almost entirely consist of invasive species as shown in Figure 2.

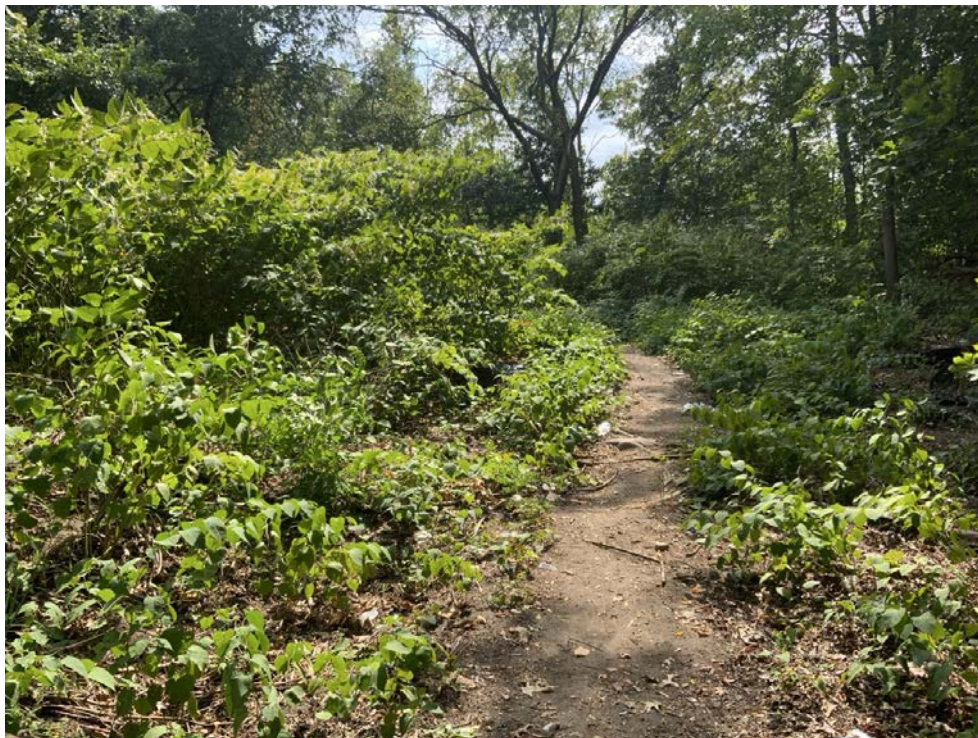
**Photo 1**

The APC and Development Zone at the Site are predominantly forested but also include several open areas vegetated with herbaceous plant species (Photos 1, 2, 8, and 11). A number of tree species throughout the Site are mature and create a well-established canopy. These trees include a mix of native, non-native, and invasive species, with the highest percentage consisting of non-native species. During the Site assessment, 862 trees were mapped and identified within the APC and the Development Zone and are listed in Table 1.

of shrubs that are listed as invasive by the Rhode Island Invasive Species Council (RIISC) Invasive Species List<sup>1</sup> dominate the understory throughout portions of the APC and Development Zone. Invasive shrubs include amur honeysuckle (*Lonicera maackii*), burning bush (*Euonymus alatus*), Privet (*Ligustrum* spp.), and multiflora rose (*Rosa multiflora*) (Photos 3 and 4). The remaining understory is densely vegetated with Japanese knotweed (*Fallopia japonica*) within the central clearing and onsite coastal wetland and is also interspersed throughout forested portions of the APC (Photos 1, 2, and 5).

View of the central clearing and stands of Japanese knotweed (*Fallopia japonica*) - facing south.

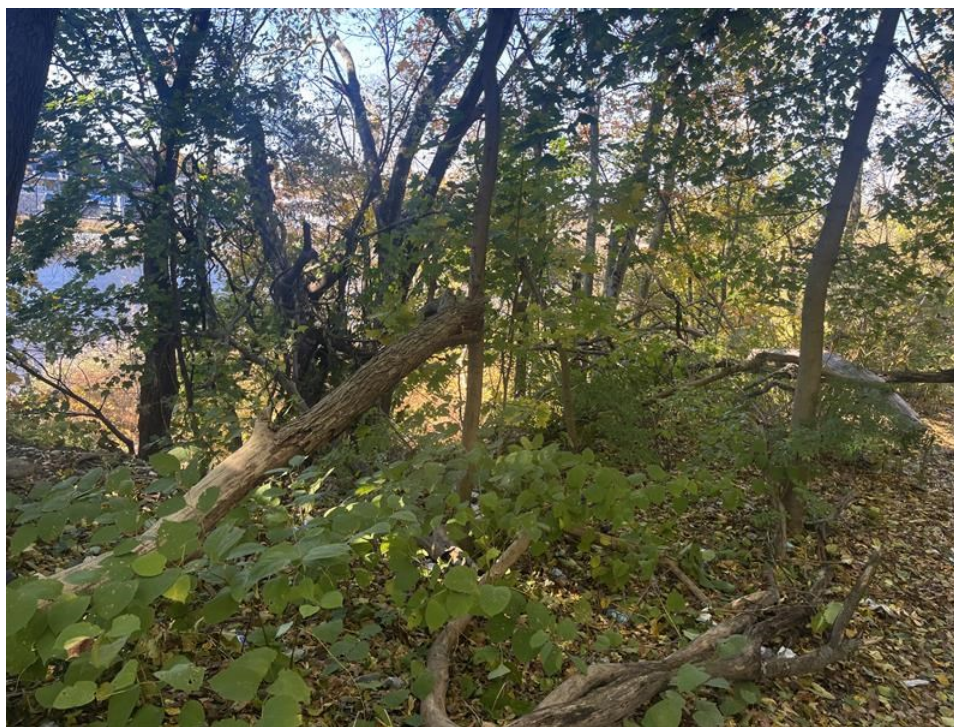
**Photo 2**

Typical view of a forested area at the Site—facing north.

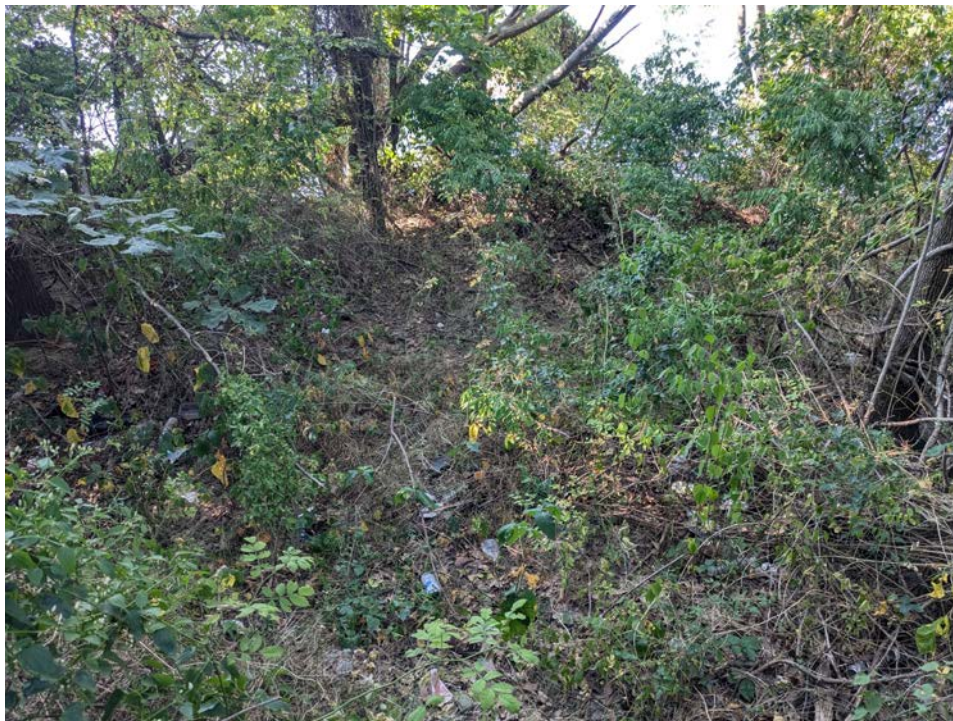
**Photo 3**

The understory throughout the Site varies with regard to the composition of vegetation (Photo 3, 4, and 5). Several clearings and walking paths have been created by human occupation that do not support vegetation due to human activity and the presence of tents and debris (Photos 6, 7, and 8). Dense stands

Climbing vines were also identified throughout the Site (Photo 3). These species include Asiatic bittersweet (*Celastrus orbiculatus*) and grape (*Vitis labrusca*). Vines were not as abundant as trees and shrubs; however, they were more commonly identified in disturbed areas and along clearings. Roundleaf greenbrier (*Smilax rotundifolia*) was observed growing in dense thickets in the northern portion of the APC. Additionally, a large population of the invasive sweet autumn clematis (*Clematis terniflora*) is present within the northern section of the Development Zone (Photo 13).

Typical view of the invasive vegetation within the understory of the APC—facing east.

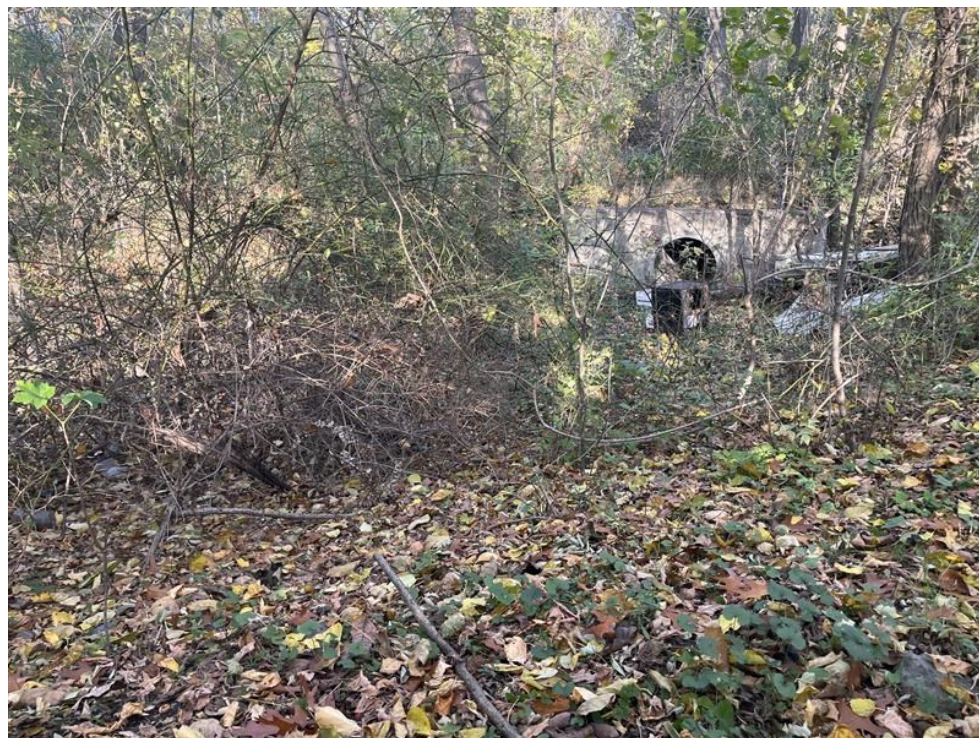
**Photo 4**

Typical view of the understory within the Development Zone—facing east.

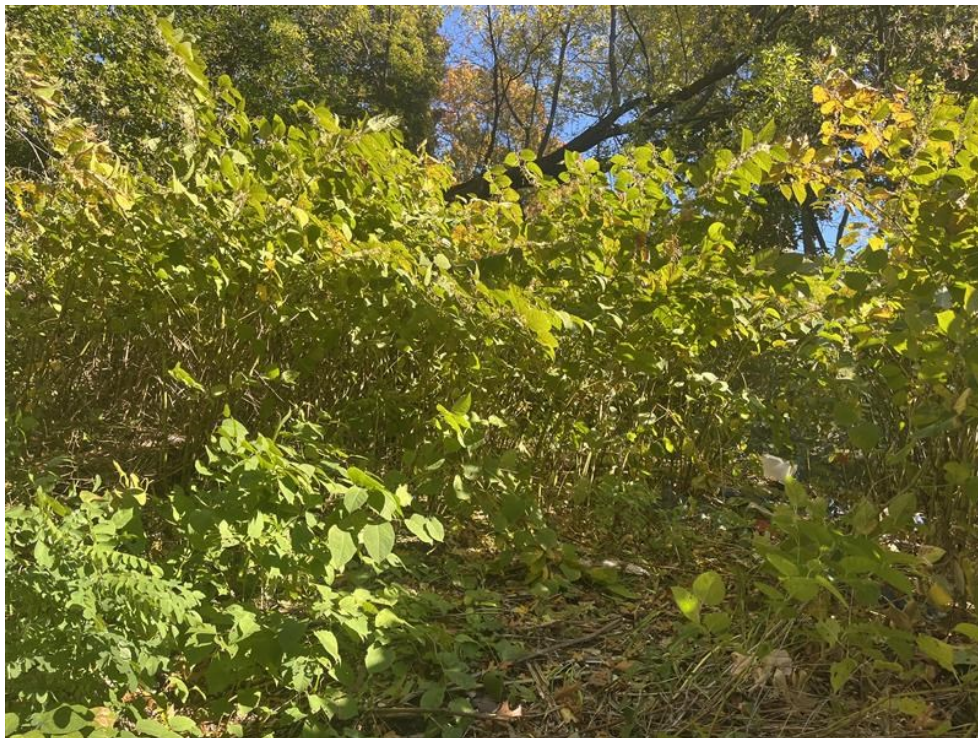
**Photo 5**

Typical view of a stand of Japanese knotweed within the central clearing and surrounding canopy cover—facing east.

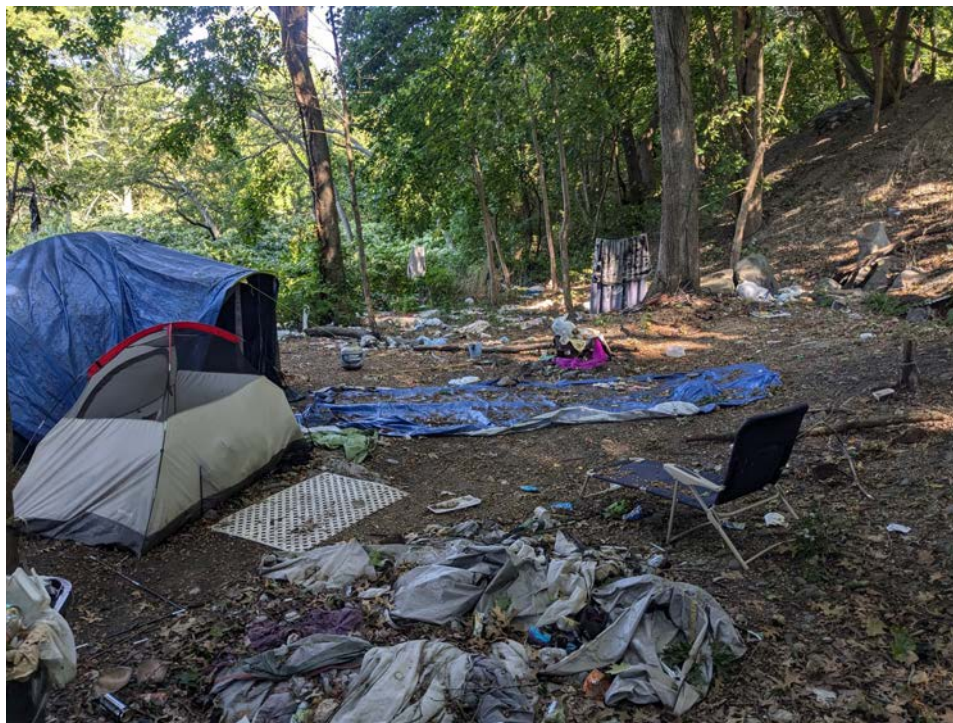
**Photo 6**

In addition to invasive vegetation, evidence of frequent disturbance from human habitation was observed throughout the Site. These include active encampments, piles of trash, debris, and clearings that serve as walking paths and living areas (Photos 6, 7, and 8). Four (4) notable encampments were observed on the Site. Two (2) are located in the southern portion of the APC, between the central clearing and the Seekonk River, a third is located in the northern portion of the APC, and the final encampment is located within the northern section of the Development Zone. All of these areas have been cleared of vegetation to make room for tents and other temporary structures and appear to be actively in use. Additionally, a ramp and retaining wall is present on the northern side of the Development Zone (Photo 12) with vegetation growing through the concrete ramp.

Typical view of anthropogenic debris at the Site—facing south.

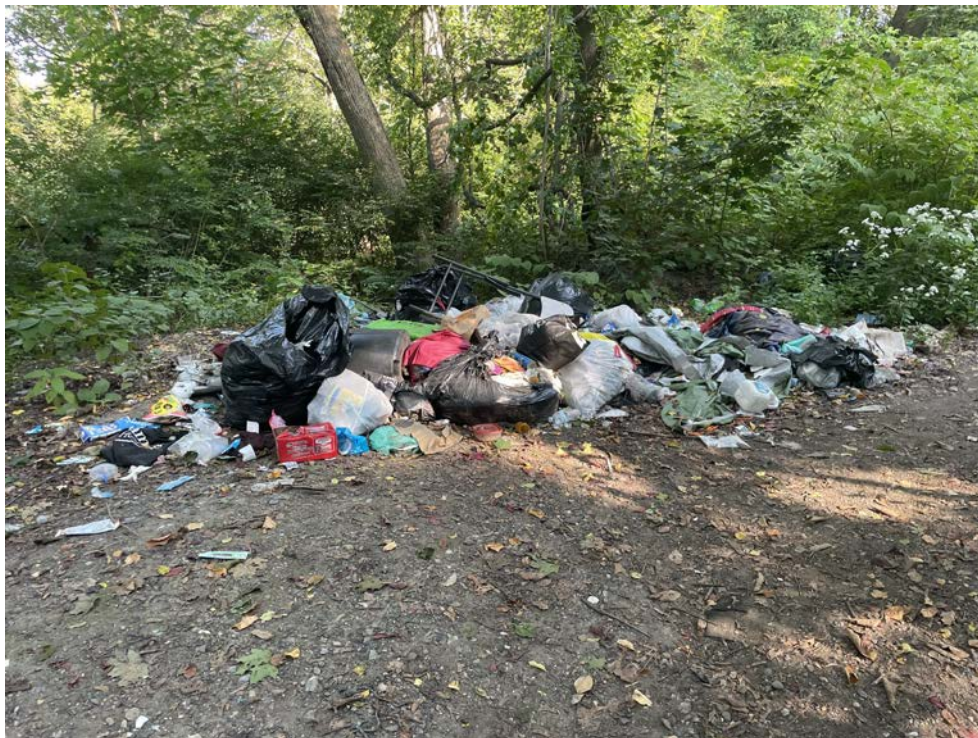
**Photo 7**

Another view of anthropogenic debris at the Site—facing northeast.

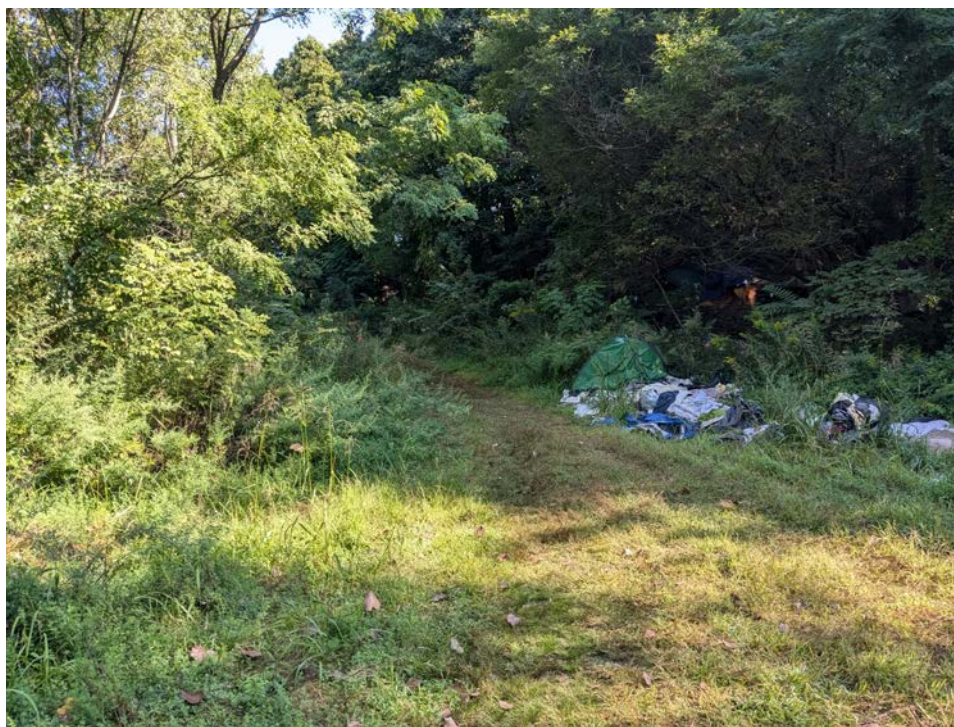
**Photo 8**

Foxglove beard-tongue can typically be found in open fields and meadows. The majority of the Site is forested and therefore not suitable habitat for this species. Three (3) open areas with no canopy cover were identified on the Site during the assessment and assessed for occurrences of this species (Photo 8 and 11). The first area is located within the central portion of the APC and is dominated by stands of Japanese knotweed or cleared by human activity. The other two (2) area are located within the Development Zone. These area are open fields vegetated primarily with invasive grasses. No individuals of this species were identified throughout the Site.

View of an open field/meadow north of the APC—facing north

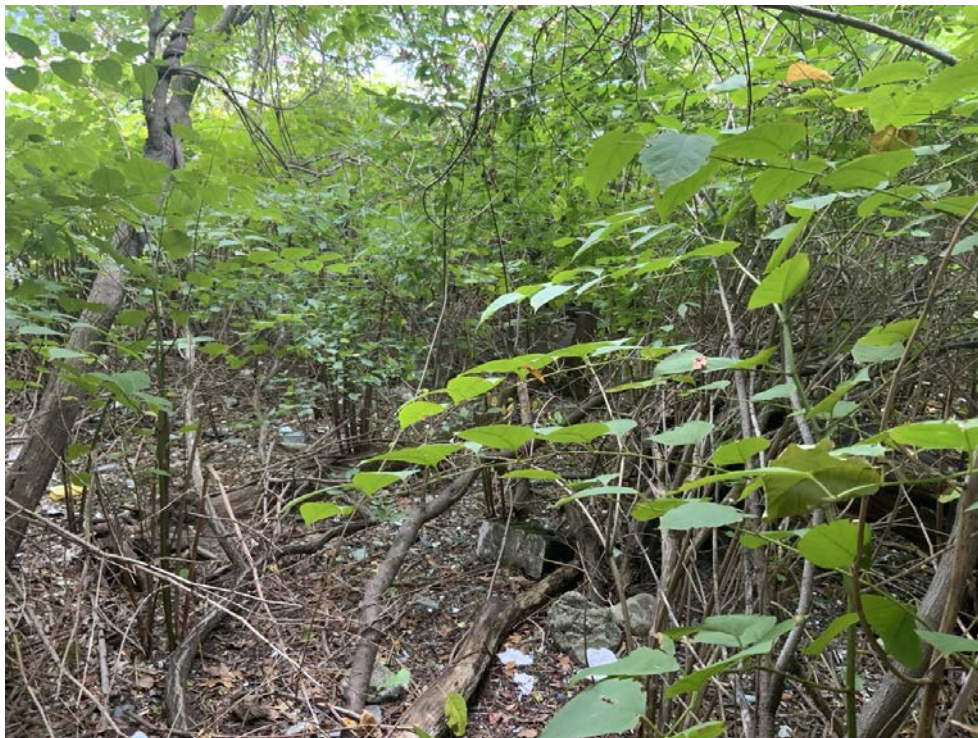
**Photo 9**

The coastal wetland located along the western portion of the Site was observed to be partially submerged during high tide, however the area was almost entirely vegetated with Japanese knotweed that restricts water flow, outcompetes native wetland vegetation, and creates a physical barrier preventing access to the wetland (Photo 9). This area is also littered with trash and debris. These conditions make this area unsuitable habitat for wildlife such as fish or crustaceans that the terrapin may use as a food source, making this unsuitable feeding habitat. One area of sandy / gravelly beach was observed at the southwest corner of the APC (Photo 10); however, this area was observed to be submerged during high tide and is therefore unsuitable for nesting.

Typical view of the coastal wetland—facing west

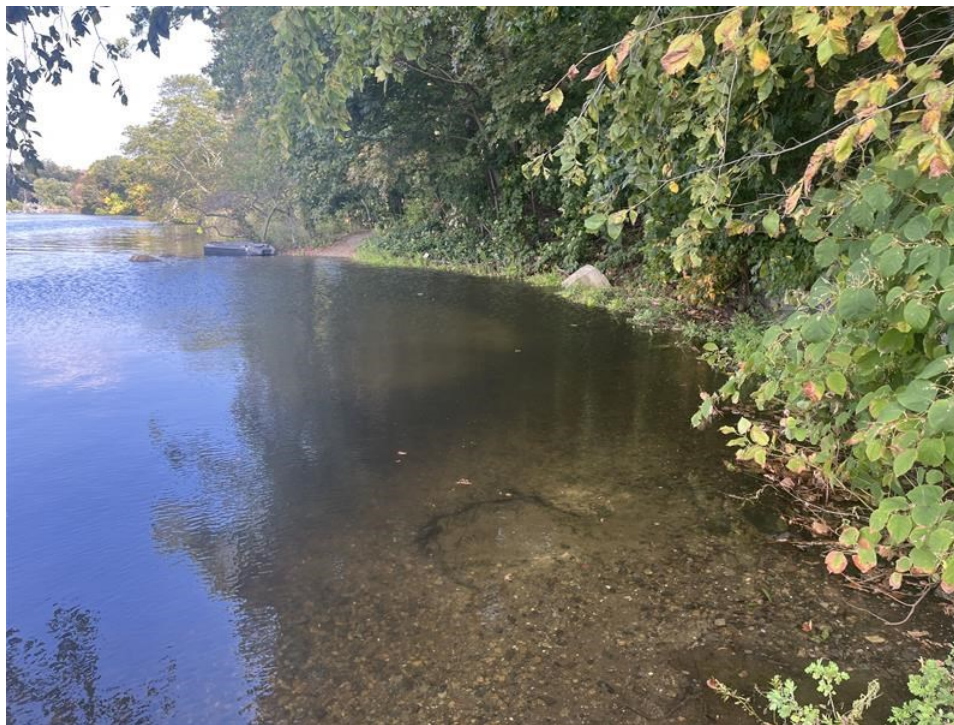
**Photo 10**

View of the sandy/ gravelly area at the southwest portion of the Site—facing north

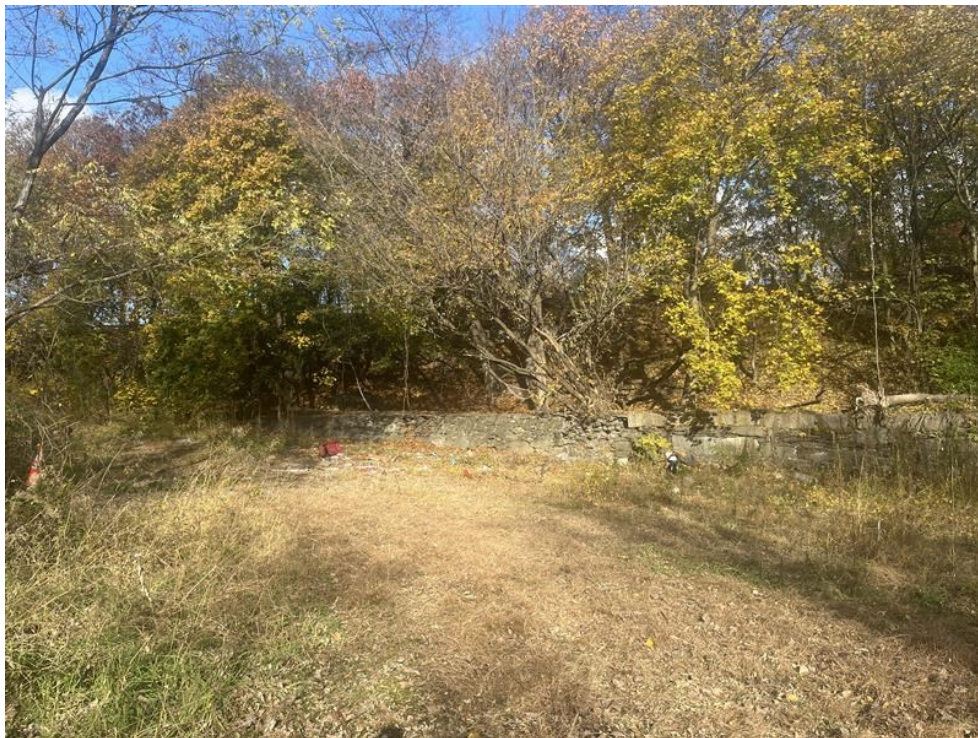
**Photo 11**

View of the open field within the Development Zone—facing south.

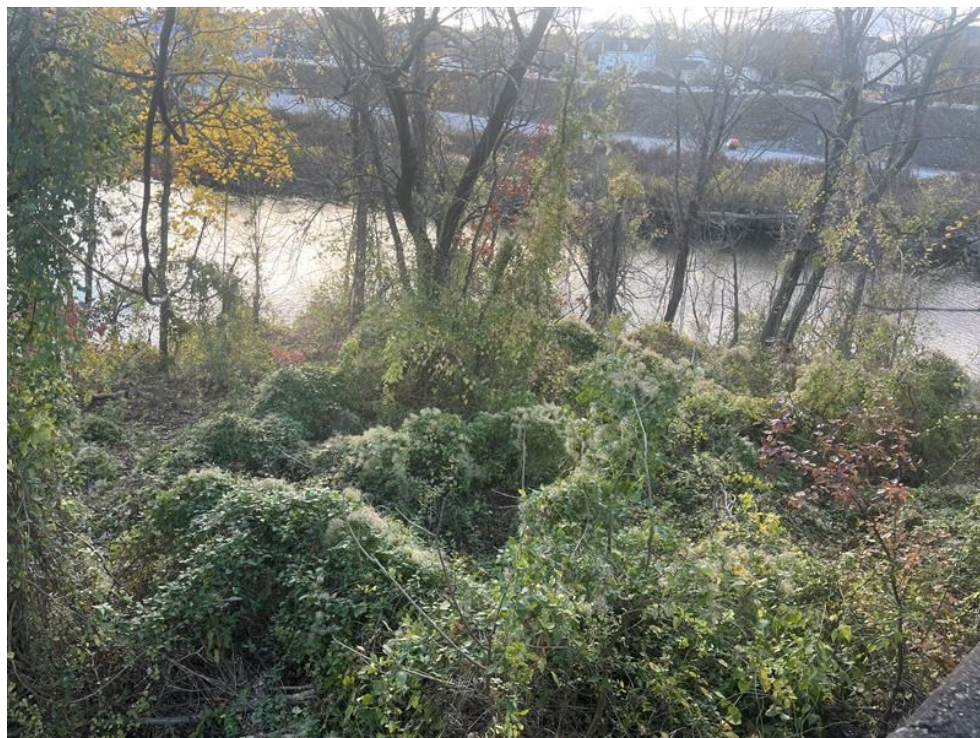
**Photo 13**

View of a population of sweet autumn clematis within the Development Zone—facing south.
