**Re: Tidewater Landing Phase 1B (Eastern Side of Seekonk River)  
Wetlands Assessment Letter of Findings**

Job No: 24.11433.00

Tidewater Landing Phase 1B—Wetlands Assessment

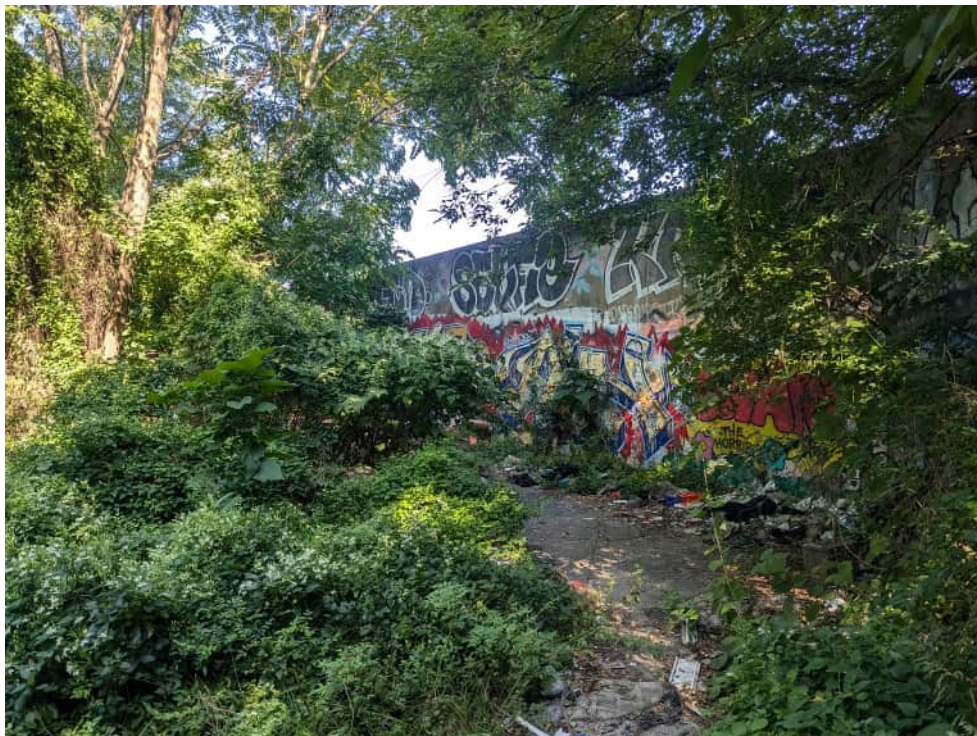
**Photo 1**

View of the large retaining wall at the northern extent of the Site that constitutes manmade shoreline—facing northeast.

BETA observed manmade shorelines along the Seekonk River, a tidal river, within the northern portion of the Site. Manmade shoreline at the Site consists of a large retaining wall situated parallel with the Seekonk River. The CRMC Preliminary Determination for the Site (Attachment B) states that the large retaining wall situated within the northern portion of the Site is the limit of the CRMC-jurisdictional coastal feature. Based on field observations and a review of topographic mapping, it appears that manmade shoreline transitions to coastal bluff directly south of the onsite parking area.

Survey location of the wall within the northern extent of the Site is required to determine the boundary of the manmade shoreline at this location. Manmade shorelines are subject to the 200-foot contiguous area measured horizontally inland from their location which determines CRMC jurisdiction for proposed project activities.

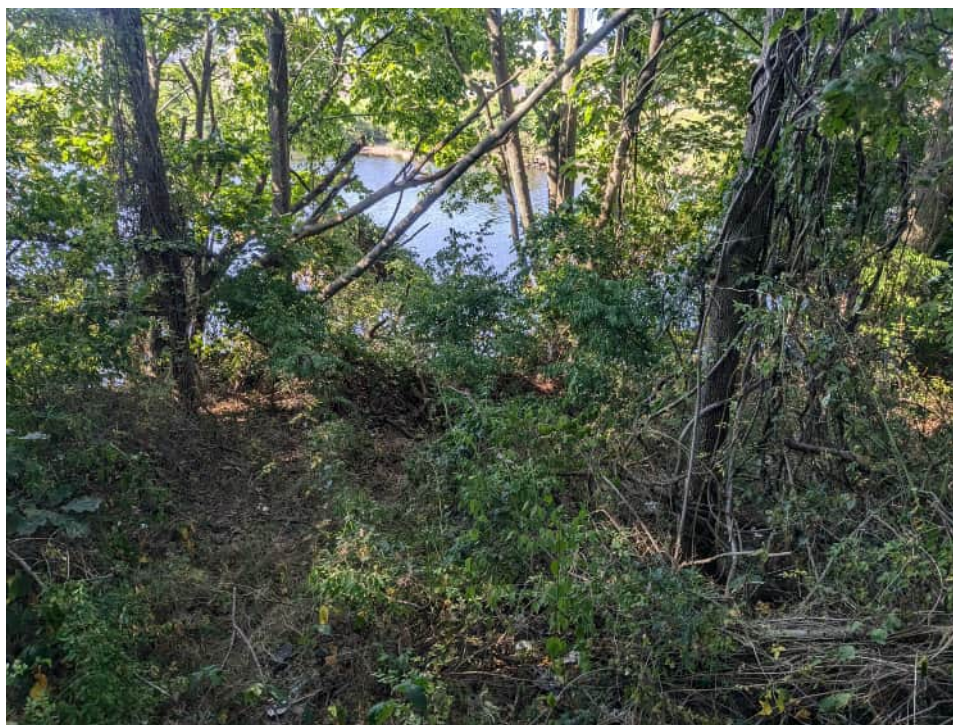
**Photo 2**

Typical view of the vegetated portions of the coastal bluff—facing west.

According to the CRMC Preliminary Determination issued for the Site (Attachment B), a coastal bluff located approximately at elevation 6 feet (NAVD88) is present at the Site outside of the limits of manmade shorelines and coastal wetlands. BETA observed this elevation to generally correspond with the boundary of the coastal bluff in the field. Coastal bluff at the Site consists

primarily of gravelly fill soils and is vegetated by species including Norway maple (*Acer platanoides*), red maple (*Acer rubrum*), white oak (*Quercus alba*), Asiatic bittersweet (*Celastrus orbiculatus*), and roundleaf greenbrier (*Smilax rotundifolia*).

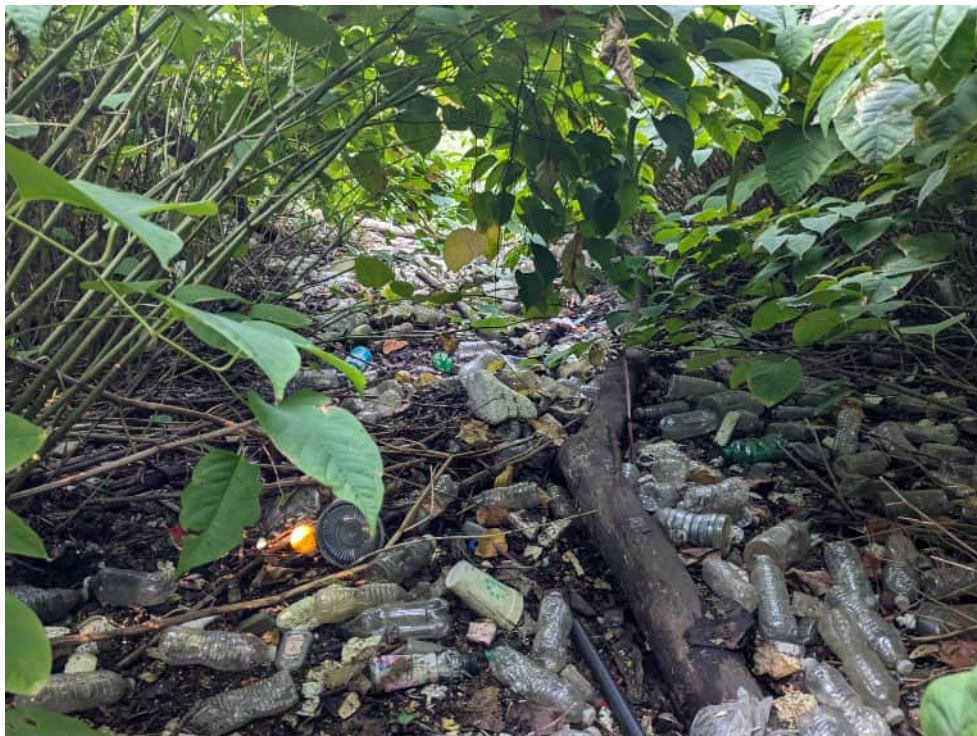
Photo 3

Typical view of the coastal wetland delineated at the southern extent of the Site—facing west.

This area was delineated with pink flagging labeled WF1-100 to WF1-112 and consists primarily of a sparsely vegetated and channelized portion of salt marsh between dense stands of knotweed. A monoculture of common reed (*Phragmites australis*) is present adjacent to the Seekonk River. Soils generally consist of histosols with a mild hydrogen sulfide odor, and indicators of hydrology including drift patterns, saturation, and groundwater at the soil surface were observed.

In order to determine the regulatory boundary of salt marsh, the spring high tide elevation must be depicted on a topographic plan of the Site. According to the National Oceanic and Atmospheric Administration (NOAA), the estimated spring high tide for the Site is 3.78 feet (NAVD88)<sup>1</sup>. Any area of coastal wetland upgradient of the spring high tide elevation, but below the flagged coastal wetland boundary, would be categorized as a contiguous brackish wetland. According to preliminary topographic survey data, this coastal feature appears to be located entirely below the spring high tide elevation and is therefore considered salt marsh.

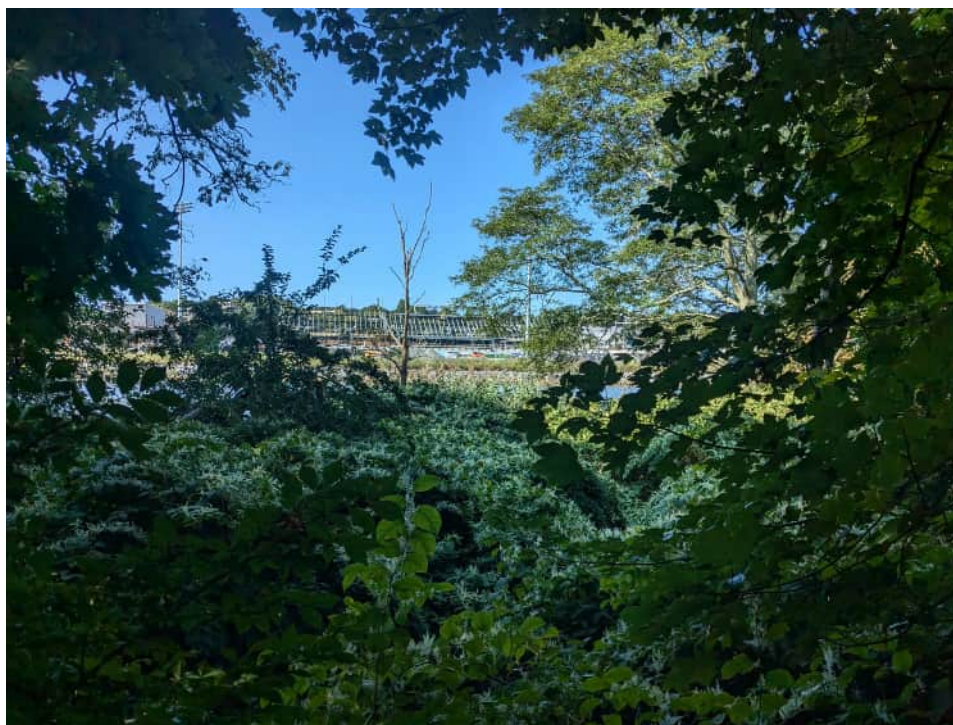
Photo 4

View of a stand of common reed (*Phragmites australis*) at the western extent of the wetland (background) and the dense stand of adjacent Japanese knotweed (*Reynoutria japonica*) - facing west.

The topographic depressions north and south of the WF1 Series salt marsh were also assessed for coastal wetland indicators. While soils in these areas would qualify as hydric (depleted matrices below dark surfaces), the vegetative community is entirely dominated by Japanese knotweed (*Reynoutria japonica*), an upland species. In addition, the presence of sandy mineral soils (likely fill) adjacent to the histosol soils within the wetland suggests that these areas are less influenced by tidal inundation and have been degraded by adjacent anthropogenic activities. Therefore, these areas would not qualify as wetlands under present day existing conditions; however, they are located within the coastal bluff as noted in the next section of this report.

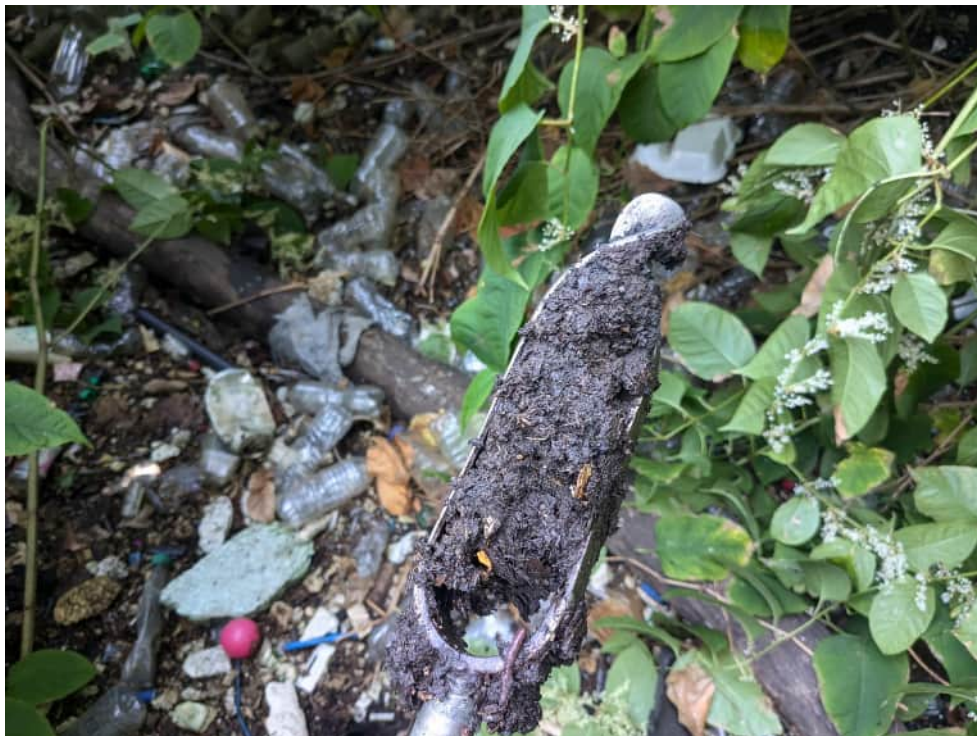
**Photo 5**

View decomposed organics within the delineated wetland.

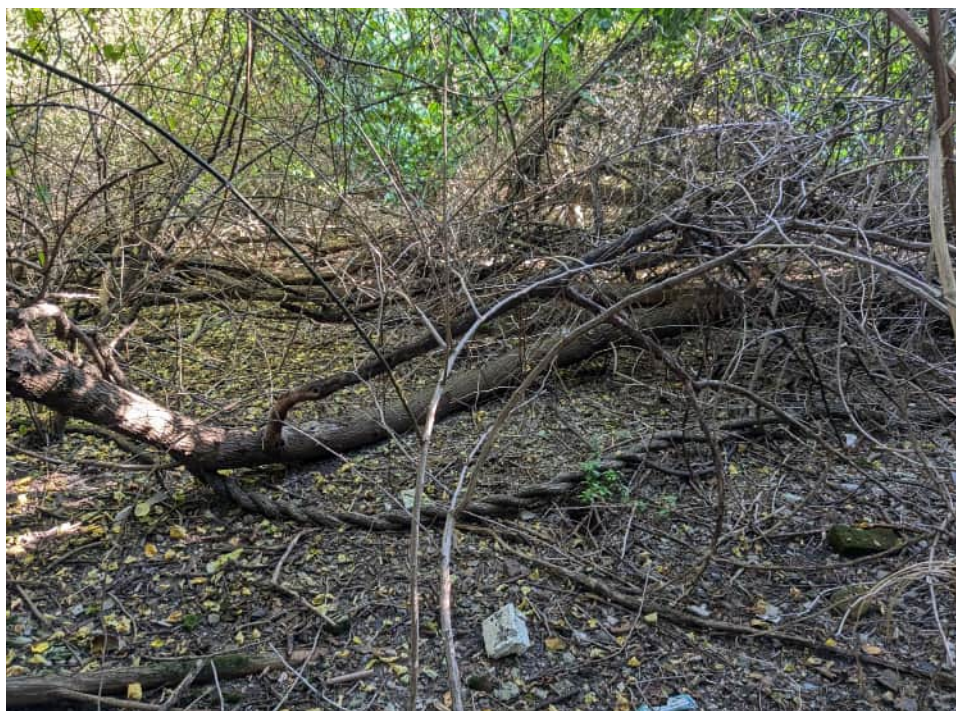
**Photo 6**

Typical view of a low-lying area within the central portion of the Site that did not qualify as a wetland—facing east.

Freshwater wetlands subject to 250-RICR-150-15-3 and/or 650-RICR-20-00-9 were not observed at the Site. Although additional topographic depressions were observed along the western portion of the Site, these areas did not qualify as wetlands (freshwater or brackish) due to the presence of gravelly fill with shallow refusal and predominately upland vegetative communities.

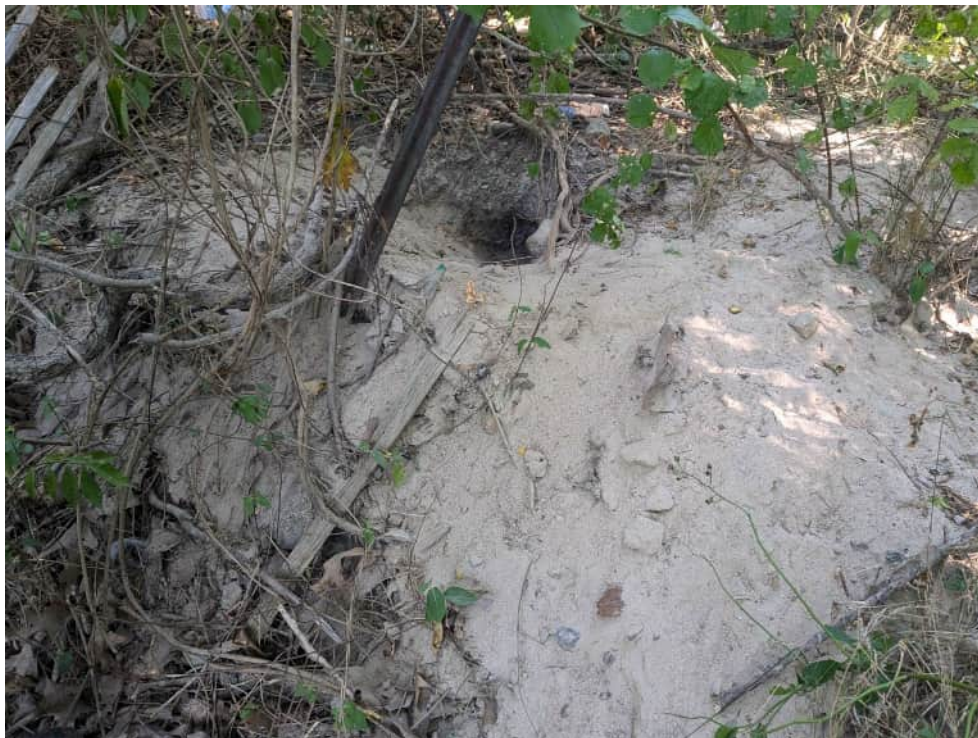
**Photo 7**

View of an unidentified mammalian den and sand along the northwestern portion of the coastal bluff—  
facing east.
