Block Island Wind Farm CVA

Status of Verification of Substructure
Installation (July 19 to November 24)

November 24, 2015

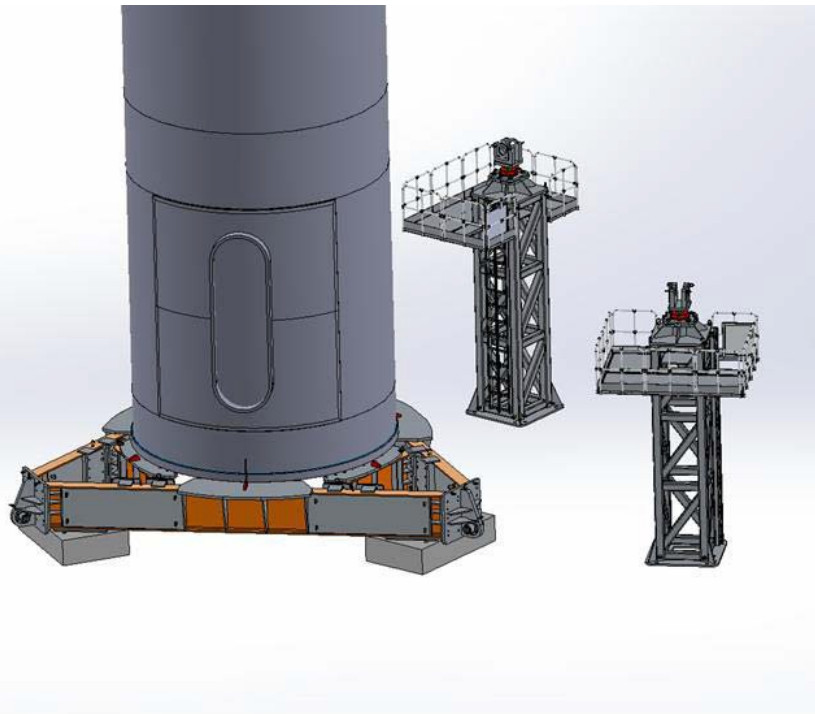
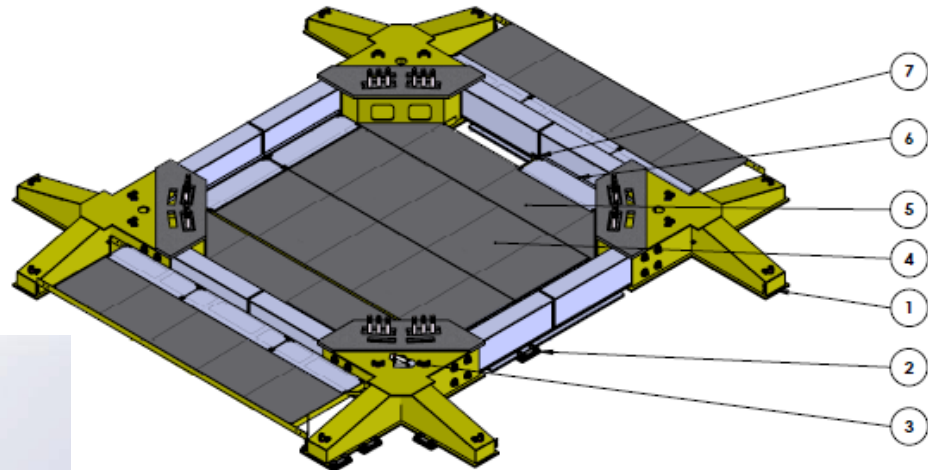
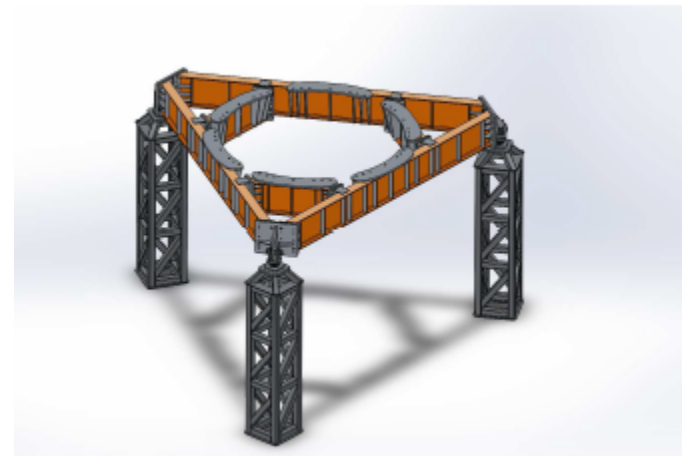
Status – ProvPort Tower Assembly

ABS is reviewing design calculations for concrete footings to hold tower storage frames and assembly frame.
