RHODE ISLAND SOUTH SHORE:
Hazard Rocks, Narragansett

SHORELINE CHANGE FROM 1939-2014

J.C. Boothroyd, R.J. Hollis, B.A. Oakley and R.E. Henderson

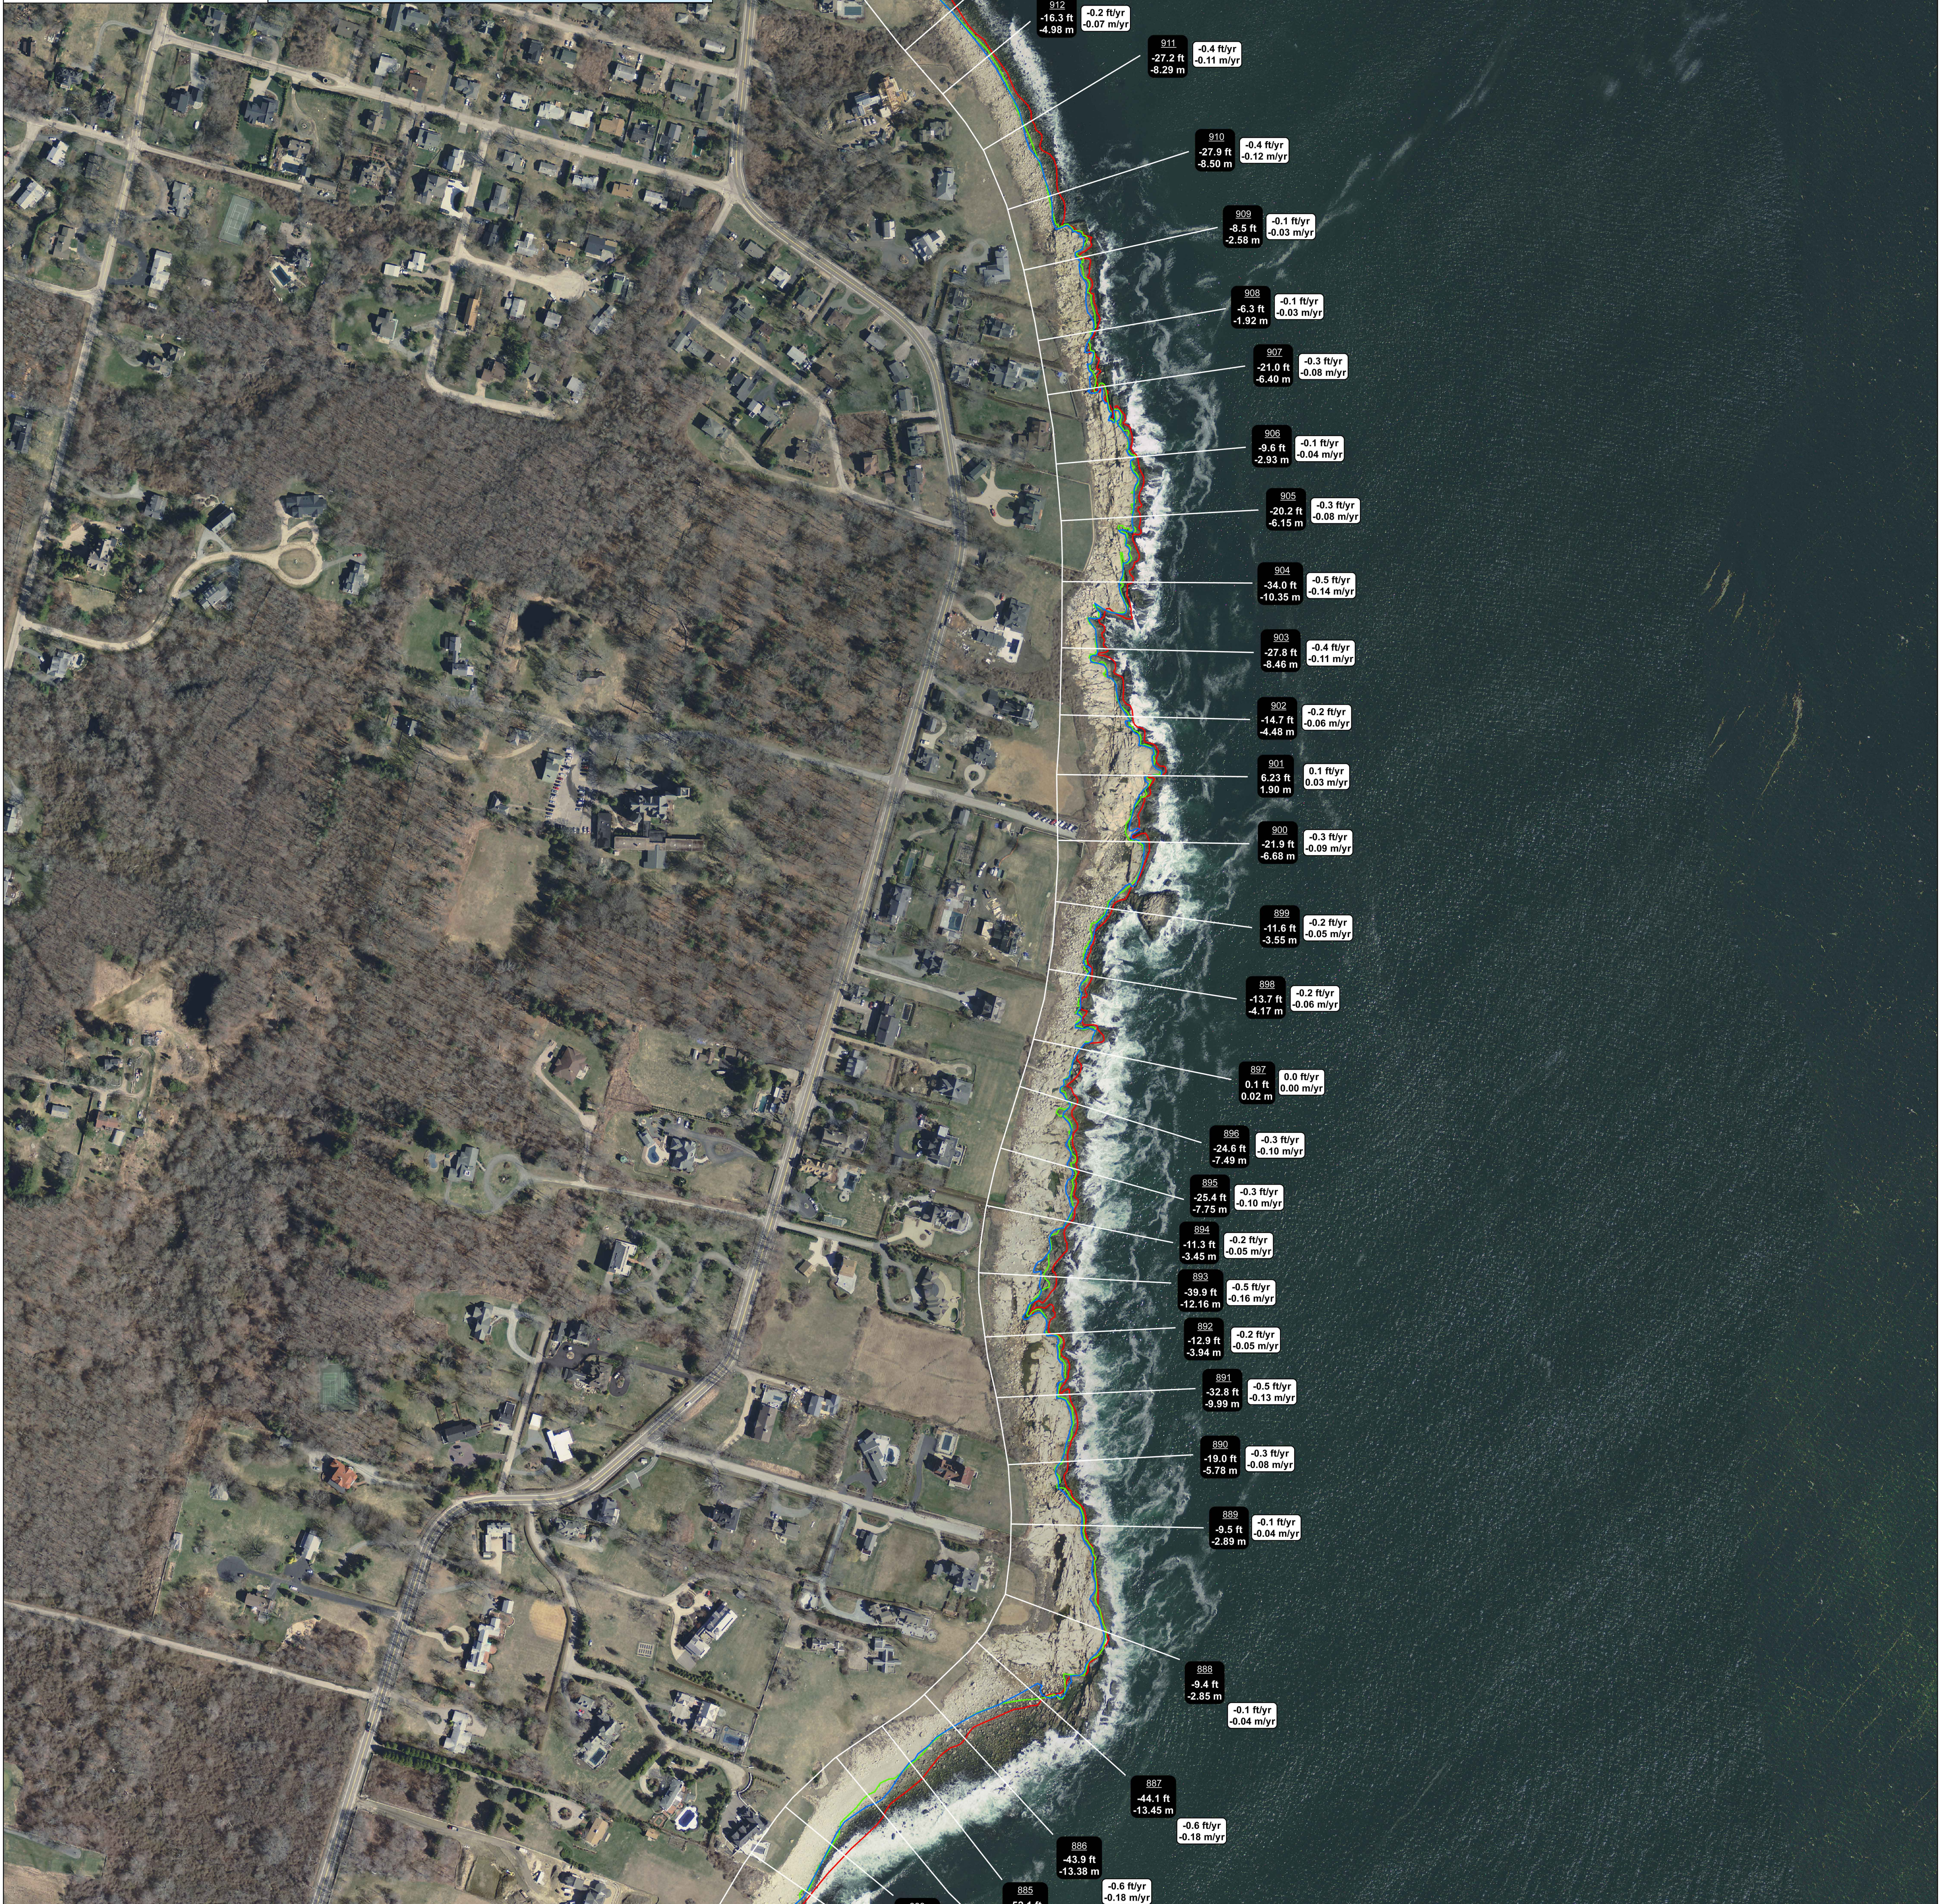
DIGITAL SHORELINE ANALYSIS

SHORELINES
Wet/Dry Lines

SHORELINE CHANGE
Transect ID: 26

DSAS Transect
 1939
 2012
 Shoreline Change Distance
 -27.5 ft
-8.4 m

Shoreline Change Rate: -0.4 ft/yr, -0.1 m/yr

2014 USGS Orthophotography Base
